In-Situ Repair of TPS

Mike Fowler

JSC

1/30/17

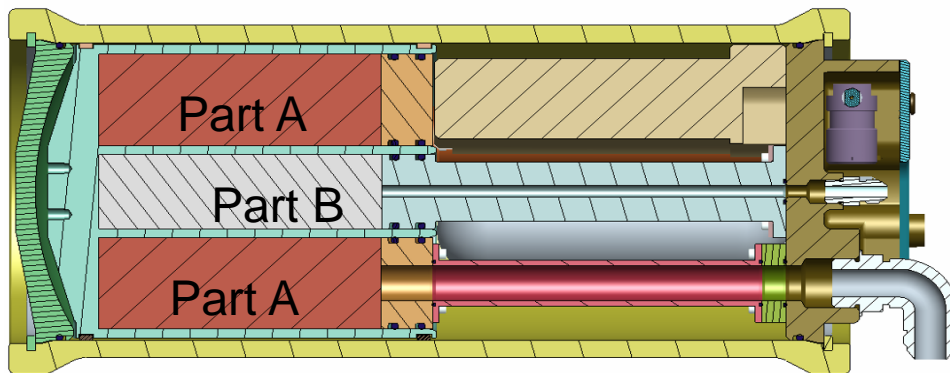
Pre-dispense

- Tile Repair Ablator Dispenser (T-RAD)
 - Smaller – dispense volume of 70 in³, about the size of handheld vacuum cleaner, could be stowed in mid-deck lockers
 - Parts A and B contained in bags, T-RAD punctured bags for mixing in static mixer, contained materials, allowed for inspection of material
 - Sold as repair for door seals

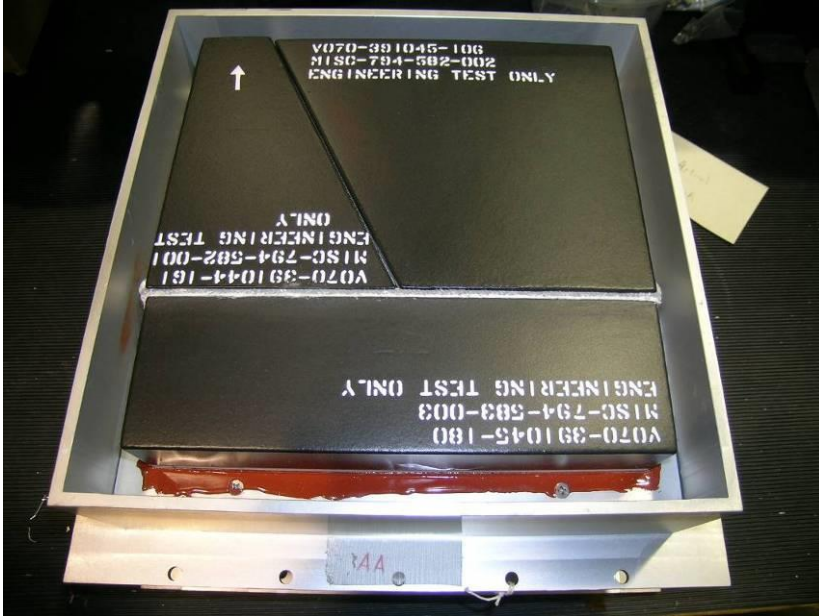
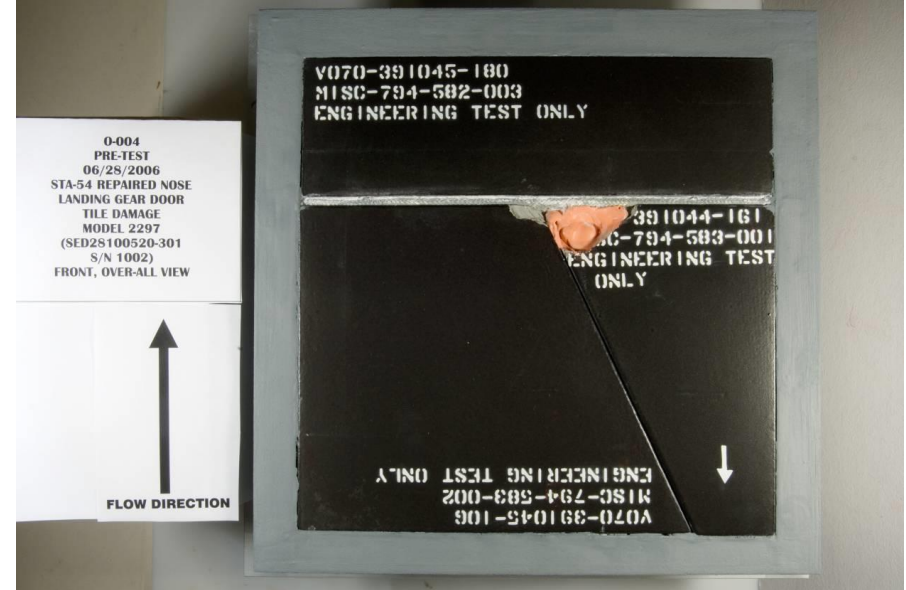
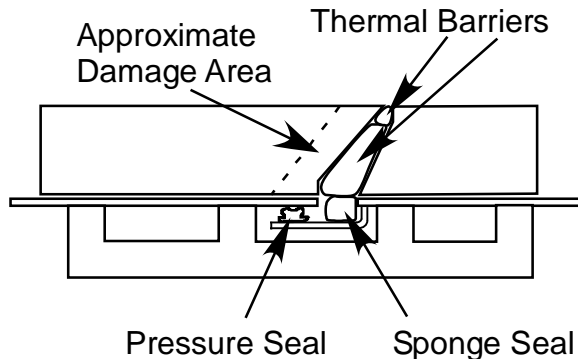
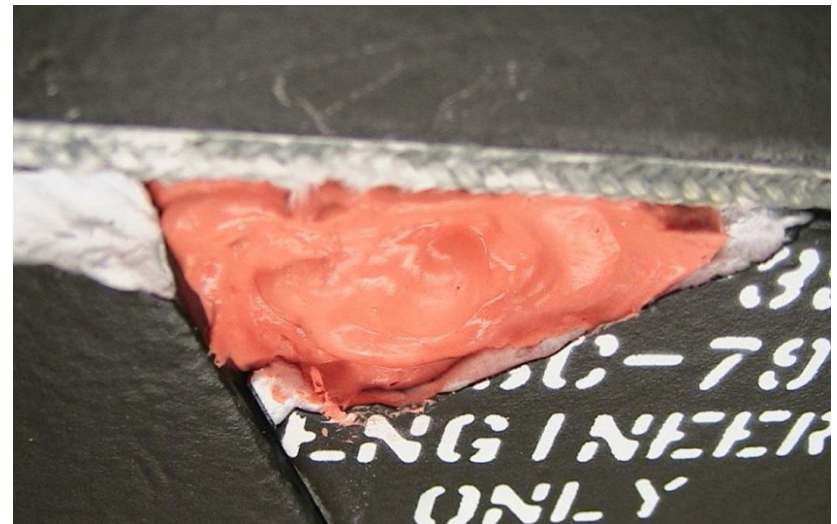
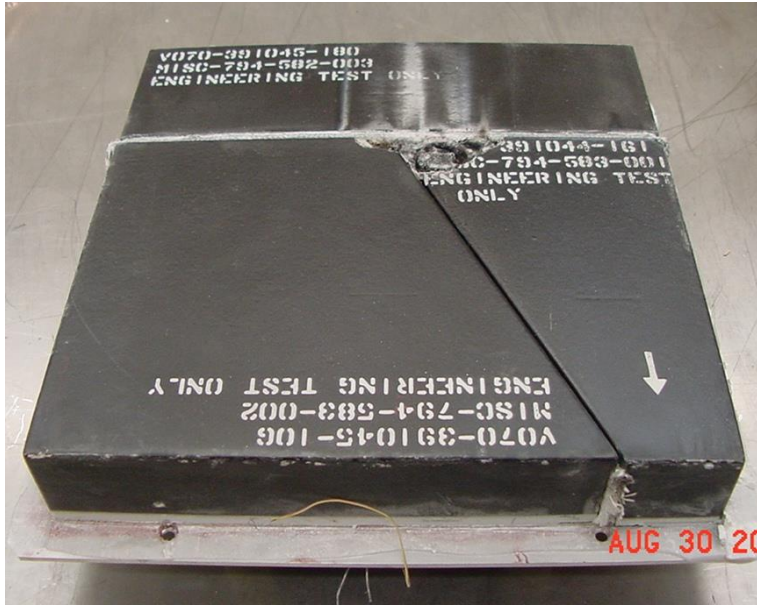
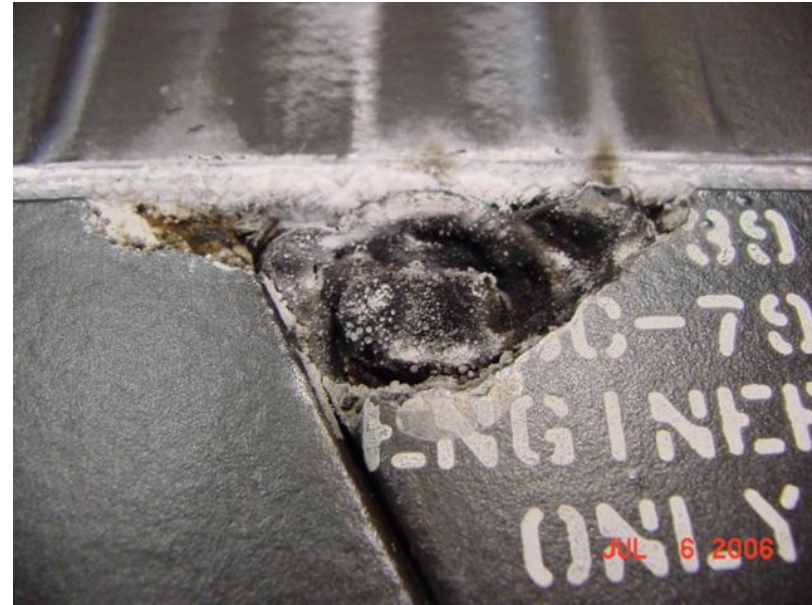
NLGD Test

- Objective
 - Demonstrate STA-54 would seal flow path in test article, protecting underlying structure
 - Demonstrated swell of STA-54 would not detrimentally affect the surrounding TPS
- Test Article
 - Three tiles
 - Structure had interface similar to door with thermal barriers and seal
 - Hole drilled in tile down to structure
 - Two holes drilled in structure to give flow path should plasma breach repair
 - Vacuum applied to back-side of article to ensure ΔP

No-swell
above OML
