# Emergency Locator Transmitter Survivability and Reliability Study

*Chad M. Stimson*<sup>cpf</sup> *Justin D. Littell*  
*Langley Research Center, Hampton, Virginia*

*Lisa M. Mazzuca*<sup>cpf</sup> *Anthony W. Foster*  
*Goddard Space Flight Center, Greenbelt, Maryland*

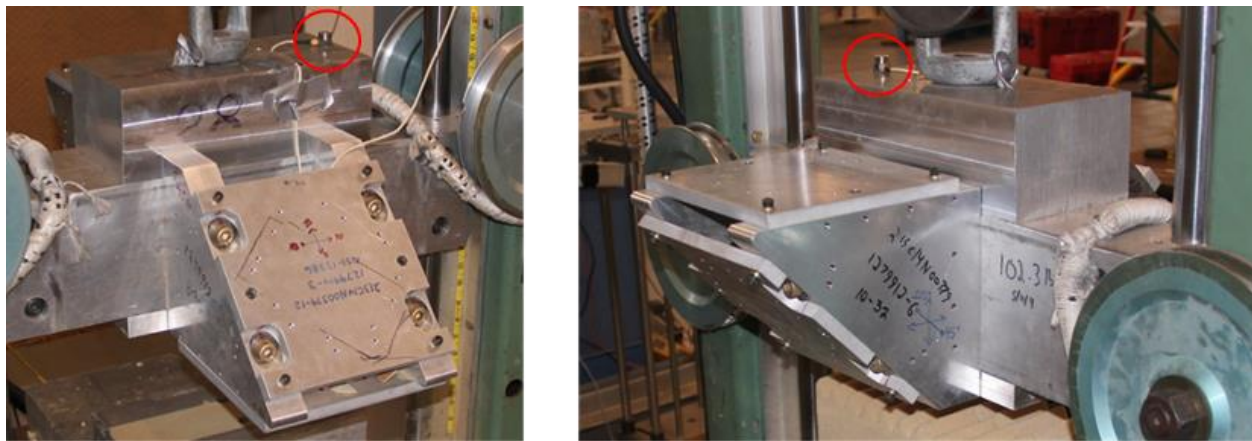
Figure 2. Crash Safety Test Fixtures (accelerometer highlighted)

In the final case of interest, another system that utilized a TSO C-126b compliant mounting system was observed to demonstrate the phenomenon of beacon ejection in a repeatable fashion. The sensitive orientation for this system was when mounted to one of the triangular, side-facing mounting planes shown in Figure 2, with the beacon primary sensing axis clocked 45° with respect to the drop direction. Rather than a metallic strap and clasp system or hook-and-loop fastener, this mounting system utilized a synthetic fabric strap and plastic buckle. As such, this finding is a motivating example of the need for improvements to the existing performance-based requirements, rather than elimination of a single design characteristic based on real world outcomes.

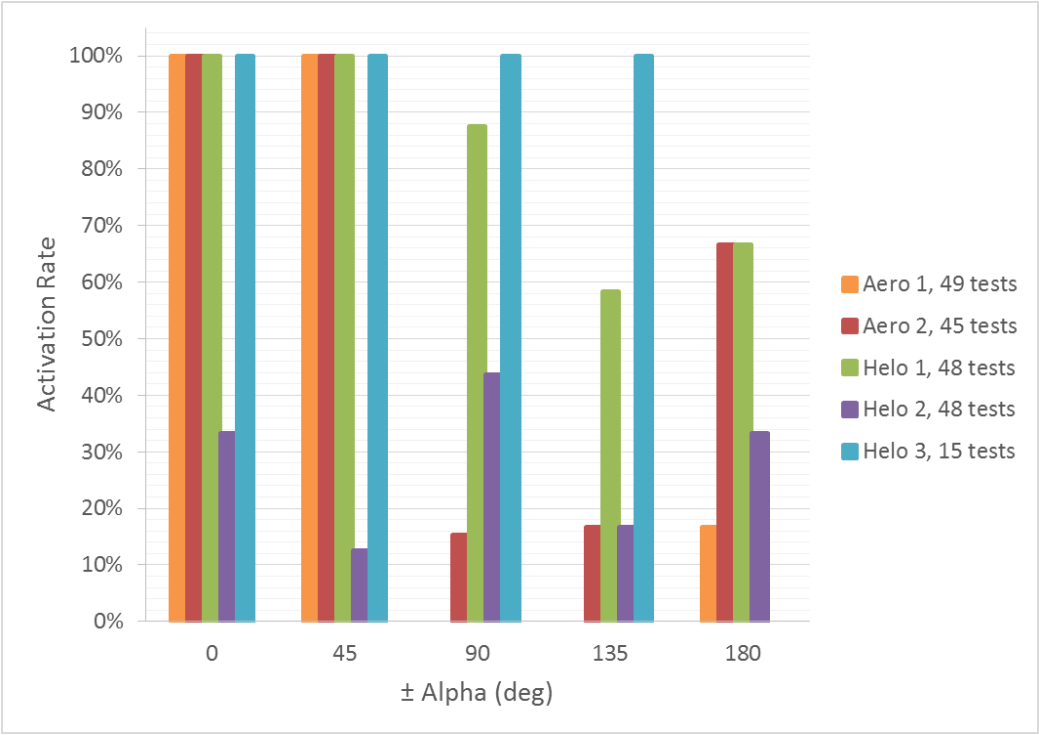
Figure 4. Crash Safety Test - Automatic Activation Rate as a Function of Beacon Orientation

Figure 4 summarizes the activation rate for the 5 ELTs tested as a function of the crash sensor orientation with respect to the gravity vector. The term “Aero”, or “airplane”, is used to refer to an ELT with a single-axis crash sensor and “Helo”, or “helicopter”, is used to denote a six-axis crash sensor. “Helo 3” incorporated a solid-state crash sensor, whereas all others employed mechanical crash sensors, or g-switches.

As shown in Figure 4, all but one of the units tested activated automatically 100% of the time when the crash sensor was oriented within  $\pm 45^\circ$  of the gravity vector. Outside of that range, performance decreased significantly for the mechanical g-switch equipped units. The only unit to activate automatically in response to every test was “Helo 3”, which used a solid-state, six-axis crash sensor. It was not possible to test this unit in the + or -  $180^\circ$  orientations due to interference issues with the test facility.

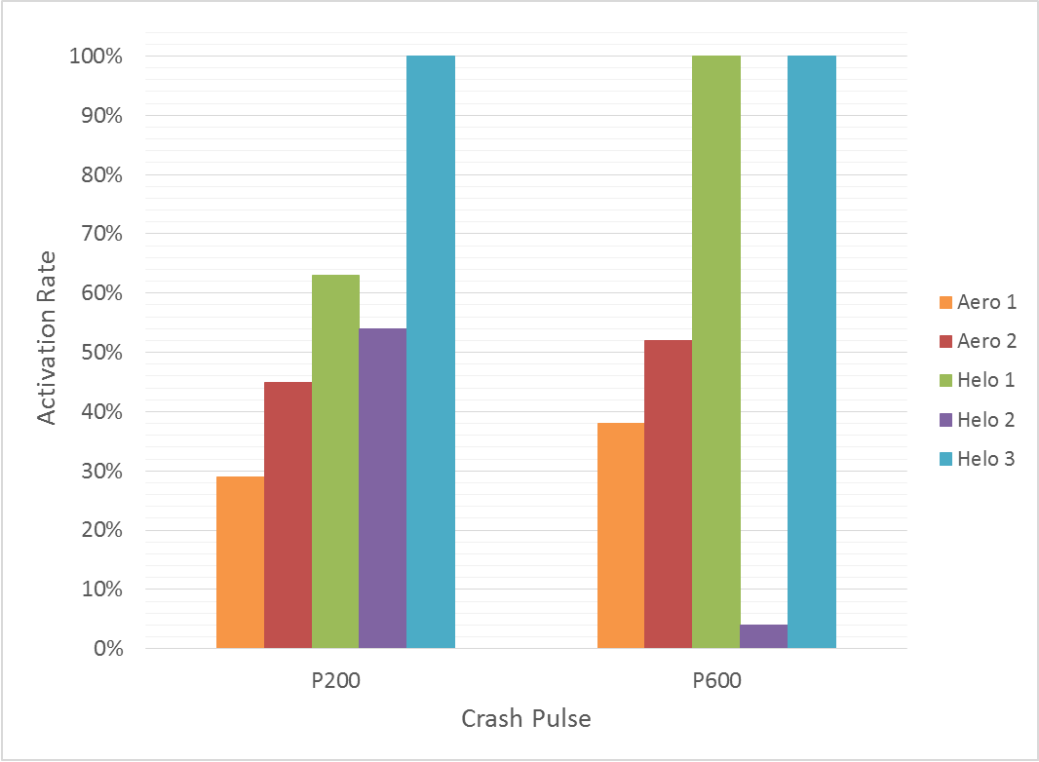
Figure 5. Crash Safety Test - Automatic Activation Rate as a Function of Pulseform

Figure 5 displays the activation rate for each ELT as a function of crash pulse. As discussed above, P200 was the lower-g, longer duration pulse with respect to P600. As can be seen, the activation rate is higher in response to the higher-g, P600 pulse, for 3 of the 5 units tested. 1 of the units performed best when subject to the P200 pulse and, again, the unit with the solid-state crash sensor activated in all cases, regardless of pulseform.

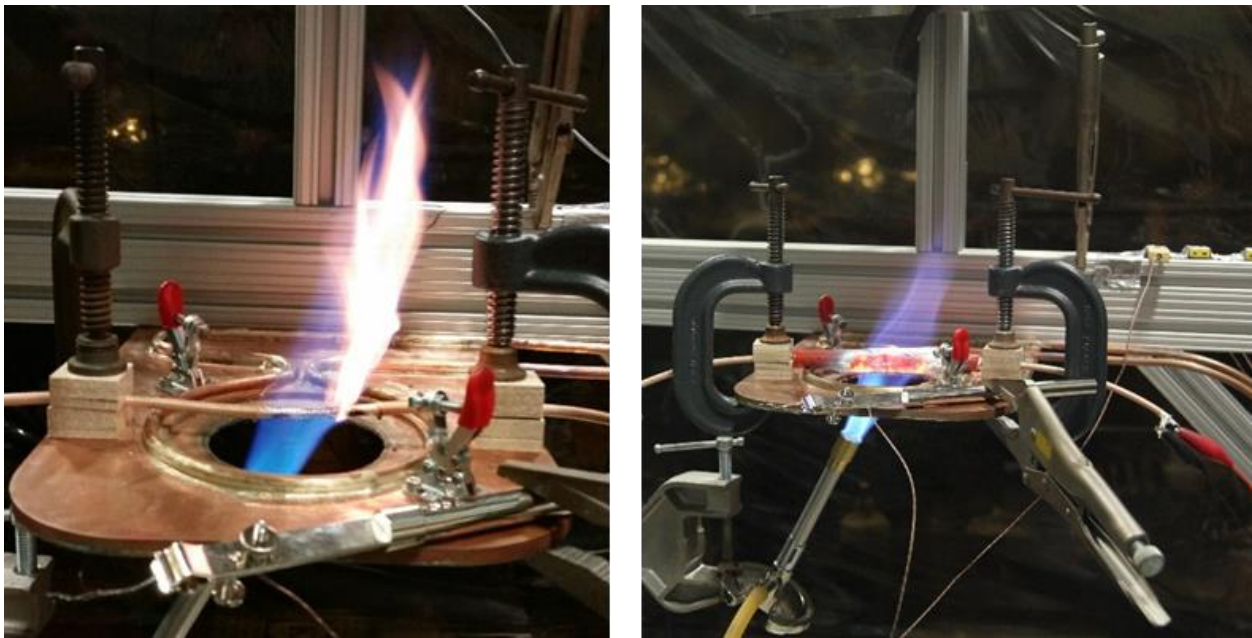
*Figure 11. Fire Testing of an Antenna Cable without (left) and with (right) a Firesleeve*

A variety of ELT antenna cables were tested with and without a variety of commercially available thermal insulation materials. The cables were directly exposed to a 2,000 °F flame and the time to loss of electrical continuity was recorded. The temperature was measured by a thermocouple placed directly in the flame before and after each test.

A Bunsen burner provided the flame, which enveloped a 1-2-in length of the cable under test. Thermal insulation products tested included an intumescent tape and a variety of firesleeves that are all marketed for the purpose of protecting electrical cables. A picture of a cable and firesleeve undergoing fire testing is shown in Figure 11.

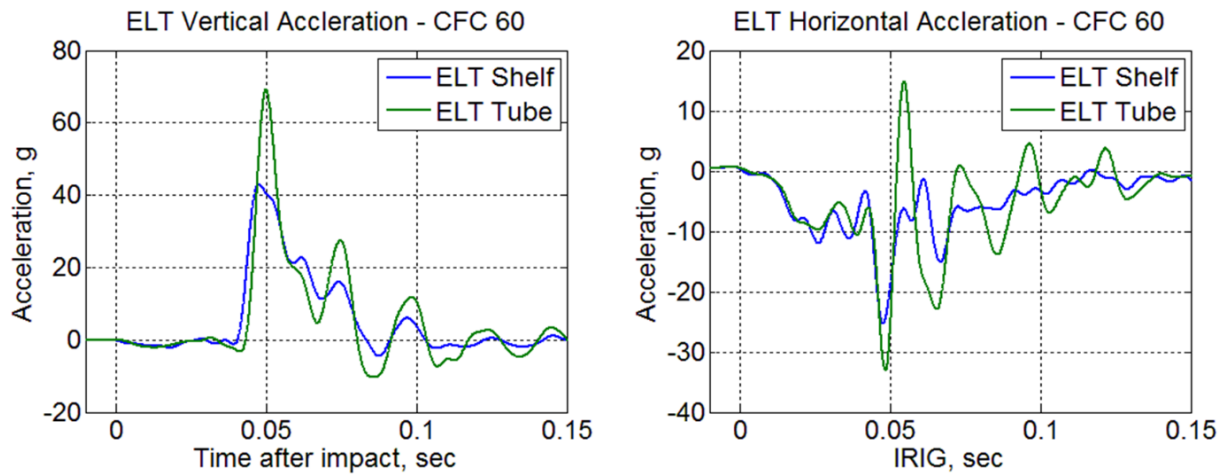
Figure 18. ELT Acceleration Time-History Onboard TRACT 2

Accelerations were recorded for both the ELT shelf and box tube and are presented in Figure 18. All acceleration data was filtered at a Channel Frequency Class (CFC) low-pass filter of 60 Hz, which is the cutoff frequency for vehicle structural responses as called out in [23].

The peak acceleration values differ between the shelf and tube responses, as the tube maximum was approximately 69-g, while the shelf maximum was approximately 43-g in the vertical direction. This difference is due to the flexure mode of the shelf, which amplified the acceleration peak. The ELT shelf accelerometer was mounted on the aft-right corner of the shelf, near the cockpit vertical wall, adjacent to the shelf-to-wall attachments. This placement was a more rigid configuration with minimal shelf deflection.

Comparing the measured accelerations to Figure 7, the TRACT 2 environment should have resulted in automatic activation of each ELT, regardless of the variations in beacon orientation.

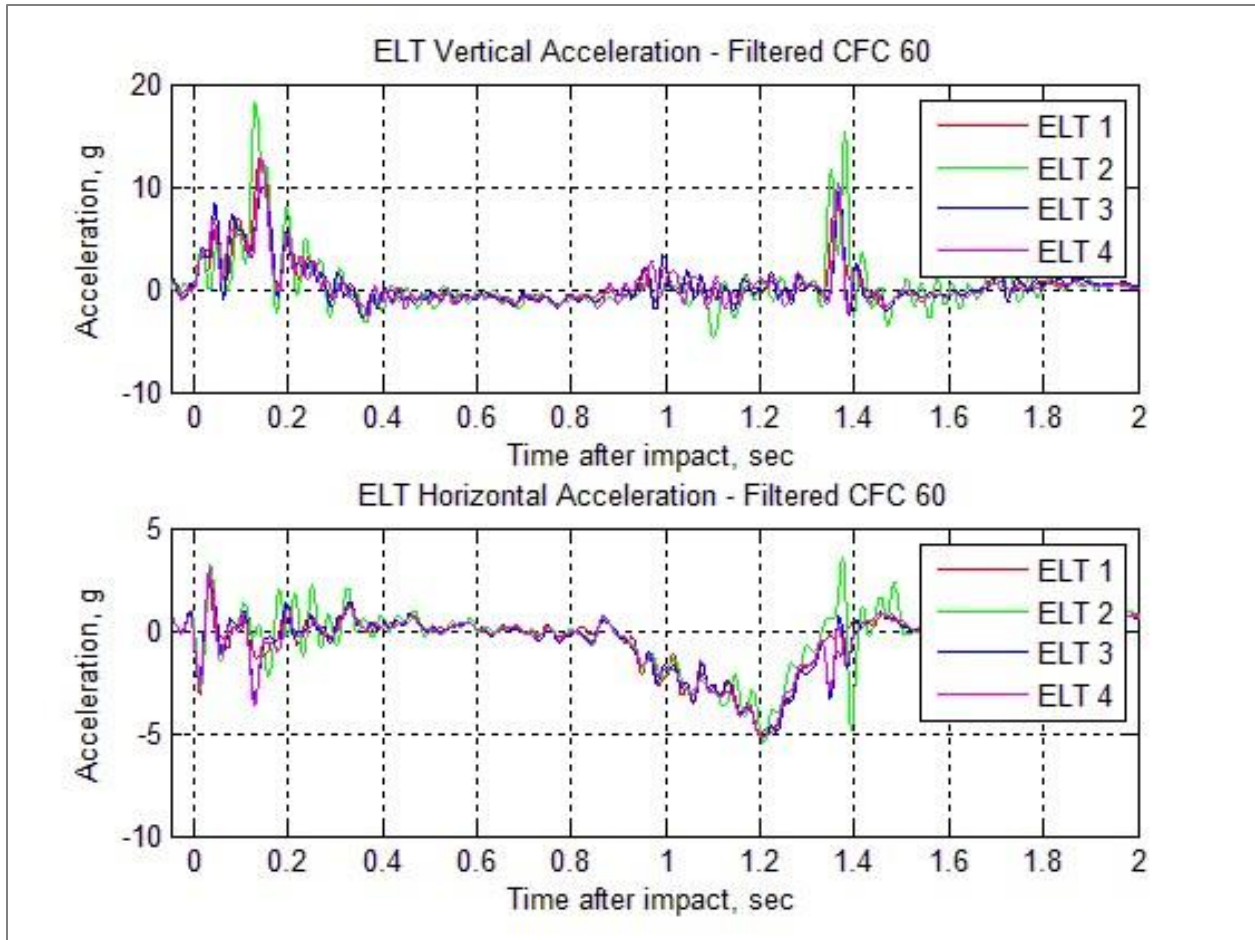
Figure 22. Beacon Accelerations - Airplane Crash Test 1

Figure 22 shows the acceleration environment experienced by each ELT beacon. Ground impact corresponds approximately from time 0- to 0.4-sec as shown in the vertical acceleration plot. Net impact corresponds approximately from time 0.9- to 1.6-sec as shown in the horizontal acceleration plot.

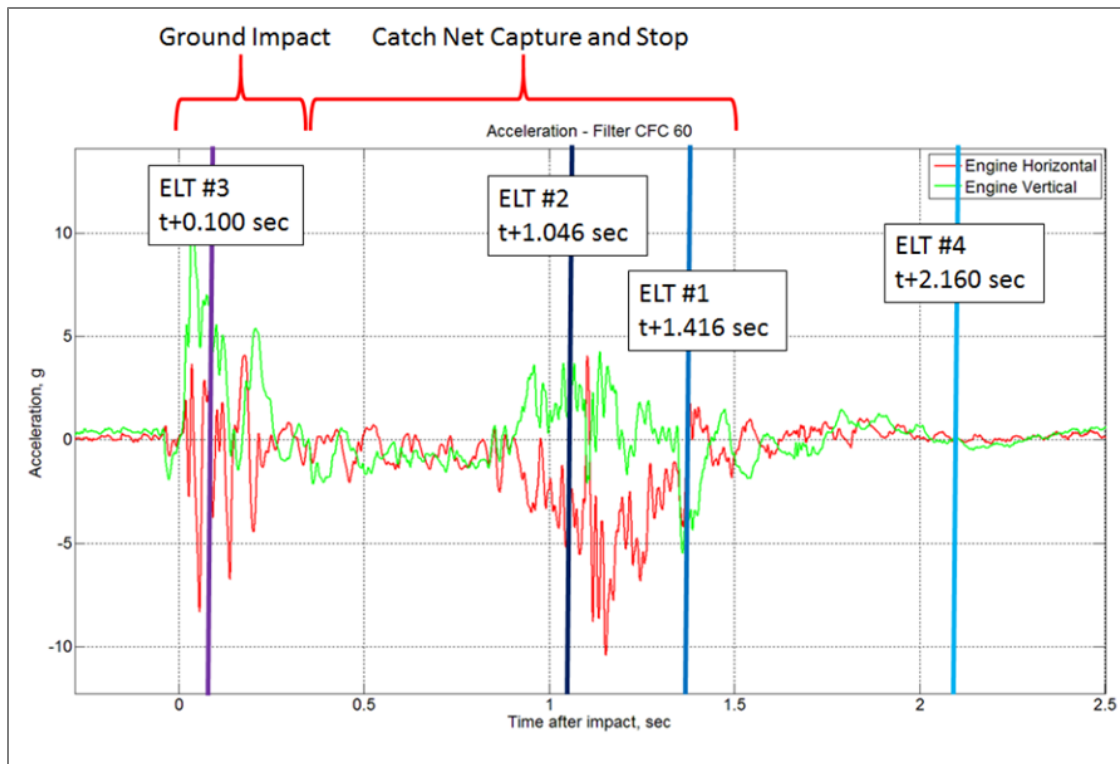
Figure 23. Relative Timing of ELT Visual Status Indications

Figure 23 compares the relative timing of the visual status indicators for each ELT to the acceleration environment measured in the engine compartment.

Further review of time-synchronized, high-speed video recorded during crash safety testing of another unit of the same model as ELT 1 provided evidence that the time delay between the triggering event (initial impact) and illumination of the visual indicator was approximately 0.4-sec. Comparison of this value to the results shown above suggests strongly that ELT 1 was triggered by the (primarily horizontal) acceleration environment generated by impact with the catch net approximately 1.0-sec after initial ground impact (primarily vertical acceleration). Given that ELT 1 possessed a single-axis g-switch aligned with the horizontal direction, the assessment above seems reasonable, although not conclusive.

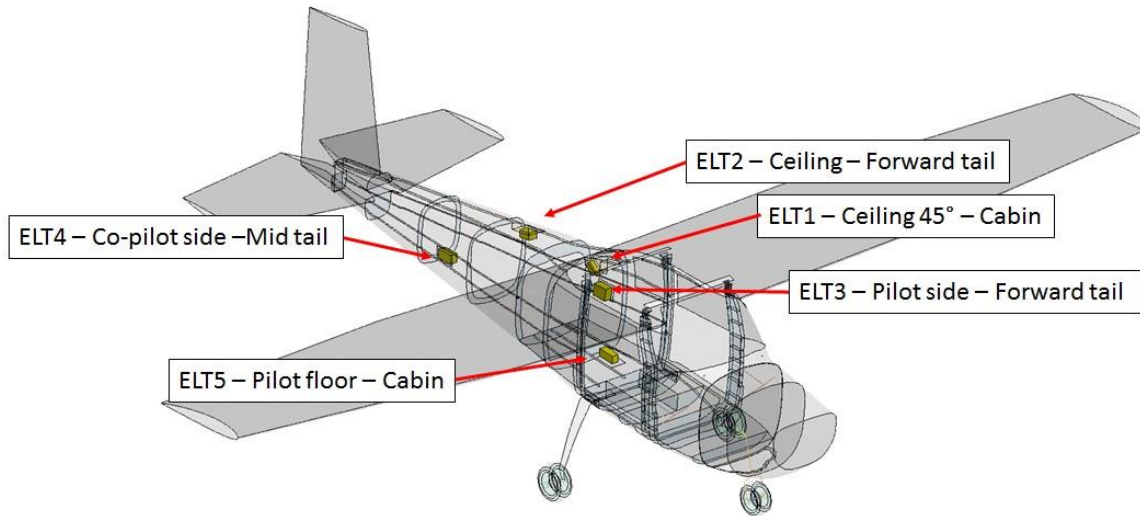
Figure 25. Beacon Layout - Airplane Crash Test 2

The layout of the 5 ELT beacons installed onboard the aircraft is depicted in Figure 25. Again, these installations represent a range of typical GA aircraft configurations. The ELT 1 beacon was installed in the typical fashion for helicopter applications when using an ELT with a single-axis crash sensor (cabin ceiling mounted at a 45° nose-down orientation). ELT 2 was a “helicopter model” containing a collection of six g-switches. These types of models are to be installed flatwise

and again, a ceiling-mounted configuration was selected aft of the ELT 1 beacon. ELTs 3-5 contained single-axis, mechanical g-switches and were located as shown.

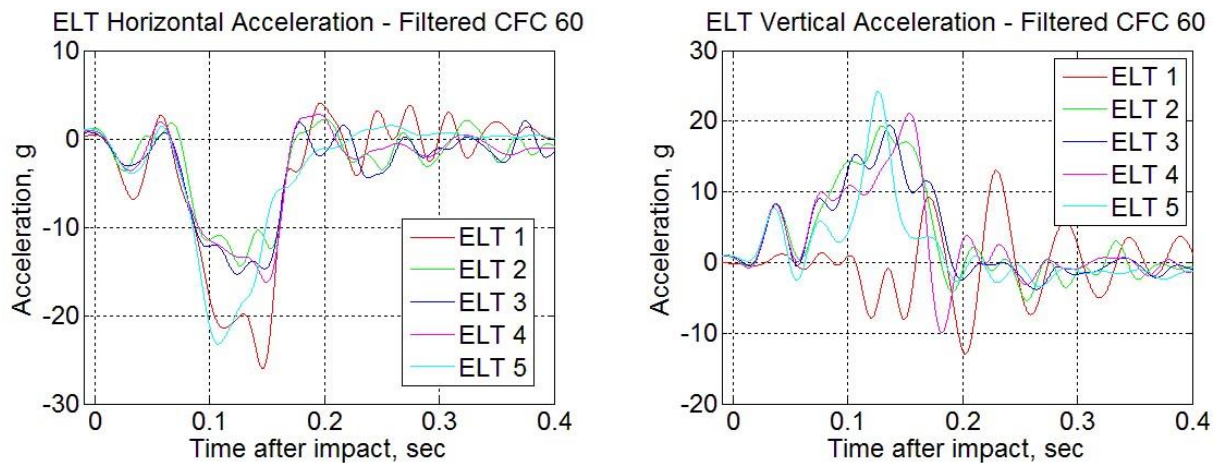
Figure 26. Beacon Accelerations - Airplane Crash Test 2

The acceleration environment experienced by each ELT beacon is shown in Figure 26. The relative amplitude and duration of loading experienced by each unit varies depending on installation location and orientation.

The largest horizontal loads were experienced by the forwardmost beacons, ELTs 1 and 5, which were installed in the cabin. In general, peak accelerations across the entire set ranged from 10- to 26-g and the pulseform can be described as trapezoidal of approximately 120-msec duration.

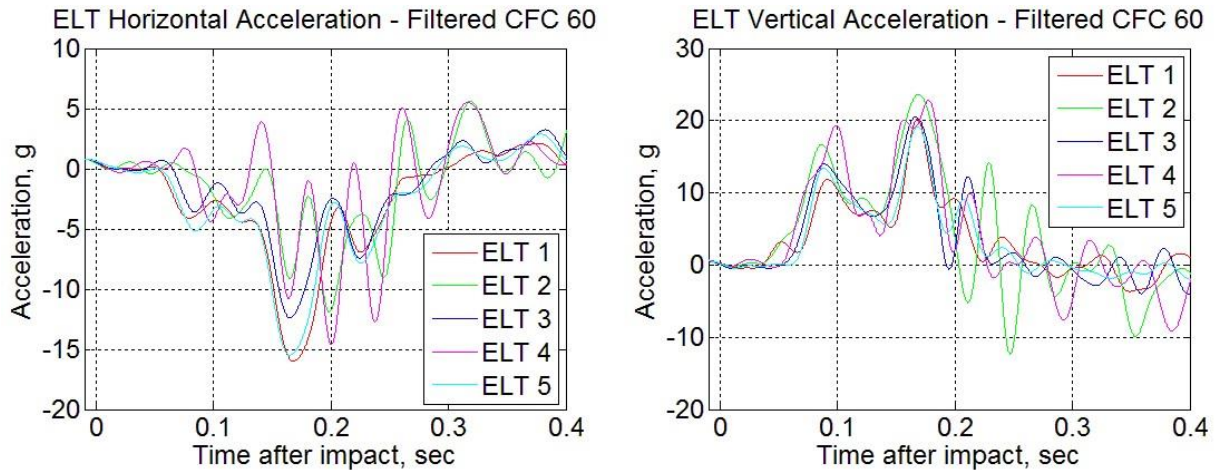
Figure 30. Beacon Accelerations - Airplane Crash Test 3

Figure 30 shows the acceleration environment measured at each beacon location during the third crash test. Variations in magnitude and dynamic content seen in the horizontal acceleration data are attributed to the large airframe deformation and structural failure of the fuselage at the cabin-tail juncture. As shown in the lower left view of Figure 28, the tail was almost completely severed during the sequence. The recorded acceleration environment at each ELT location exceeded the minimum threshold for automatic activation.

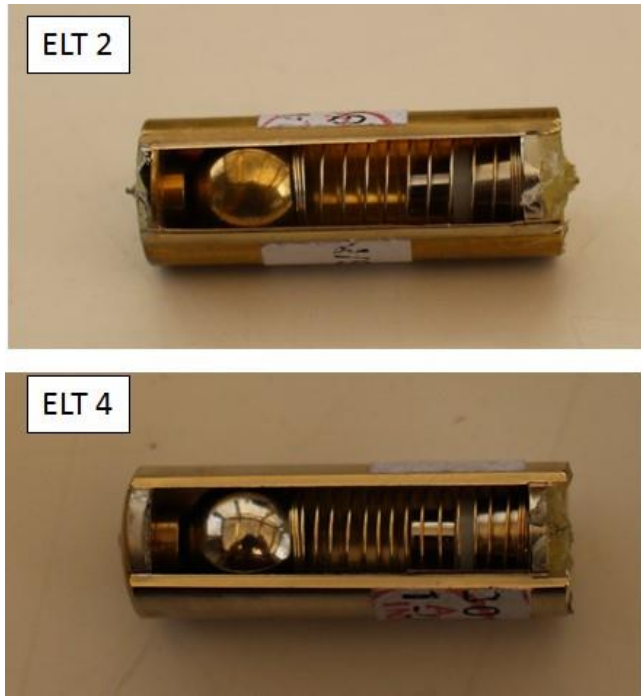
Figure 31. Cutaway View of G-switch Assemblies

ELT 2 passed post-crash internal self-test per the manufacturer’s instructions and activated automatically when armed and shaken by hand. This procedure indicated that the crash test performance was due to the g-switch failing to trigger. ELTs 2 and 4 were both disassembled and inspected. Although both systems were acquired in a single purchase order, the g-switches were observed to be different. The coloring and finish of both cylinders and internal masses varied from a dull, brass-like appearance to shiny gold-like appearance. The number of coil winds also varied between the springs contained in each g-switch. These differences are visible in Figure 31.

The one ELT that failed to activate during the test was installed in a mirror configuration to an identical model that did activate during the test. Further inspection revealed that the failed g-switch was made of different materials and behaved differently under 1-g loading than the one that performed as intended.

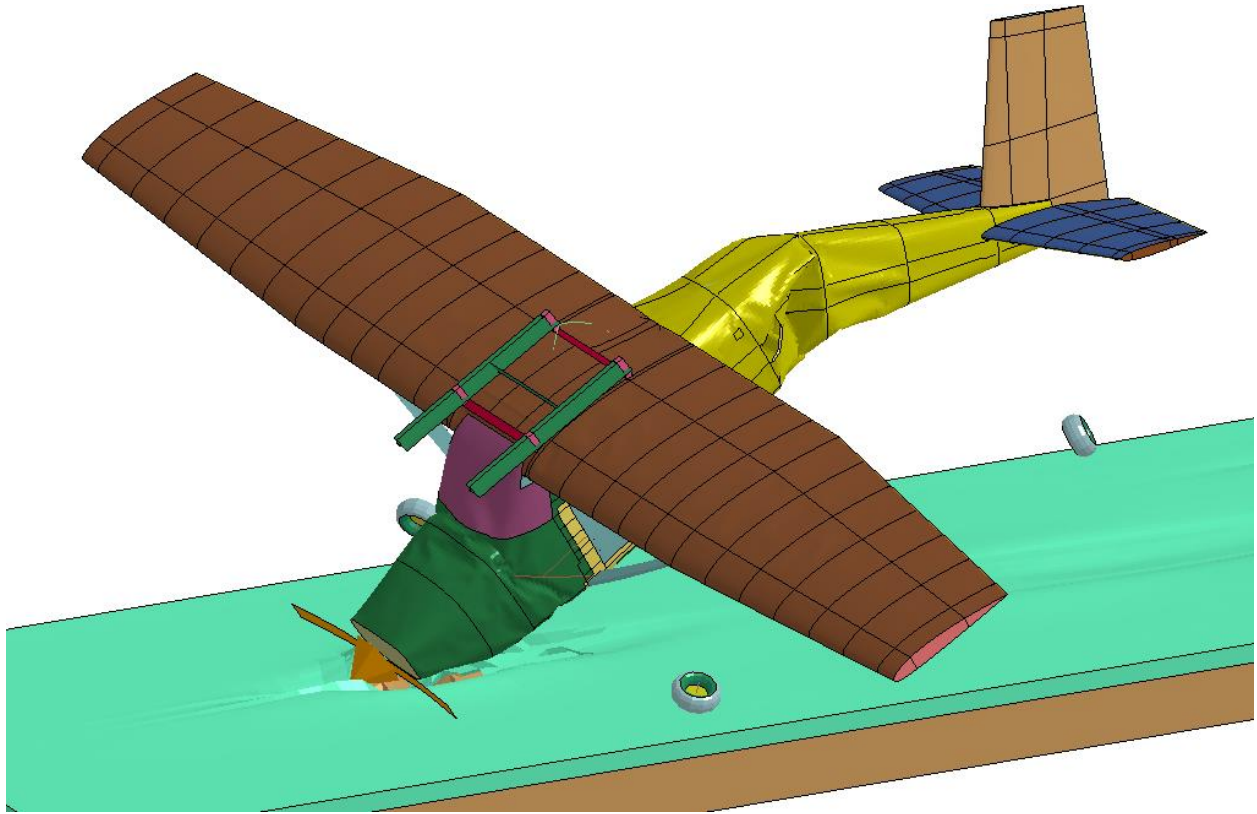
Figure 34. Simulation of Second Airplane Crash Test

Finite Element Models (FEMs) were constructed of each airplane and analyzed under tested crash conditions using LS-DYNA and Abaqus as detailed in [28] through [30]. After model calibration, a series of simulations were run with variations on aircraft pitch attitude, velocity and impact surface. Simulation results were then used to help formulate recommendations for ELT system installation. An example of one of the analysis model of the second airplane crash test is shown in Figure 34. Some internal modelling details can be seen in the half-model shown in Figure 35 (Note, DAS = Data Acquisition System).
