Post-test Inspection of NASA's Evolutionary Xenon Thruster Long-Duration Test Hardware: Discharge and Neutralizer Cathodes

Rohit Shastry and George C. Soulas

NASA Glenn Research Center, Cleveland, OH 44135, USA

Presented at the 52nd AIAA/SAE/ASEE Joint Propulsion Conference

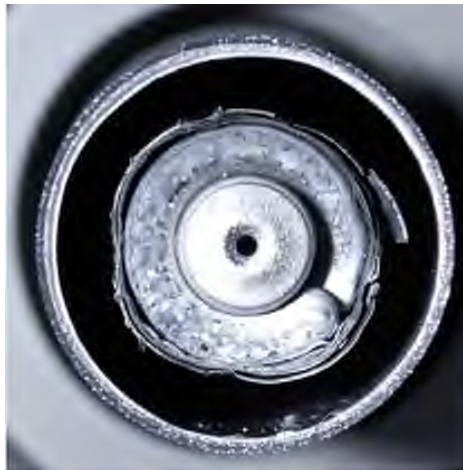
NSTAR ELT after 30,352 hours*

- Primary purpose of discharge keeper in NEXT is to protect cathode components (cathode tube, heater etc.) from discharge plasma
- Have observed significant erosion of downstream surface as well as orifice in prior life tests
 - NSTAR Life Demonstration Test
 - NSTAR Extended Life Test
 - NEXT 2,000 Wear Test
- Had changed material of NEXT keeper after results from 2 kh wear test to reduce sputter yield and increase keeper lifetime

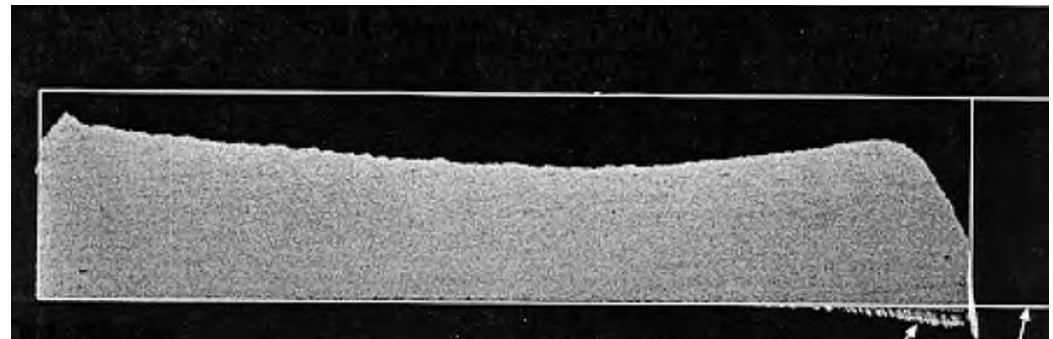
NSTAR LDT after 8,192 hours*

- Cross section of NEXT LDT keeper indicates maximum erosion was 15.8% of the pretest thickness, at a location of 39% of the total radius
- Results are remarkably close to the NEXT 2 kh wear test – observed maximum erosion of 17% of pretest thickness at location of 40% of total radius
- Minimum orifice diameter did not change significantly
- Deposition observed on upstream surface of orifice plate, similar to previous life tests
- Indicates **substantial** increase in keeper lifetime compared to NSTAR LDT and ELT, as well as NEXT 2 kh WT

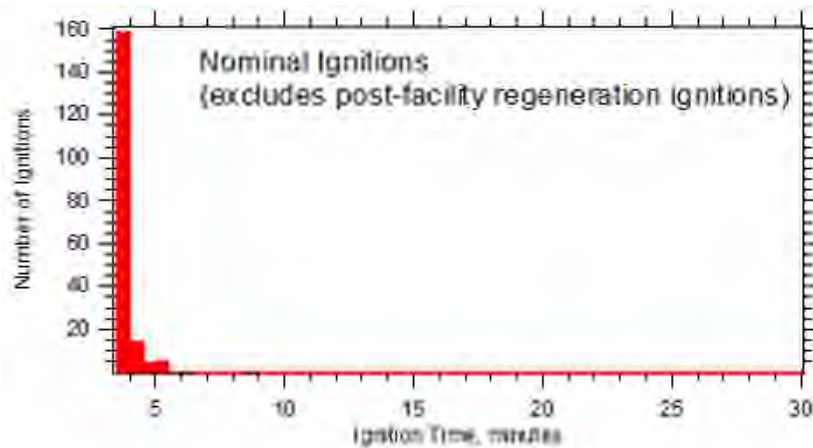
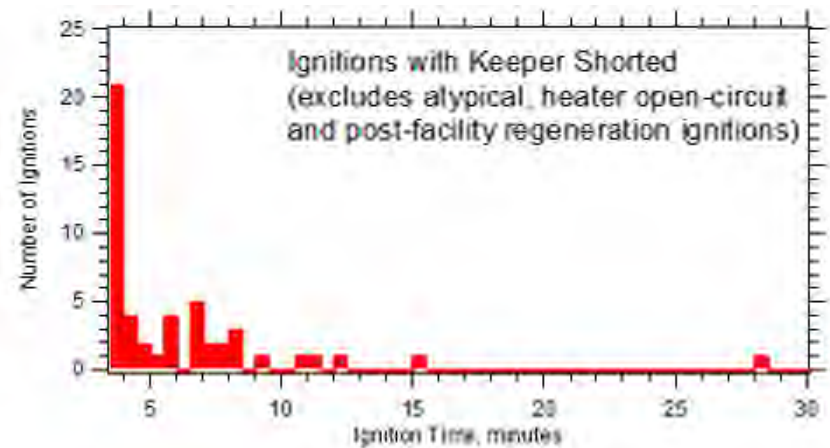
- Discharge cathode ignitions characterized in order to isolate effect of keeper-cathode short on ignition time
- Many factors found to affect ignition time during test, including:
 - Facility regenerations
 - Intermittent heater open circuits
 - Atypical conditions where ignition procedure was not strictly followed
- Isolating effect of keeper short indicates that average ignition time increased by ~ 2.5 minutes from 3 minutes 44 seconds to 6 minutes 5 seconds

- Presently investigating effect of attenuated igniter pulse (by nearly 2X) due to long electrical line lengths between thruster and power supplies

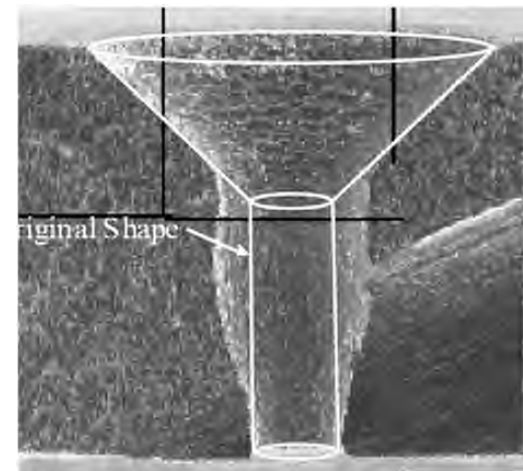
NSTAR ELT after 30,352 hours*

- Significant erosion of orifice chamfer occurred, with surface appearing somewhat porous
 - Indicates either net deposition or pitting similar to downstream surface
- Net deposition found in upstream cylindrical portion, decreasing minimum diameter by 8%
 - Material determined to be either from orifice plate itself or emitter
- Shape differs from what was found in NSTAR ELT, where downstream portion of chamfer remained intact and cylindrical portion exhibited “fluting”
 - Orifice dimensions and operating currents differ between two cathodes

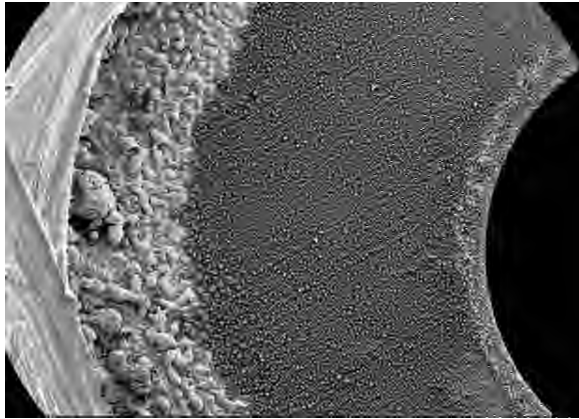
Neutralizer Common-GND Low Impedance

- Observed low impedance between neutralizer common and facility ground during test, sometimes as low as $\sim 10 \text{ k}\Omega$
- Found to be caused by deposition within low voltage propellant isolator
 - Deposition found to have come from metallic ends, likely caused by arcing within isolator
- Plasma shield with relatively high open-area fraction downstream of LVPI may allow plasma to seed breakdowns within LVPI
- Evidence of arcing also found in NEXT 2 kh WT LVPI, but not in PM1R
 - PM1R LVPI (and present design) has plasma shield with much lower OAF, potentially mitigating issue
