Topic: Orbiter Water Dump Nozzles Redesign Lessons Learned

Orbiter Water Dump Nozzles Redesign Lessons Learned

Hank Rotter

April 14, 2017

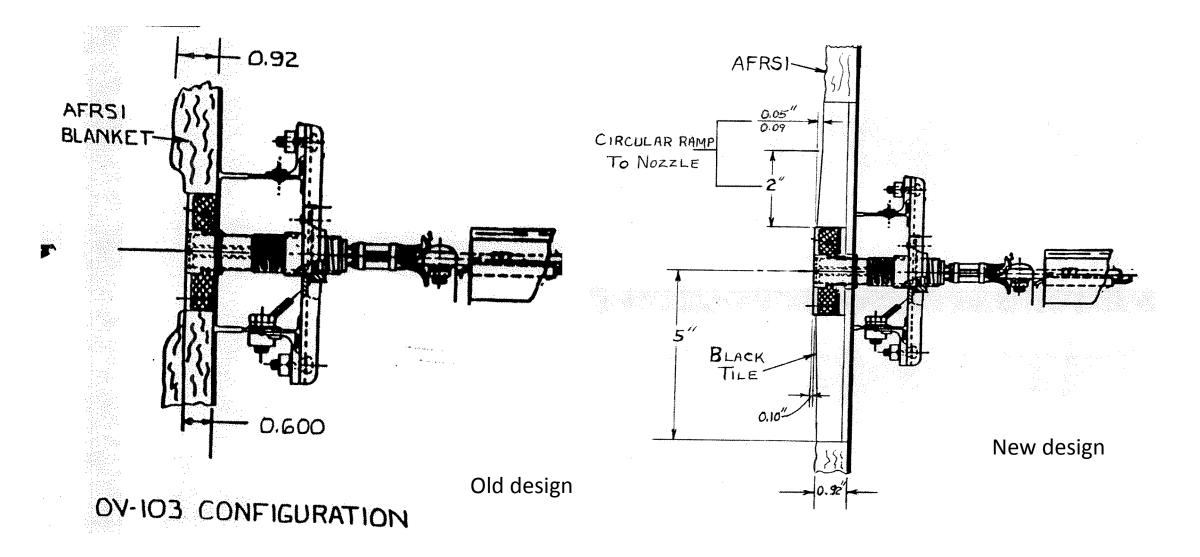
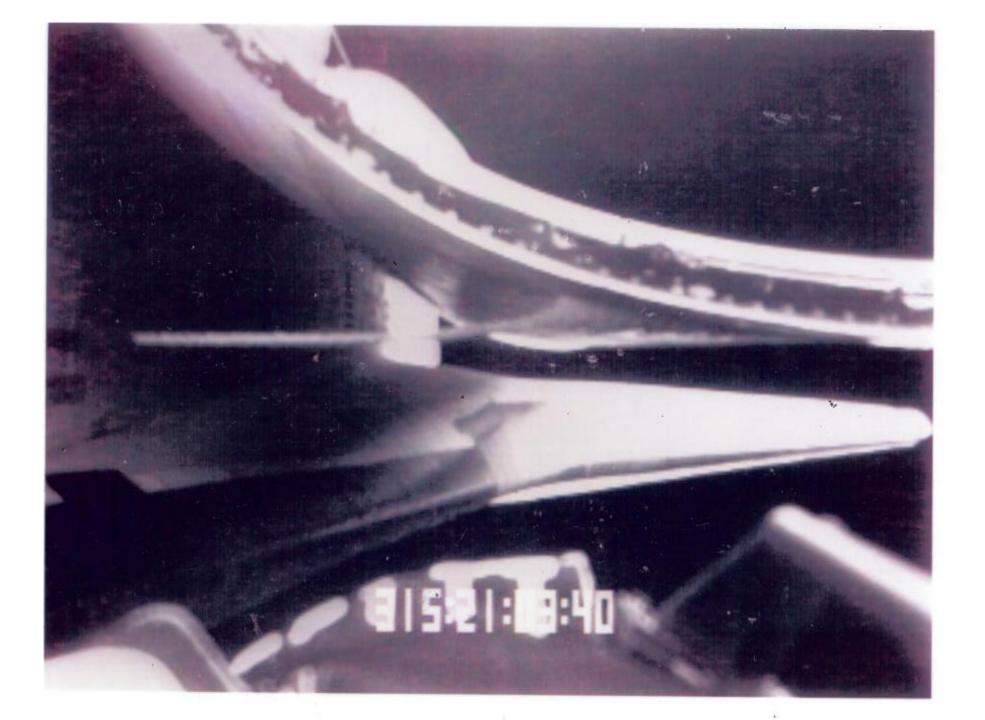
- One of the four sensor wells had a small water leak path through it and unusual temperature drops during the supply water dumps the first error.
- Rockwell or their vendor suggested putting a braze plug in the bottom of the sensor well about 0.1 to 0.2 inch thick.
- I assumed that they had a solder expert to review this, but no one did it.
- The next flight had two new nozzles installed with a braze plug, and we had the same problem with a water leak into a sensor well.
- Brazen requires two surfaces with no more than a 0.0005-inch thick layer of braze compound.
- Then we brazed a metal plug into the bottom of old nozzle sensor wells and changed the drawing to include a new nozzle that did not require the plug.

- Lessons learned:
 - No change is simple; all changes must be integrated with other systems that can be impacted.
 - Must fully analyze, test, and/or assess any new off-normal operations.
 - Engineers are not experts in all technical areas. An expert is needed to check any technique used in design change.
