Surveys of Returned ISS Hardware for MMOD Impacts

Jim Hyde...... [Jacobs/CLG XI4] Eric Christiansen... [NASA/JSC XI4] Dana Lear.......[NASA/JSC XI4] Kornel Nagy........ [NASA/JSC ES2] Eve Berger........[Jacobs/CLG XI3]

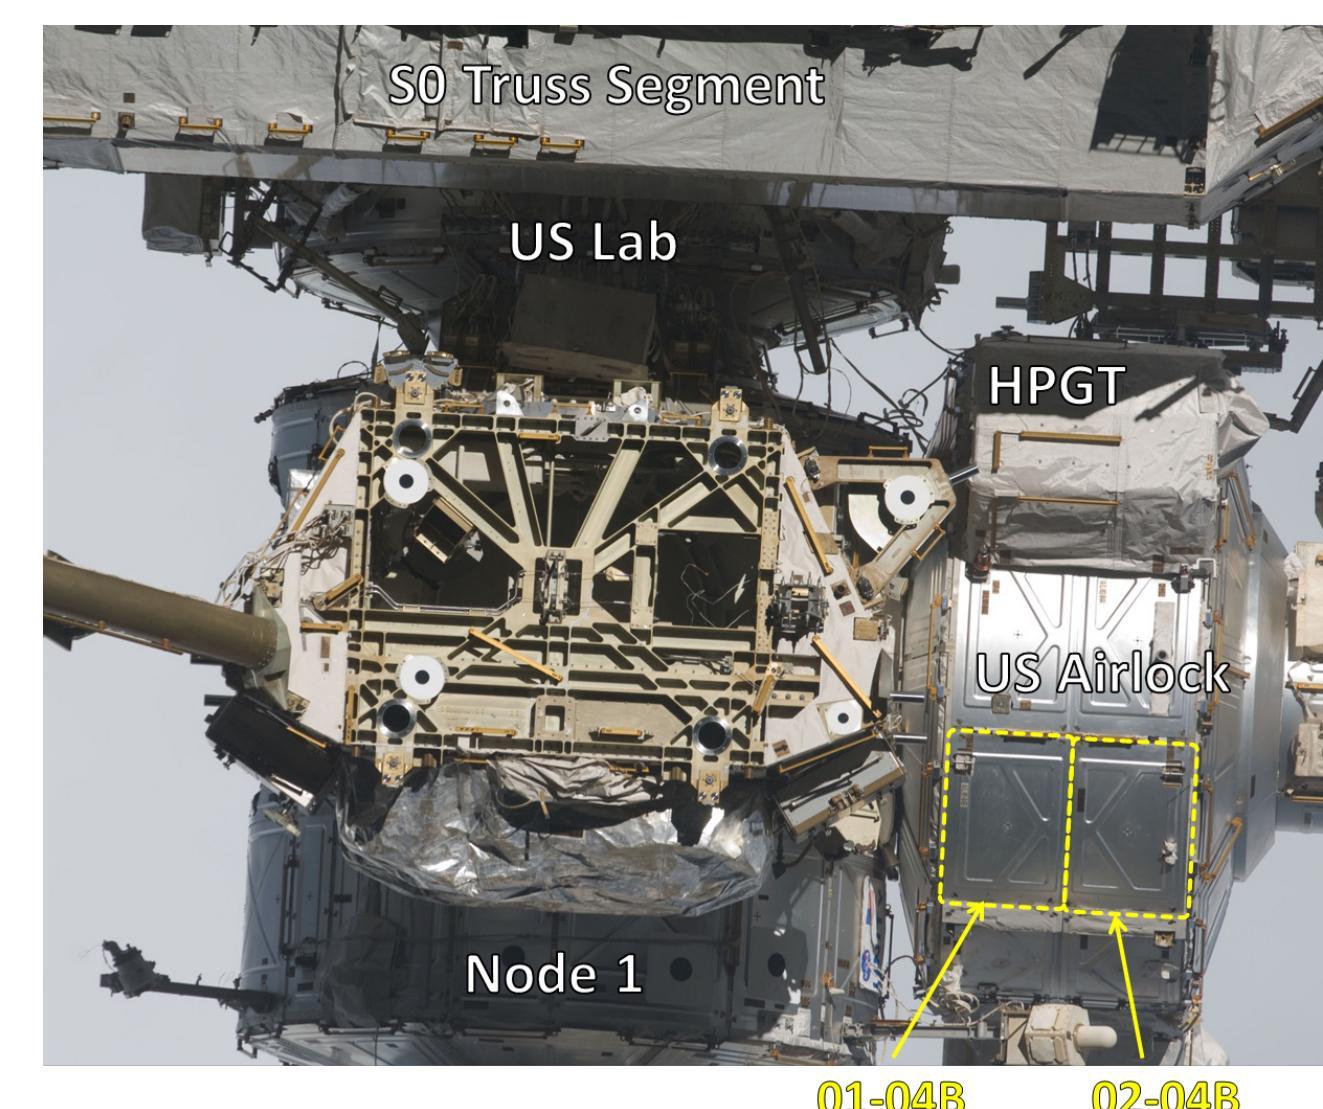
Airlock Shield Panels

- Airlock launched July 2001
- Installed on ISS Node 1 starboard
- Originally equipped with 4 high pressure gas tanks (HPGT)
- Airlock shield panels 01-04B & 02-04B removed November 2009 to allow for the installation of a 5th HPGT
- Panels returned April 2010
- Exposure time = 8.75 years

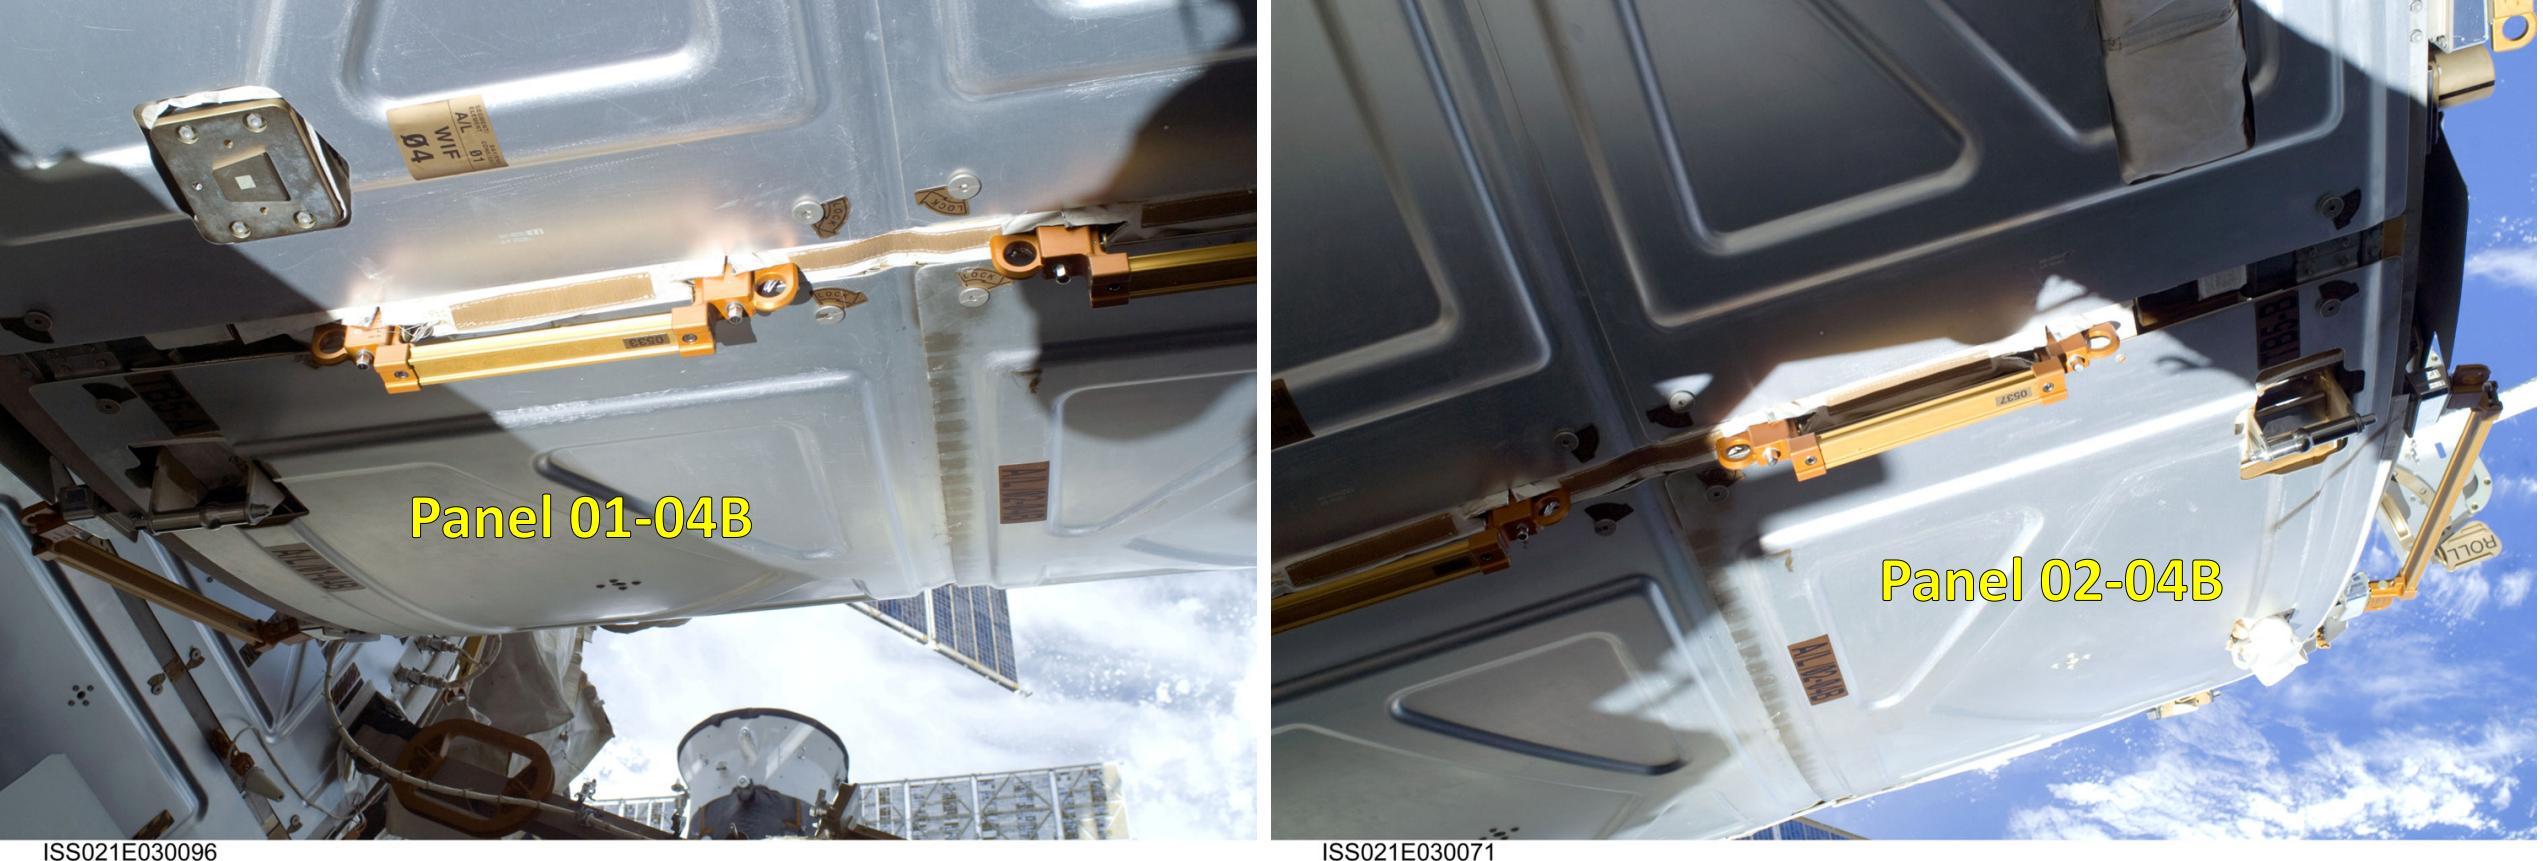
ISS021E030071

- Airlock pressure walls are protected by aluminum panels (Whipple Shield)
- Shield panel is 2 mm thick aluminum, with overall dimensions of 1.30 x 0.84 m

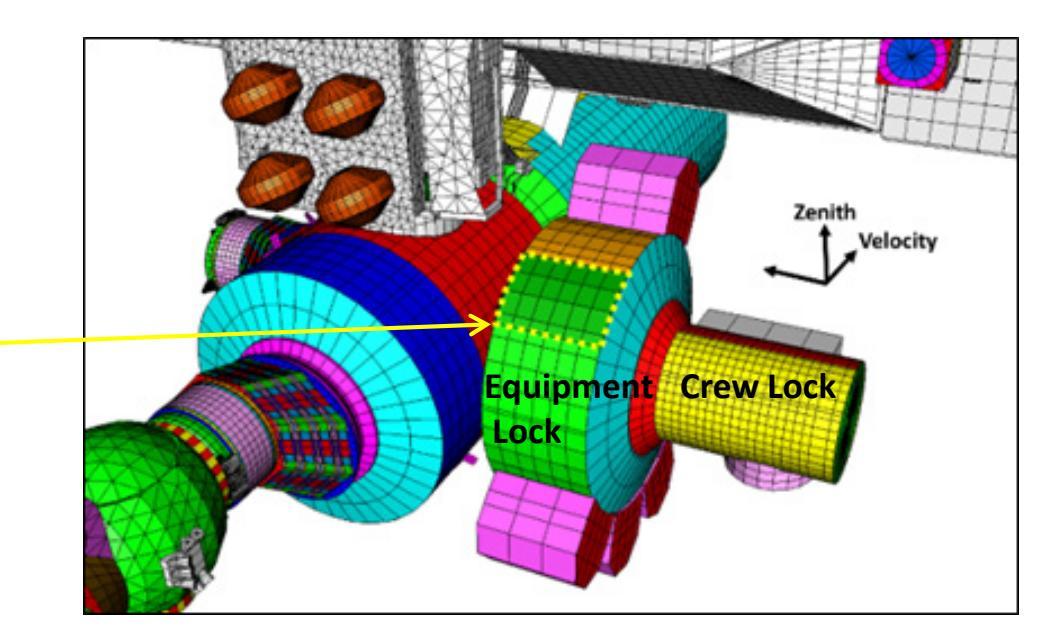
- Bumper 3 was used to calculate the expected number of craters on a 2 m² patch of the equipment lock region of the airlock
- Years = 2001 through 2010
- Time averaged altitudes
- Damage equation = Cour-Palais crater depth

Crater	Crater			
Depth	Diameter	MEM	ORDEM	MMOD
(cm)	(cm)	R2	3.0	TOTAL
0.02	0.04	26.955	0.026	26.980
0.04	0.08	4.726	0.006	4.732
0.06	0.12	1.467	0.003	1.470
0.08	0.16	0.605	0.002	0.607
0.10	0.20	0.297	0.001	0.298

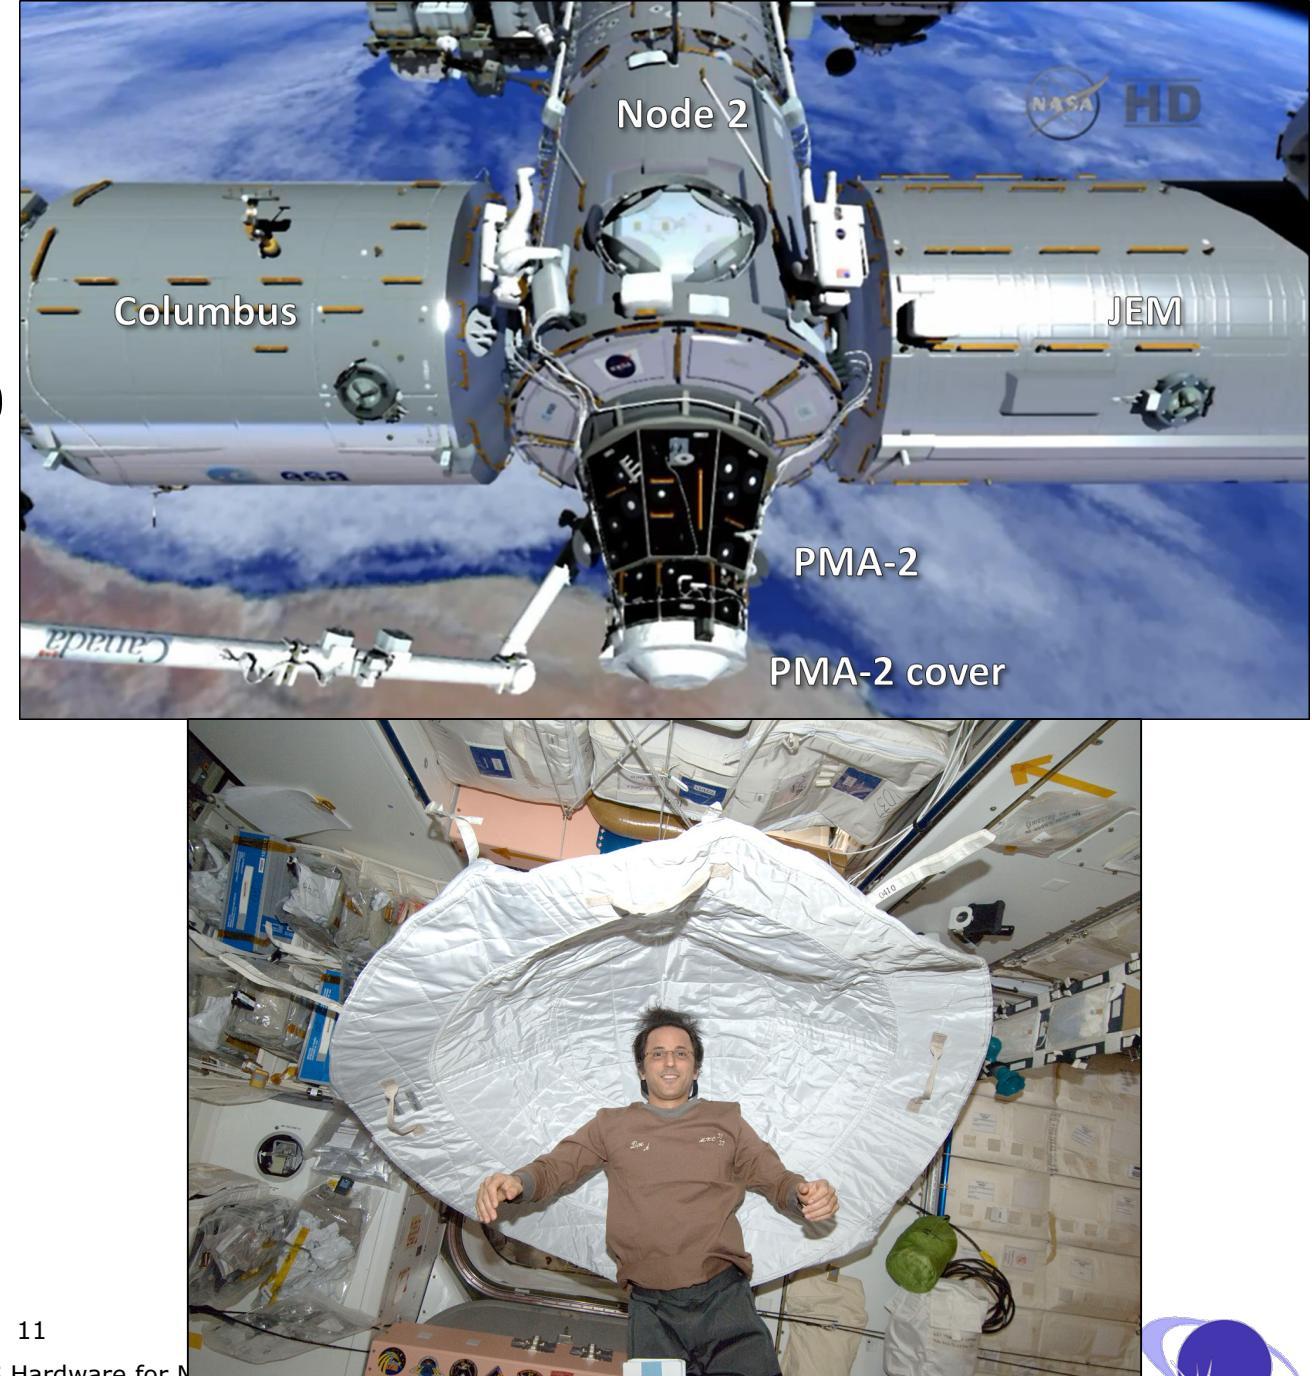
PMA-2 Cover

- Installed July 9, 2013 during US EVA 22
- Removed February 25, 2015 US EVA 30
- Returned on SpaceX CRS-6 May 2015
- Exposure time = 1.633 years
- Beta Cloth outer layer (t = 0.2 mm) with internal layers of ballistic fabric
- Overall diameter of cover = 2.0 m
- Tie down strap length = 0.6 m

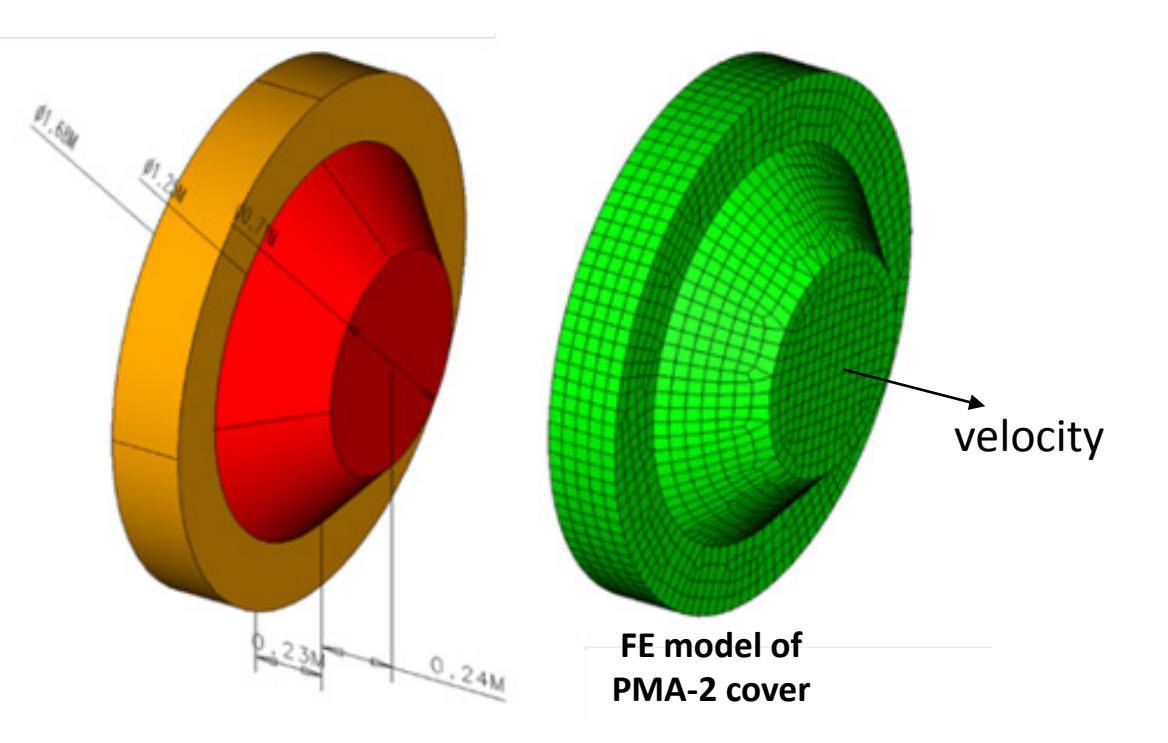
- Bumper 3 was used to calculate the expected number of holes on a stand alone model of the PMA-2 cover
- Years = 2013 through 2015
- Time averaged altitudes
- Damage equation = beta cloth hole size

Hole	Particle			
Diameter	Diameter	MEM	ORDEM	MMOD
(cm)	(cm)	R2	3.0	TOTAL
0.0288	0.0125	16.89	14.60	31.49
0.0460	0.020	4.40	3.87	8.27
0.0920	0.040	0.46	0.68	1.14
0.1380	0.060	0.11	0.30	0.40
0.1840	0.080	0.04	0.15	0.19
0.2300	0.100	0.02	0.08	0.10
