Surveys of Returned ISS Hardware for MMMOD Impacts

1 PMA-2 COVER

5 AIRLOCK SHIELD PANELS

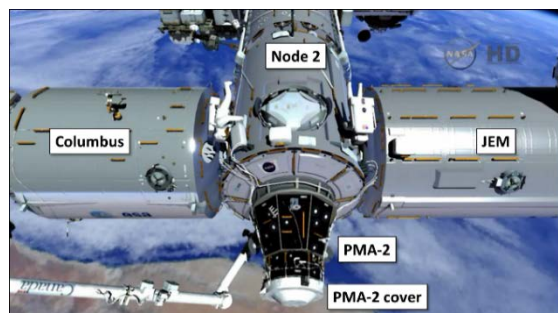
Figure 1. Location of PMA-2 cover

Two of the three Pressurized Mating Adapters (PMAs) on the International Space Station (ISS) are utilized for visiting vehicles. In recent years both PMA-2 and PMA-3 had temporary covers installed over the docking port to provide thermal control and MMOD protection. The covers were constructed with Beta cloth outer layers and internal layers of Kevlar. The PMA-2 cover (Fig. 1) was installed on the forward facing docking port during US extravehicular activity (EVA) #22 on July 9, 2013 and removed during US EVA #30 on February 25, 2015 [1]. The cover was returned May 21, 2015 on the SpaceX CRS-6 mission and a post flight MMOD inspection was performed by NASA, Jacobs and Boeing personnel at the JSC HVIT facility on March 16, 2016.

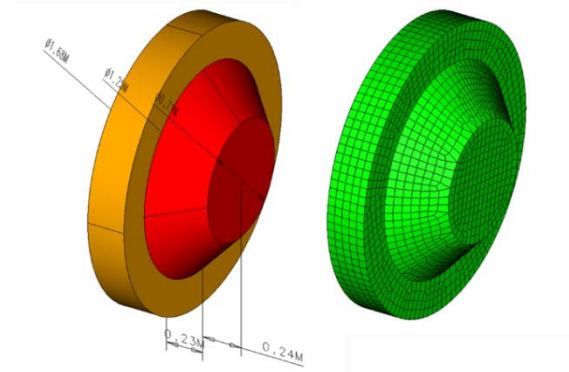
Figure 8. PMA-2 cover surface geometry and FE model

The analysis procedure in Bumper 3 involved calculating the expected number of MM and OD impacts from selected particle diameters in Tab. 1. The standalone finite element representation of the PMA-2 cover used as the input geometry in Bumper 3 is shown in the right hand side of Fig. 8.

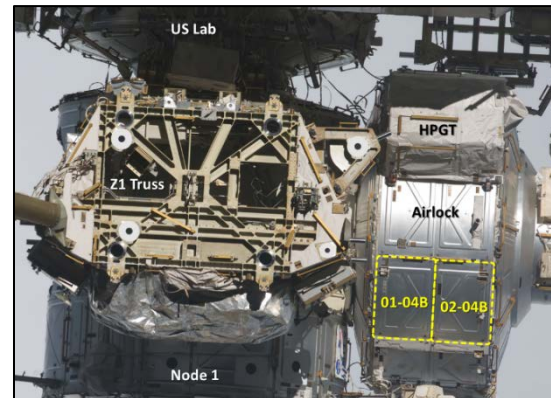
Figure 10. Location of removed airlock shields

years of exposure time. The post flight MMOD inspection was performed by NASA and Jacobs personnel on January 7, 2011 in JSC Building 13. Fig. 10 shows the zenith side of the airlock with the removed shield panels highlighted.

The airlock shield panels are made of aluminum 6061-T6 and are each 1.3 m long, 0.84 m wide and 0.2 cm thick. The survey of these panels was limited to a visual inspection with additional characterization by handheld digital microscope. Craters less than 0.25 mm diameter were not recorded. The inspection measured the “inside diameter” of the crater, recorded at the original height of the panel surface. A total of 58 craters were observed, 34 on the outboard panel and 24 on the inboard. The inspected shield panels can be seen in Fig. 11 with the 58 regions of interest flagged (colored arrows). 56 of the 58 observed craters were nearly circular, with only two elliptical craters recorded. The largest circular impact crater (Fig. 12) measured 1.8 mm in diameter.

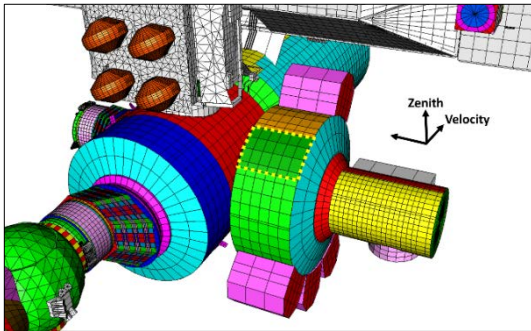
Figure 19. Airlock shield FEM

The analysis was performed against a 1.98 m² finite element mesh area on the equipment lock region of the airlock. The region is highlighted in Fig. 19.

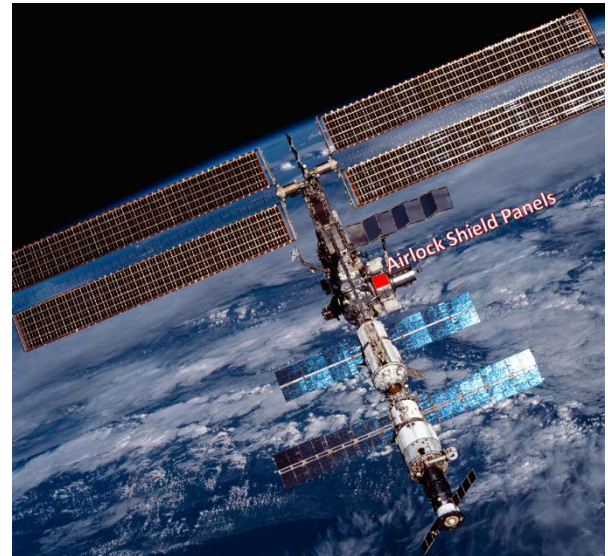
Figure 22. Airlock on ISS after 7A mission

The damage found in post-flight inspection of the PMA cover and the returned airlock bumper panels was generally consistent with Bumper code predictions using the ORDEM 3.0 debris model and MEM-R2 meteoroid model. An excess of orbital debris damage was observed on the airlock bumper panels compared to predictions, although this discrepancy is likely the result of secondary debris impacts. Fig. 22 shows the ISS configuration for a majority of the time the airlock panels were exposed to MMOD. The airlock bumper panels lie in close proximity to the solar array wings on the P6 truss. The silica rich impact sites on the airlock panels could be a product of secondaries from the solar array panels, either front side ejecta from the initial impact or back side penetration products. Painted radiator surfaces are also near the airlock shield panels,

and secondaries from these surfaces could account for the paint detected by SEM in some of the airlock craters.
