Thermal Inspection of a Composite Fuselage Section using a Fixed Eigenvector Principal Component Analysis Method

Joseph N. Zalameda^{*a}, Sean Bolduc^b, and Rebecca Harman^b,

^aNASA Langley Research Center Hampton, VA 23681-2199;

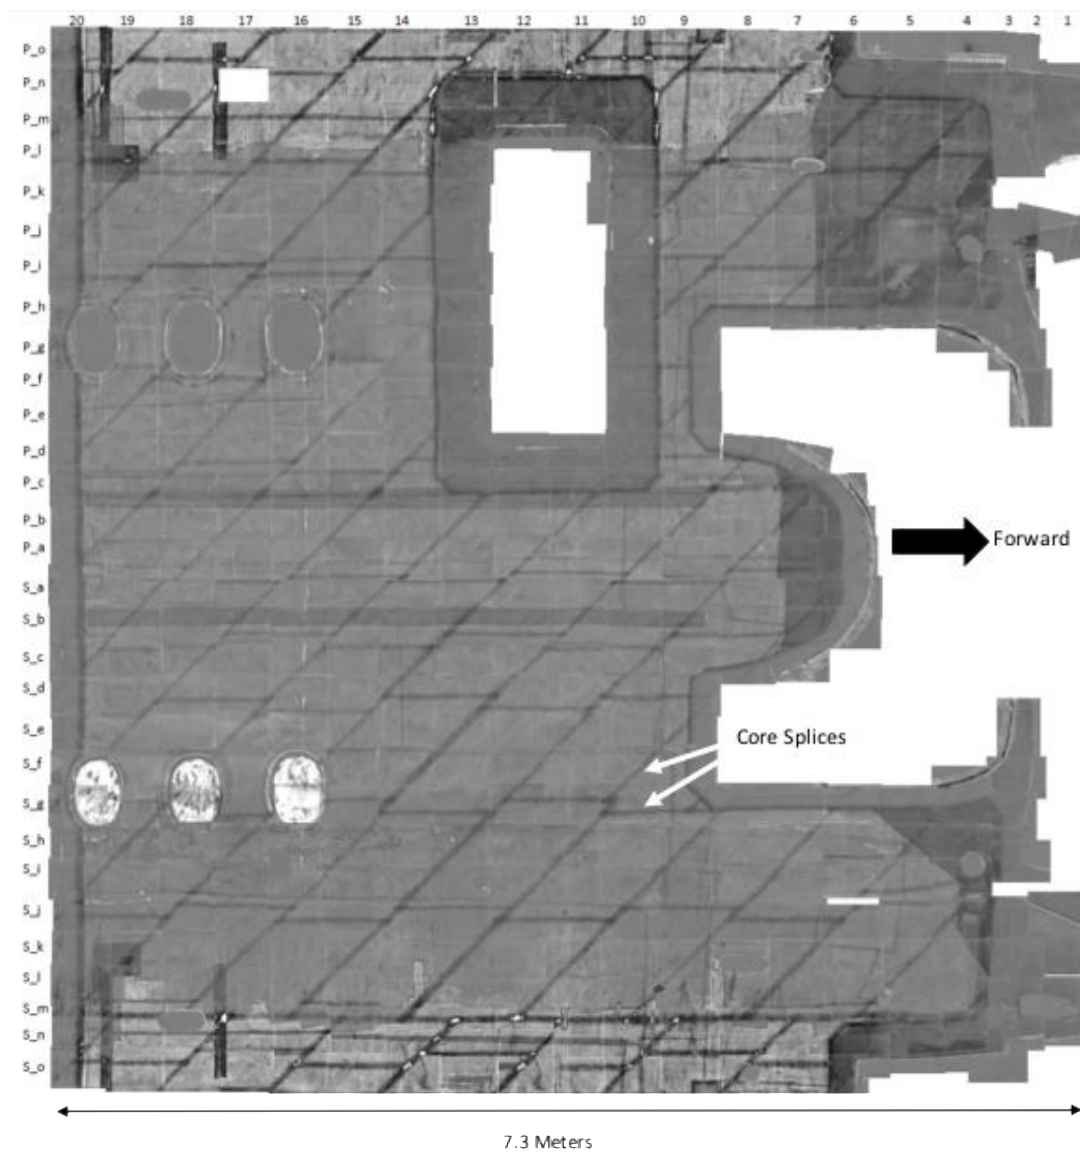
Figure 6. Entire data set assembled into one mosaic. This mosaic consists of 477 data sets processed using a fixed eigenvector.
