Cyclic Fatigue Durability of uncoated and EBC coated 3D SiC/SiC Composites under thermal gradient conditions at 2700F in air

Craig Smith, Bryan Harder, Dongming Zhu
NASA Glenn Research Center, Cleveland, OH

Ramakrishna Bhatt, Sreeramesh Kalluri
Ohio Aerospace Institute, Cleveland, OH

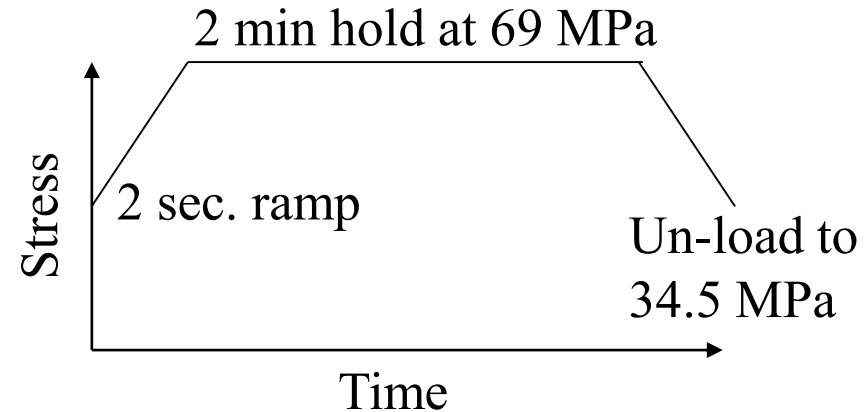
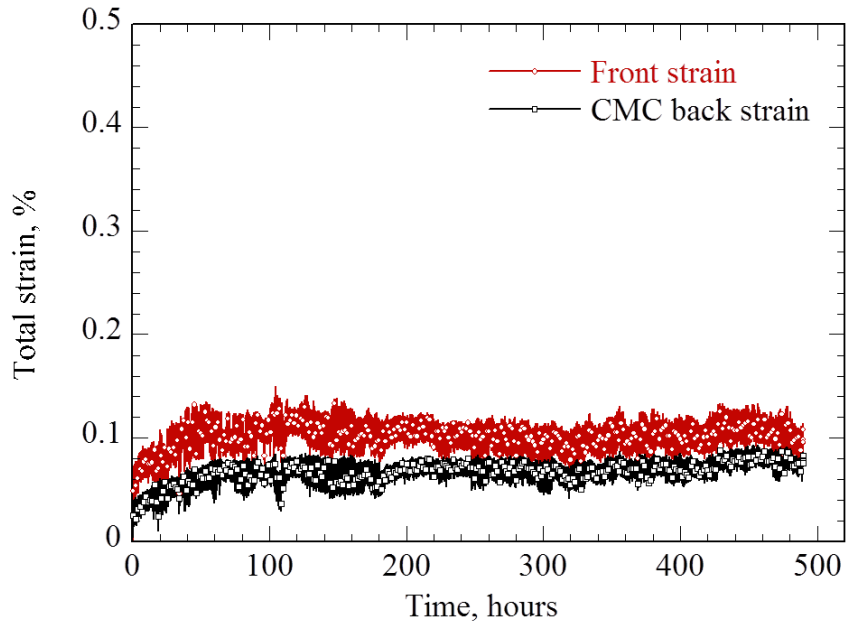
SPLCF Results under Through-Thickness Thermal Gradient

- EBPVD Coated sample
- Average EBC surface temperature: 2950°F
- Average EBC/CMC interface temperature: 2742°F
- CMC back surface temperature: 2442°F
- Maximum EBC surface temperature: >3000°F

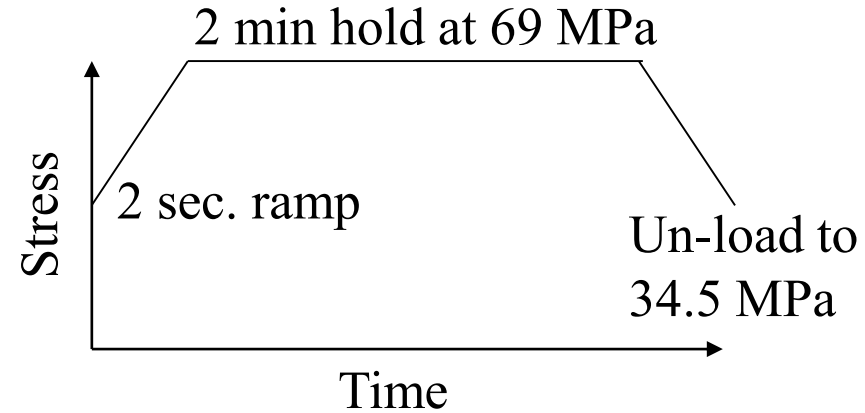
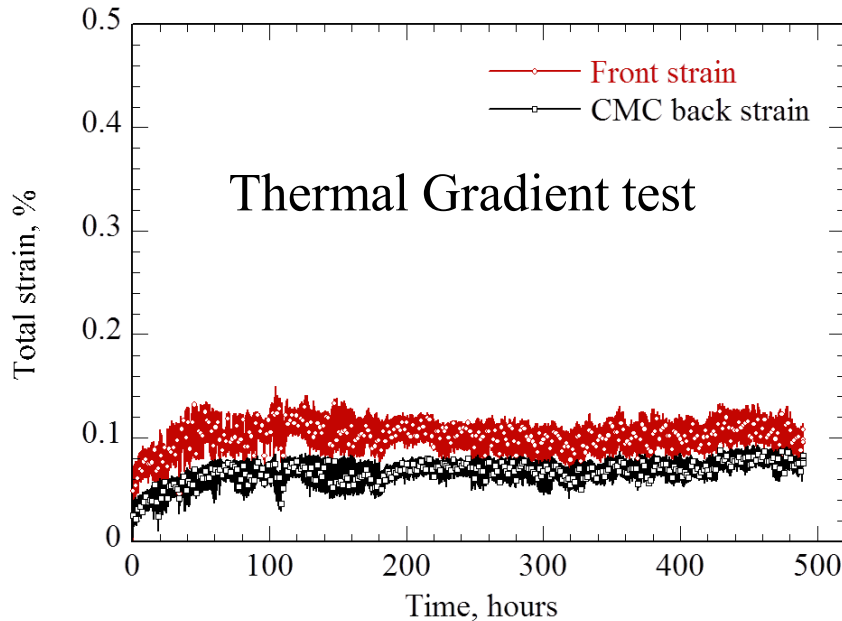
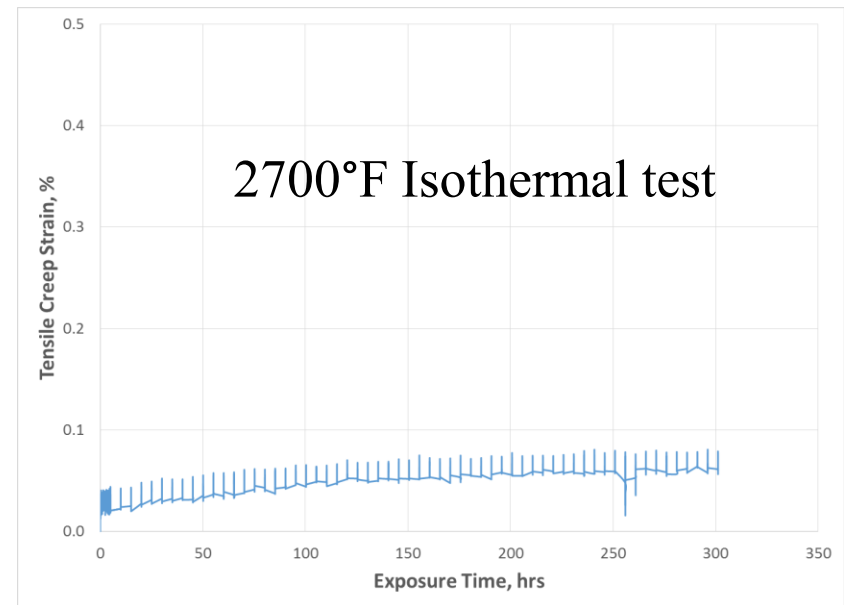
Thermal Gradient Compared to Isothermal Conditions

- Both CMC samples were the same system (architecture, matrix, bond coat, EBPVD EBC)
- Both loaded with the same stress profile
- 2700°F isothermal temp is similar to the CMC/EBC interface temp (2742°F) for laser test
- Strain of the isothermal sample is expected to be similar to the front strain of the laser sample

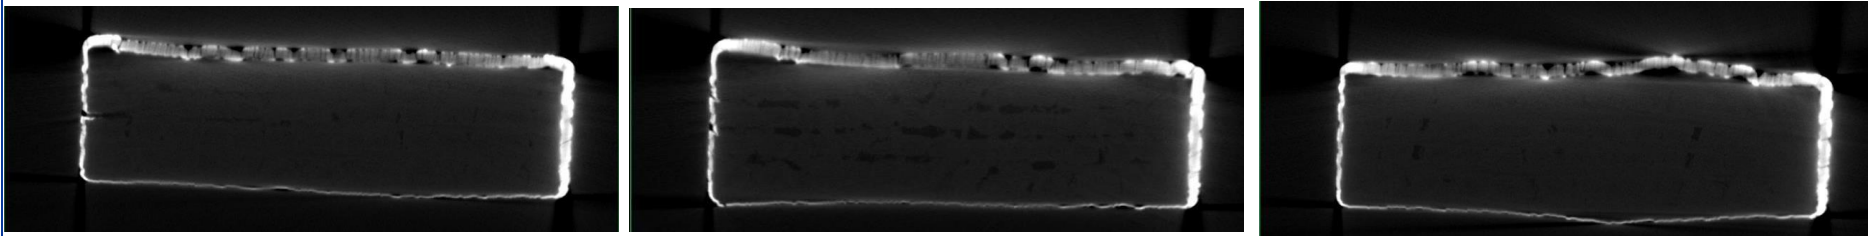
Before Testing

CT Cross-Section Images Before and After Thermal Gradient SPLCF

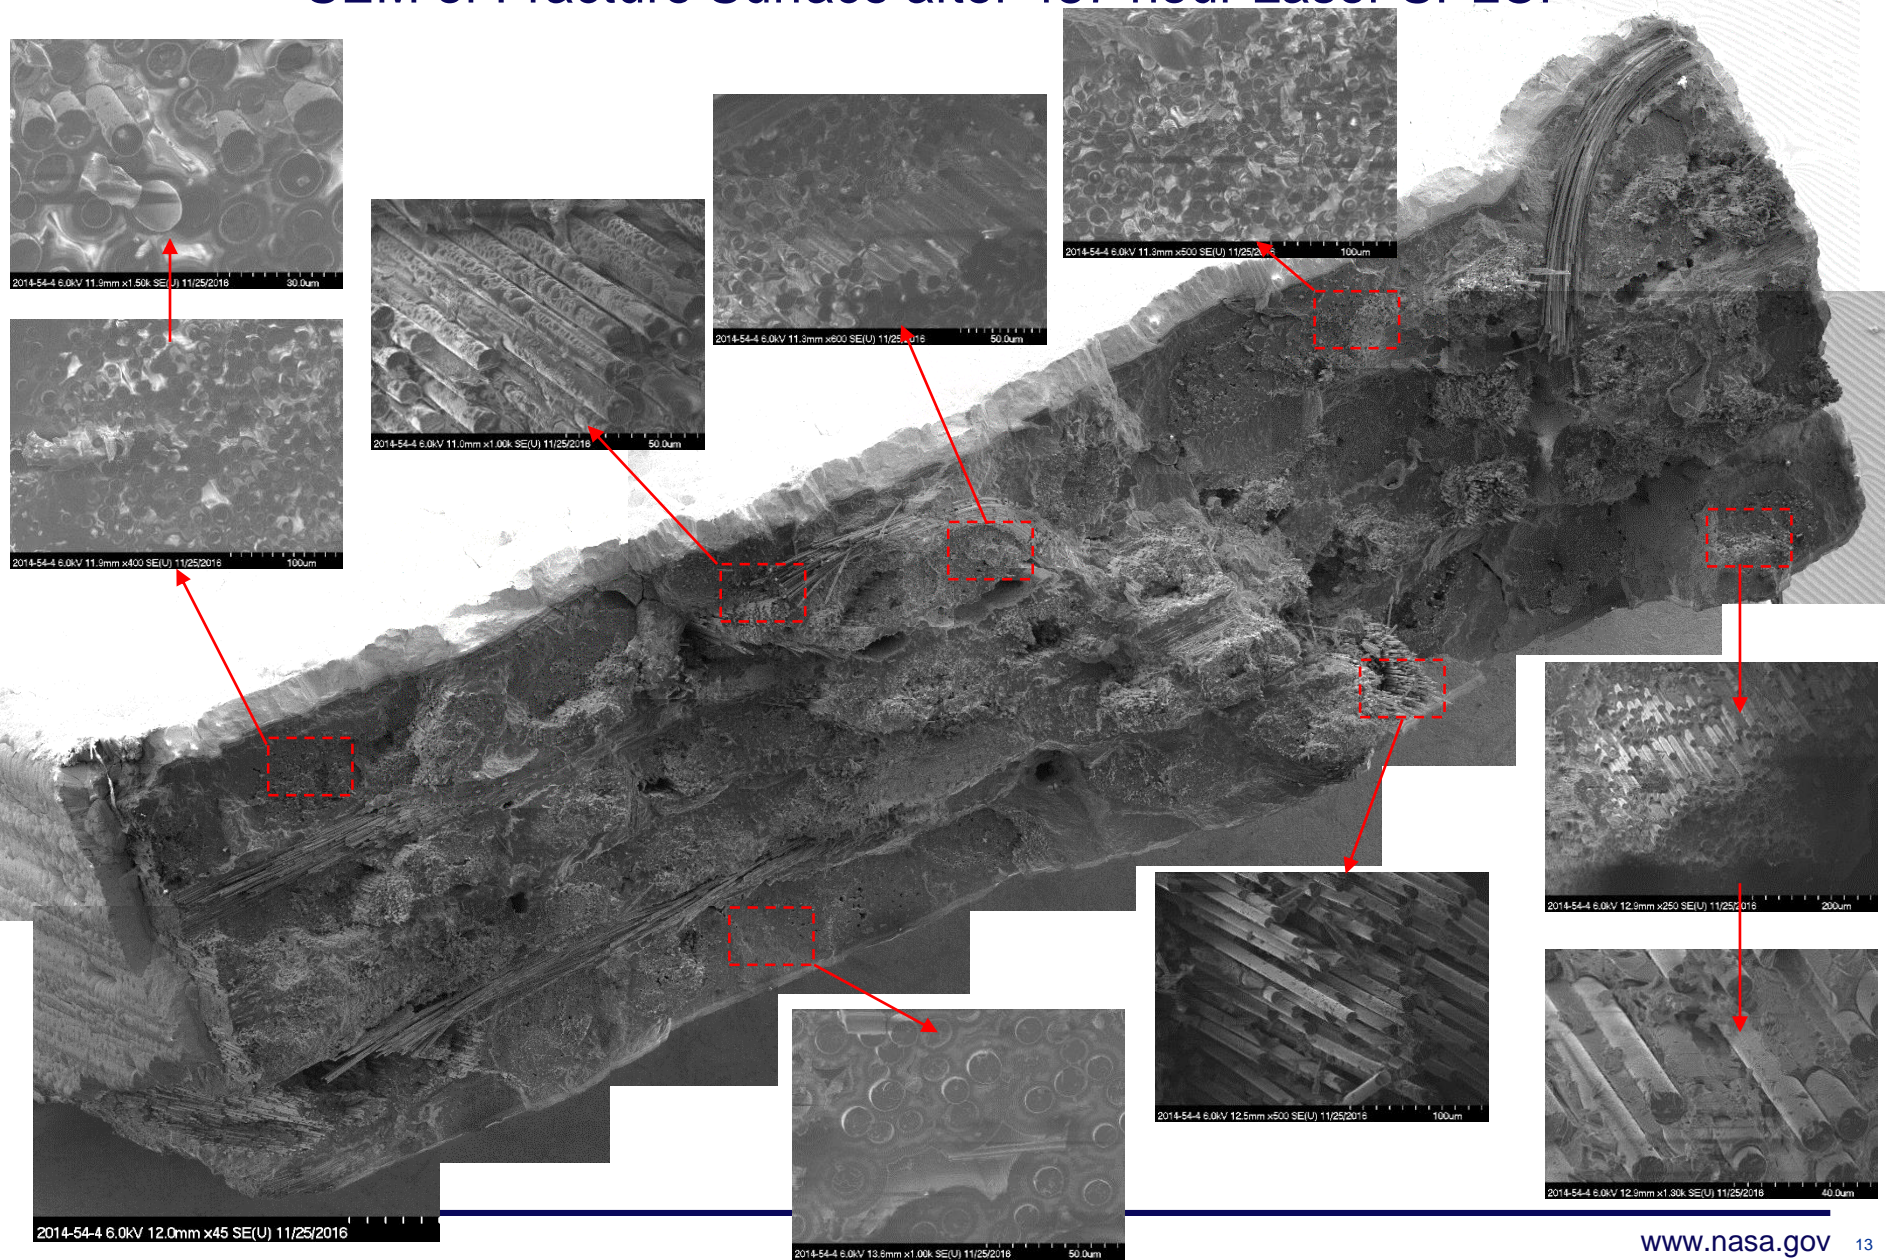
SEM of Fracture Surface after 487 hour Laser SPLCF

- Very flat fracture surface, little fiber pull-out

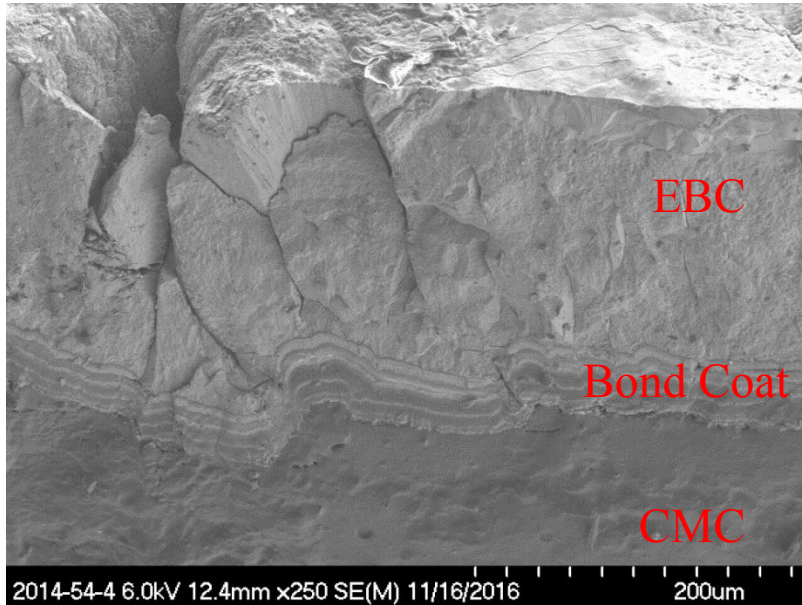
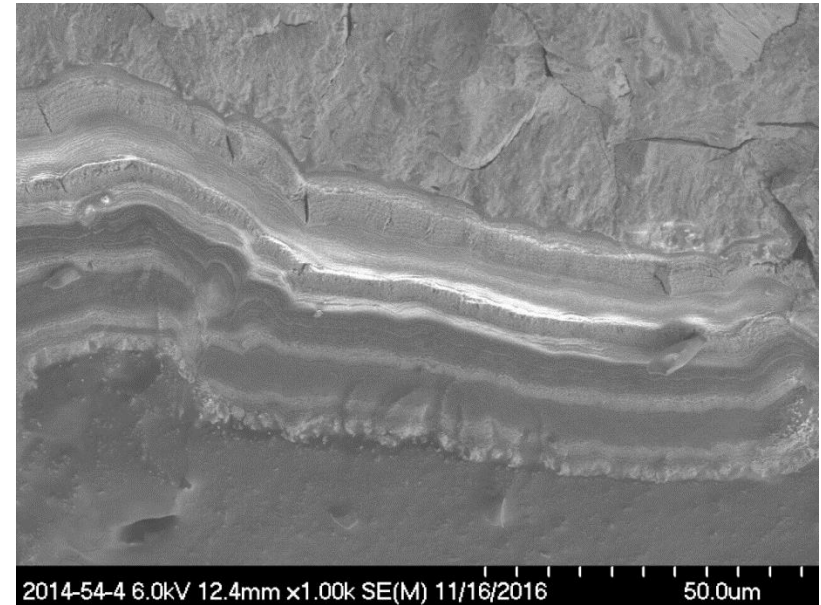
SEM of Fracture Surface after 487 hour Laser SPLCF

- Most of the fiber tows exhibited brittle failure
- Oxygen mapping of the cross-section was planned, but not yet completed
 - We want to know if the bond coat is oxidizing in air, before moving on to steam
 - Regardless, the sample lasted 487 hours
