Cyclic Fatigue Durability of Un-coated and EBC Coated 3D SiC/SiC Composites under Thermal Gradient Conditions at 2700°F in Air

Craig Smith, Bryan Harder, Dongming Zhu
NASA Glenn Research Center, Cleveland, OH

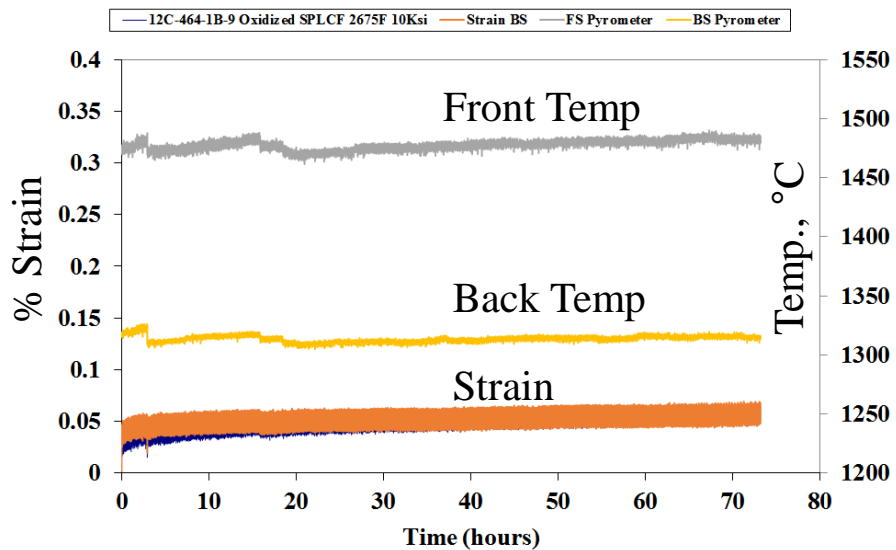
69 MPa Peak Stress

- Front surface temp: 1482°C (2700°F)
- Back surface temp: 1315°C (2400°F)
- 74 hour SPLCF at 69 MPa (10 ksi)
- >220 hour SPLCF at 103 MPa (15 ksi)
- Sample broke after >300 hours total SPLCF

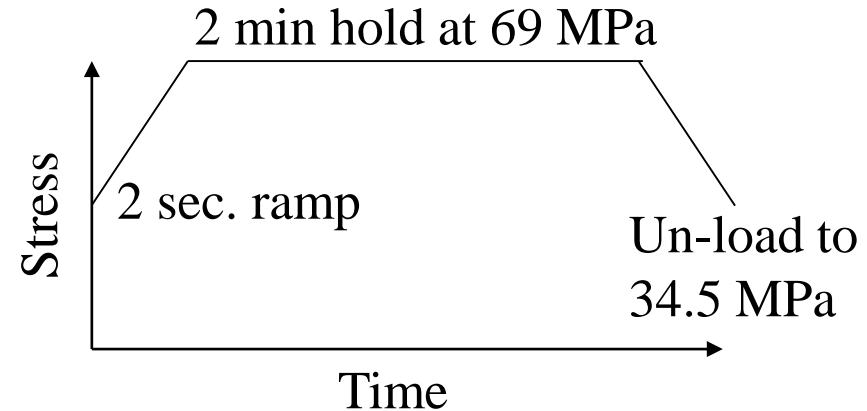
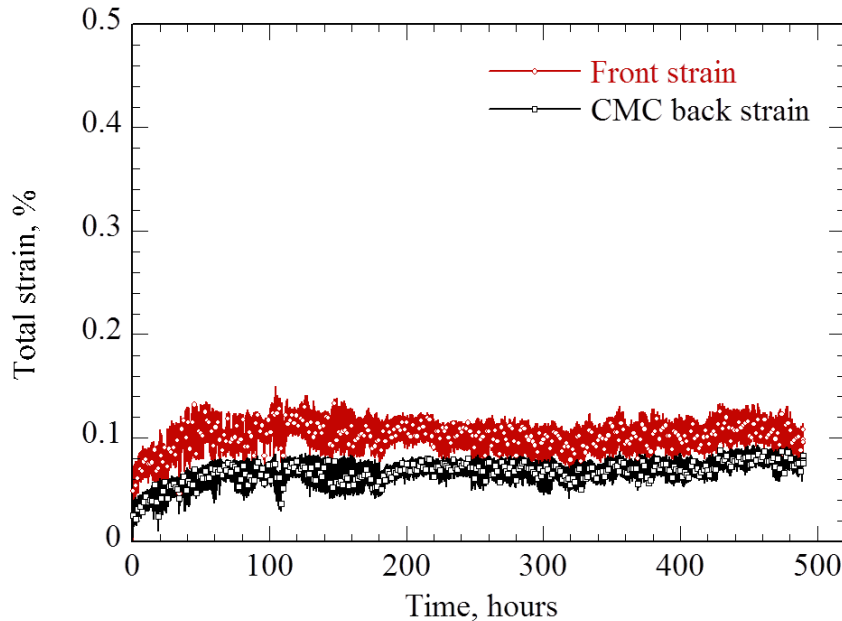
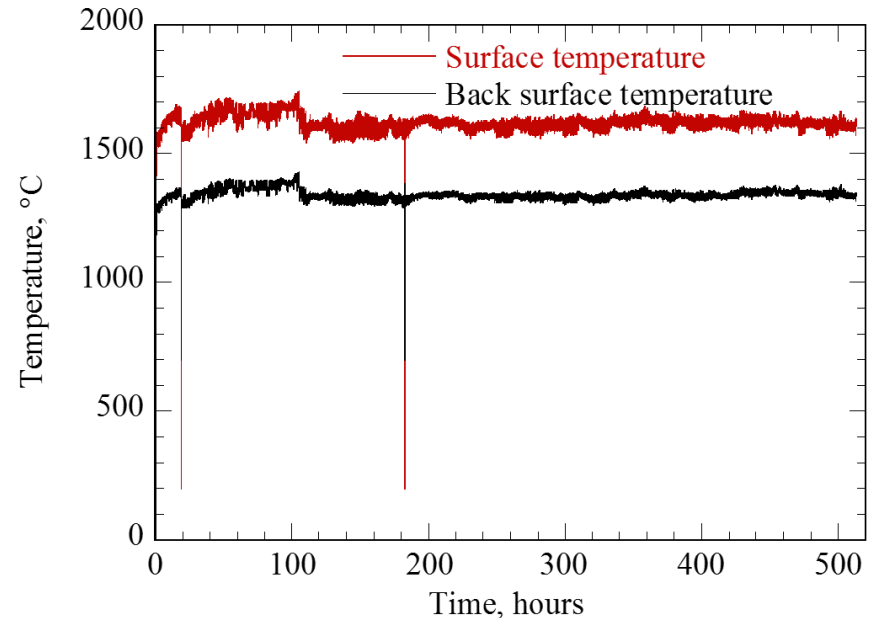
- Measured EBC temp: 1620°C (2950°F)
- Measured CMC back side: 1339°C (2442°F)
- EBC/CMC interface: 1506°C (2742°F)
- Max. EBC temp: >1650°C (>3000°F)
- SPLCF at 69 MPa (10 ksi)
- Sample broke at 487 hours

- Broke after 487 hours SPLCF at 69 MPa
- The sample broke outside the hottest region
- The fracture surface was close to the edge of the hot zone ($\sim 2200^{\circ}\text{F}$)
- The EBC showed pitting/ cracking in the hot zone, below the fracture surface

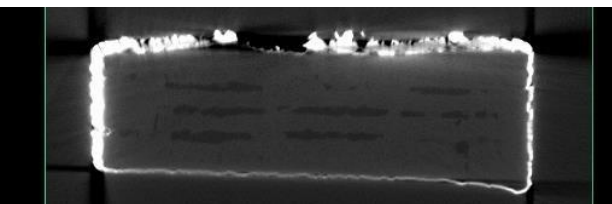
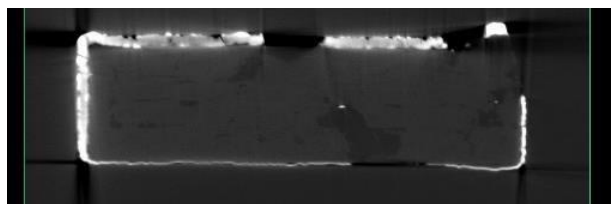
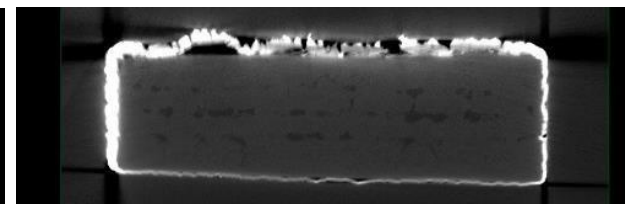
After Laser SPLCF (69 MPa, 487 hr)

- Prior to testing, the EBC appeared to have thin areas
- After testing, there appeared to be an increase in the size of the thin areas
