Nuclear Cryogenic Propulsion Stage (NCPS) Fuel Element Testing in the Nuclear Thermal Rocket Element Environmental Simulator (NTREES)

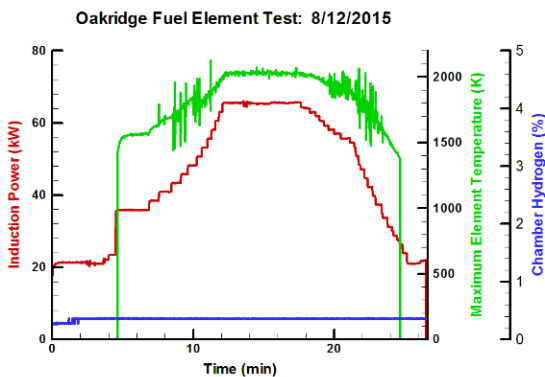
Figure 2 Nominal Test Conditions
