NASA/TM-2017-219497

Mission Success of U.S. Launch Vehicle Flights from a Propulsion Stage-based Perspective: 1980-2015

April 2017

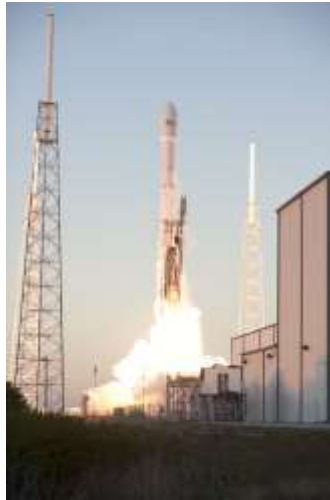
Figure C-7. A Falcon 9 launch vehicle lifts off from Cape Canaveral. Credit: NASA

The first stage of the launch vehicle operated nominally until T+139s when an overpressure event occurred in the upper stage LOX tank. The first stage of the vehicle continued to power through the overpressure event for several seconds before it disintegrated. The Dragon

spacecraft on board the launch vehicle survived and continued to communicate until it fell below the horizon. The time from first indication of trouble to loss of all data was 0.893 seconds. A steel strut holding a high-pressure helium tank was later discovered to have snapped during ascent under the combination of g-forces and cryogenic temperatures, ultimately leading to helium tank rupture within the LOX tank or impact with, and puncture of, the LOX tank wall. In either case, the LOX tank experienced an overpressure event and ruptured catastrophically. The helium tank is located inside the cryogenic oxygen tank for temperature regulation [51].

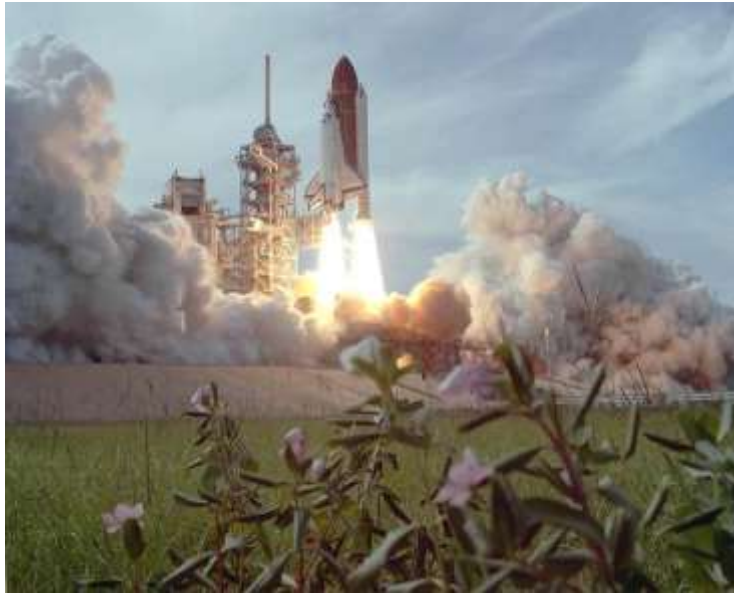
Figure C-8. STS-51-F launches from Kennedy Space Center, Florida. Credit: NASA

The number one main engine experienced a premature shut down at T+345s (the only in-flight main engine shutdown of the entire shuttle program) due to a faulty fuel turbine discharge temperature sensor. The crew was instructed to Abort to Orbit (ATO). Approximately 8 minutes into the flight, after the ATO order, one of the same temperature sensors in the right engine failed and the remaining sensor displayed values close to the redline, which would have prompted a second engine shutdown. The systems engineer commanded the crew to inhibit any further automatic engine shutdowns based on readings from the remaining sensors. STS-51-F completed the mission objectives at a much lower orbit than originally planned. This quick action prevented the loss of another engine and a possible abort scenario far riskier or far worse

than the already in-progress ATO [55].
