Advanced Stirling Radioisotope Generator EU2 Anomaly Investigation

The Advanced Stirling Radioisotope Generator (ASRG) Engineering Unit 2 (EU2) is the highest fidelity electrically-heated Stirling radioisotope generator built to date. NASA Glenn Research Center (GRC) completed the assembly of the ASRG EU2 in September, 2014 using hardware from the now cancelled ASRG flight development project. The ASRG EU2 integrated the first pair of Sunpower's ASC-E3 Stirling convertors (ASC-E3 #1 and #2) in an aluminum generator housing with Lockheed Martin's Engineering Development Unit (EDU) 4 controller. After just 179 hours of EU2 generator operation, the first power fluctuation occurred on ASC-E3 #1. The first power fluctuation occurred 175 hours later on ASC-E3 #2. Over time, the power fluctuations became more frequent on both convertors and larger in magnitude. Eventually the EU2 was shut down in January, 2015. An anomaly investigation was chartered to determine root cause of the power fluctuations and other anomalous observations. A team with members from GRC, Sunpower, and Lockheed Martin conducted a thorough investigation of the EU2 anomalies. Findings from the EU2 disassembly identif

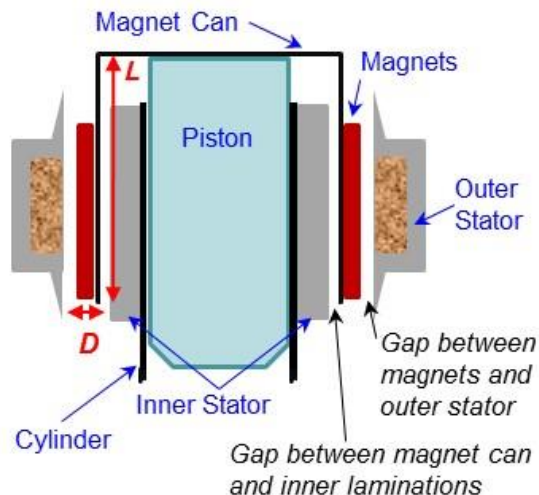
Figure 9. Cross-section of ASC alternator showing location of air gaps.

Findings from the drop tests showed that because the surface that the magnet can beams contacted on the ASC-E3 #1 cylinder was not flat, the collision would introduce a rocking motion in the magnet can, which could result in contact between the magnets and the outer stator (location 6 in Fig. 8, see also Figs. 9 and 11). If the rocking amplitude is large enough, the magnet can could also contact the inner stator (location 7 in Fig. 8, see also Figs. 9 and 11). The drop tests showed that with sufficiently high impact velocities and number of drops, collisions could

The magnet can clearance theory postulates that insufficient running clearance, possibly in combination with imperfect alignment of the magnet can within the air gap between the inner stator and the outer stator (Fig. 9), could not accommodate all thermal and dynamic effects encountered during operation. This would result in rubbing contact between the magnets and outer stator and/or between the magnet can and the inner stator, initiating damage and eventual failure.

The second aspect is associated with the relatively tight alternator air gaps in the ASC alternator. The ASC alternator air gap in combination with the magnet can’s high L/D ratio (see Fig. 9) is challenging to manufacture, and creates potential failure modes that reduce robustness to unacceptable levels for a critical component in a nuclear power system.
