Columbia Crew Survival Investigation Report

What happened to the
STS-107 *Columbia* crew

and what can be learned from it.

Nigel J. Packham
JSC S&MA

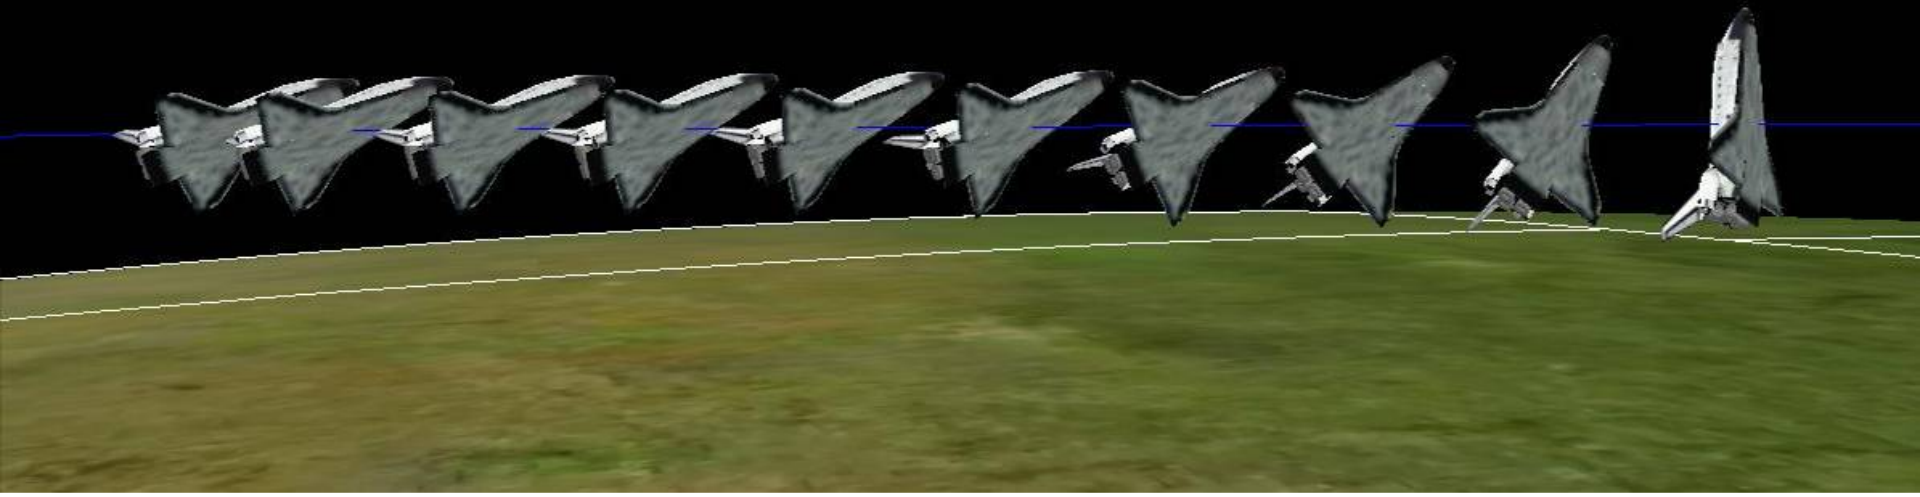
- 13:44:09 Greenwich Mean Time (GMT) - Entry Interface (~400,000', Mach 24.5)
- 13:58:40 – Backup Flight Software (BFS) Fault Messages were annunciated on board, left inboard tire pressure reading goes off scale low
- 13:59:32 – Loss Of Signal (LOS) - loss of real time telemetry data in the MCC
- 13:59:32 - 13:59:37 - Reconstructed General Purpose Computer (RGPC1) data indicate systems nominal, increase to 4 yaw jets & bank angle to try to eliminate yaw error & rate
- **13:59:37 - Start of vehicle Loss of Control (LOC), based on Roll Ref alarm at 13:59:46**
 - Vehicle dynamics were within human tolerance (probably no injuries, but probably disorienting)

13:59:37 – 13:59:46

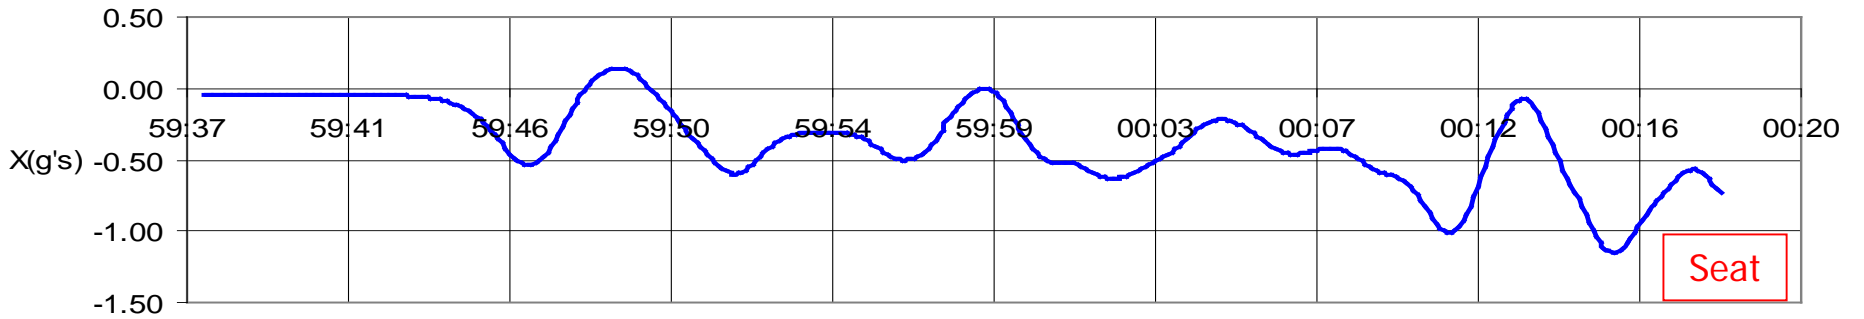
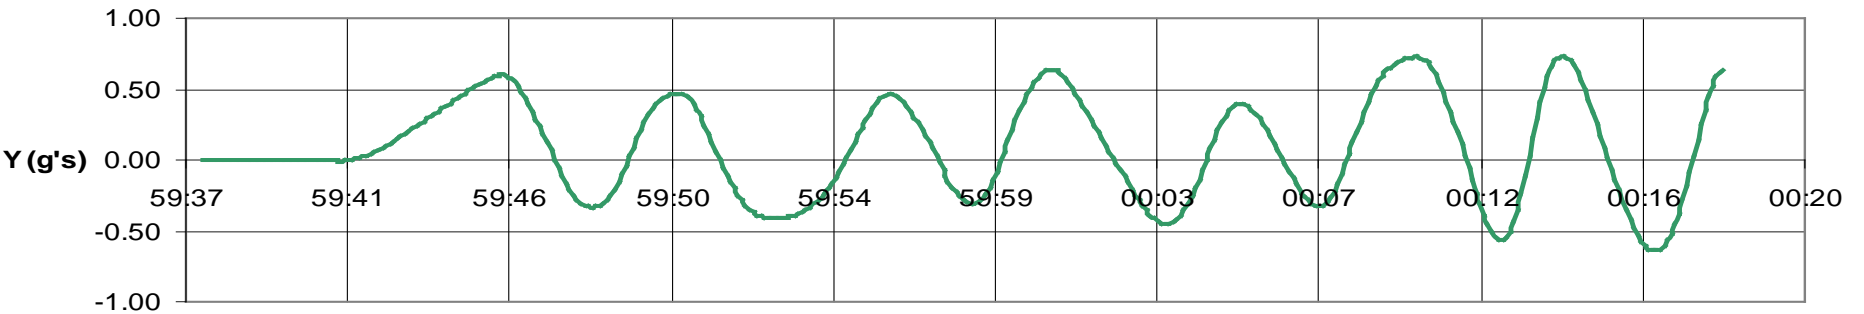
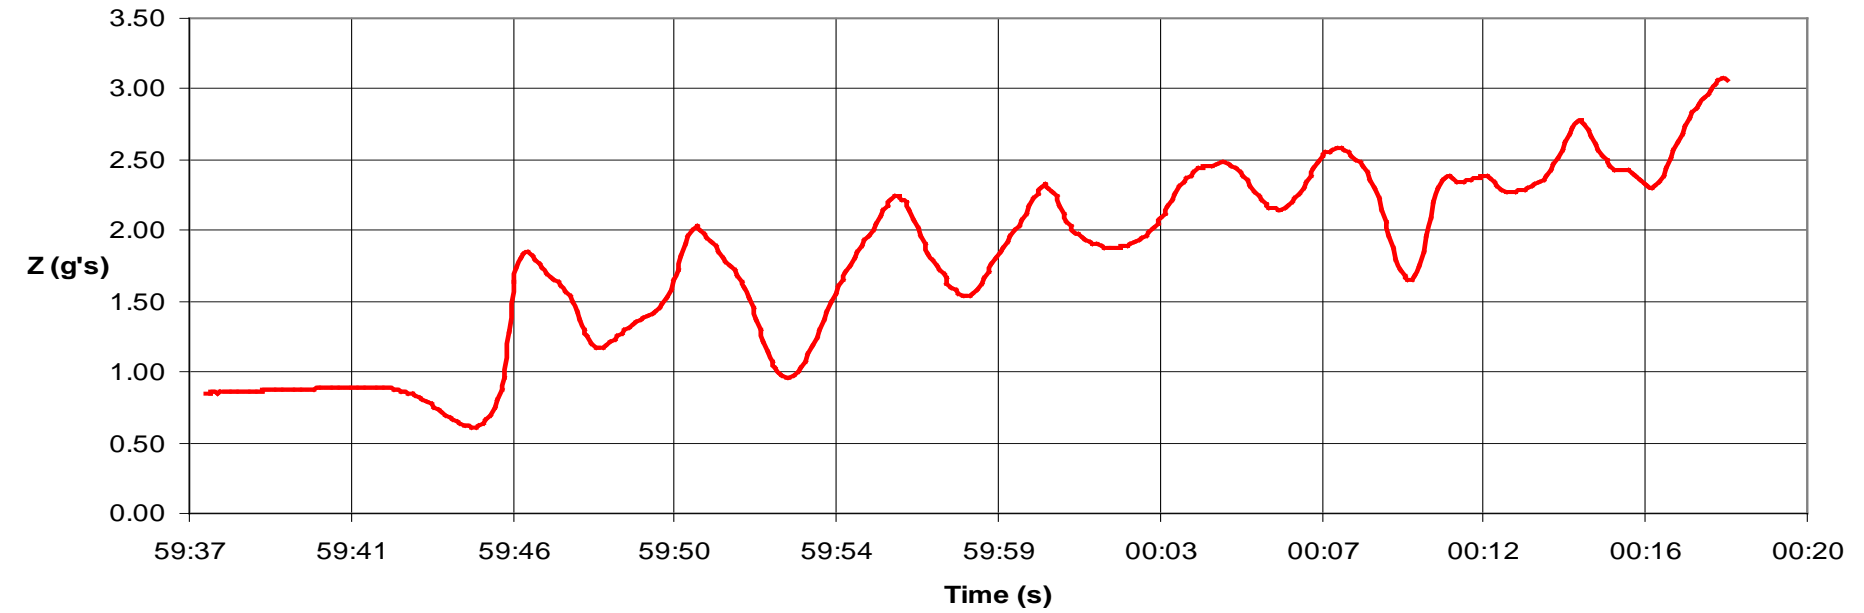
13:59:32
:59:37 LOC

14:00:03
14:00:05
