NASA Electronic Parts and Packaging (NEPP) Program

NEPP Task: “Screening Techniques for Ceramic Capacitors with
Microcracks”

Susceptibility to Cracking of Different Lots of CDR35 Capacitors

Alexander Teverovsky

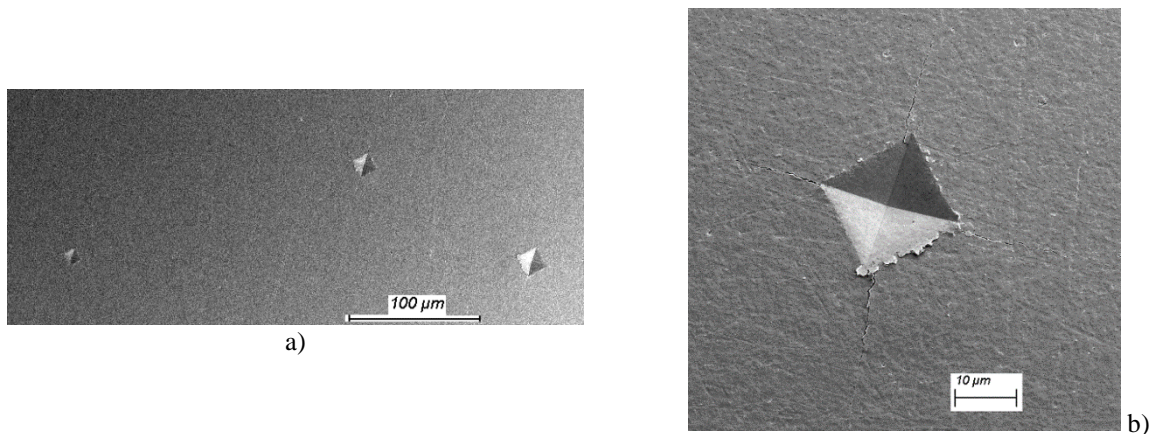
Figure 1. An example of Vickers imprints at 1 N, 2 N, and 3 N (a) and a close-up view of the 3 N imprint (b) showing cracks emanating from the corners.

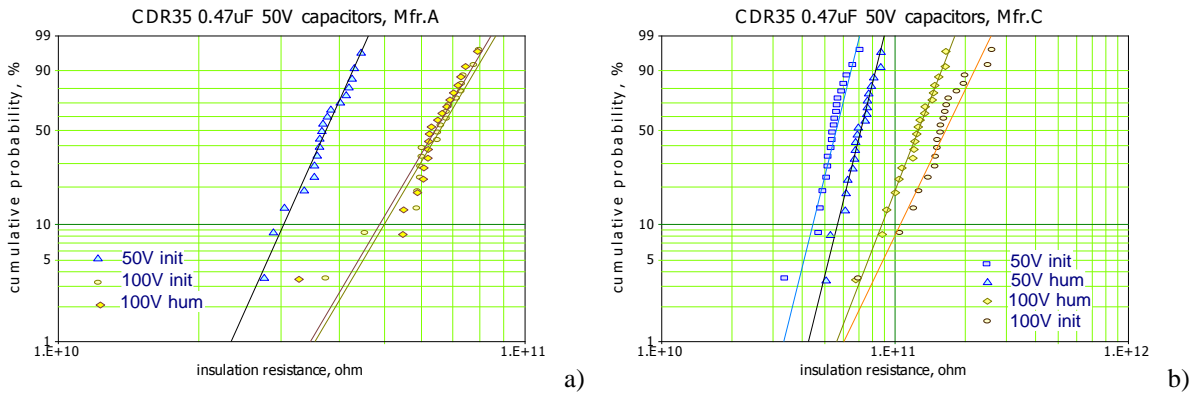
Soaking the parts in humidity chamber at 85C, 85% RH for 10 days did not cause any significant variations of AC and DC electrical characteristics. Distributions of *IR* measured before and after exposure to humid environments are shown in Fig.9.

Figure 9. Effect of storage in humidity chamber on distributions of IR for Mfr.A (a) and Mfr.C (b) capacitors

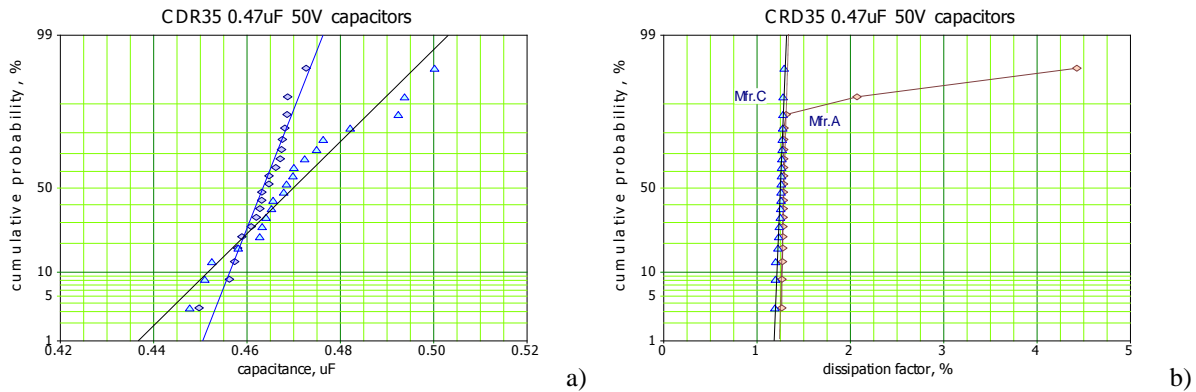
Measurements of AC characteristics after TSD350 did not reveal any significant variations in capacitance, but two samples from Mfr.A (SN1 and SN5) had substantially increased dissipation factors (see Fig.12). This concurs with the results reported in [5], where capacitors with delaminations had increased DF , but normal capacitance values.

Figure 12. Distributions of capacitance (a) and dissipation factors (b) after TSD350.

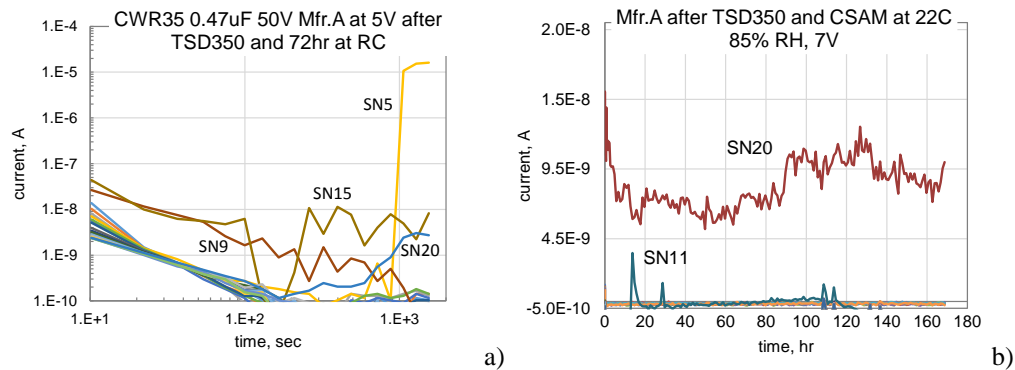
Then the parts were installed in humidity chamber and the testing continued at 7 V, 22 °C, and 85% RH for 170 hr. Leakage currents in capacitors from Mfr.C remained below 1 nA. However, two samples, SN20 and SN11, from Mfr.A had relatively minor, below ~ 10 nA, but noticeable current spikes (see Fig. 13b).

Figure 13. Variations of leakage currents in Mfr.A capacitors at room conditions and 5 V after TSD350 and 3 days of storage at room conditions (a) and at room temperature, but humidity increased to 85% (b).

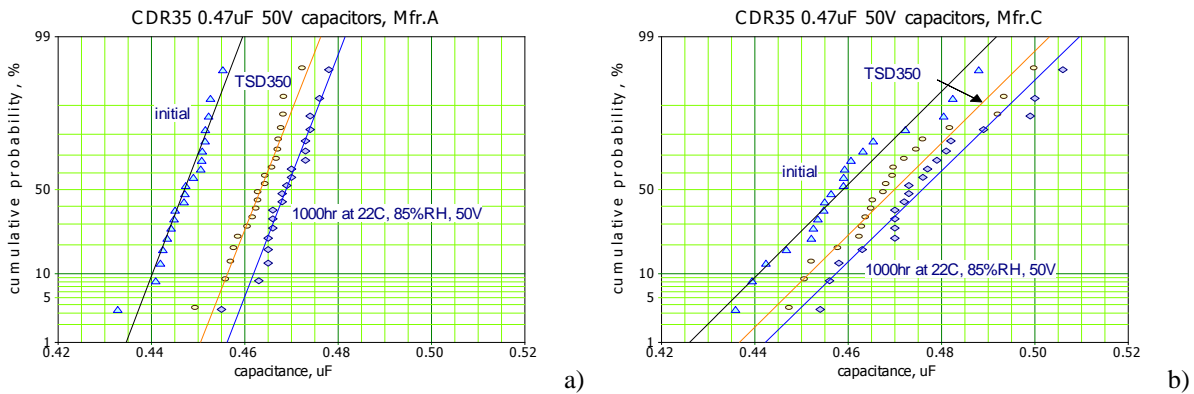
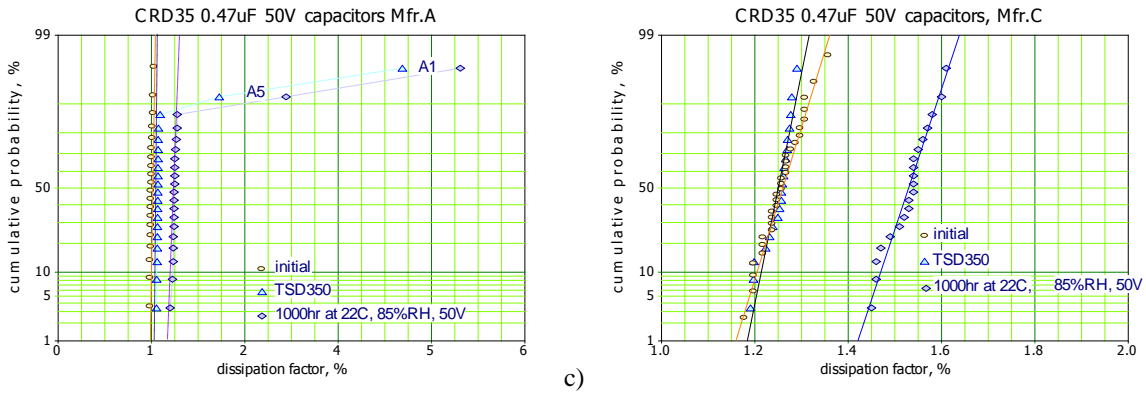
Distributions of AC characteristics measured after 1000 hours of testing in humidity chamber in comparison with initial characteristics and characteristics measured after TSD350 are shown in Fig.15. Except for two samples from Mfr.A, AC characteristics of the parts had no significant variations. Results show that DF is a more sensitive parameter to the presence of defects compared with C and IR .

Figure 15. Distributions of capacitance (a, b) and dissipation factors (c, d) for capacitors from Mfr.A (a, c) and Mfr.C (b, d) measured initially, after TSD350, and after 1000 hours of testing at 85% RH, 50V.

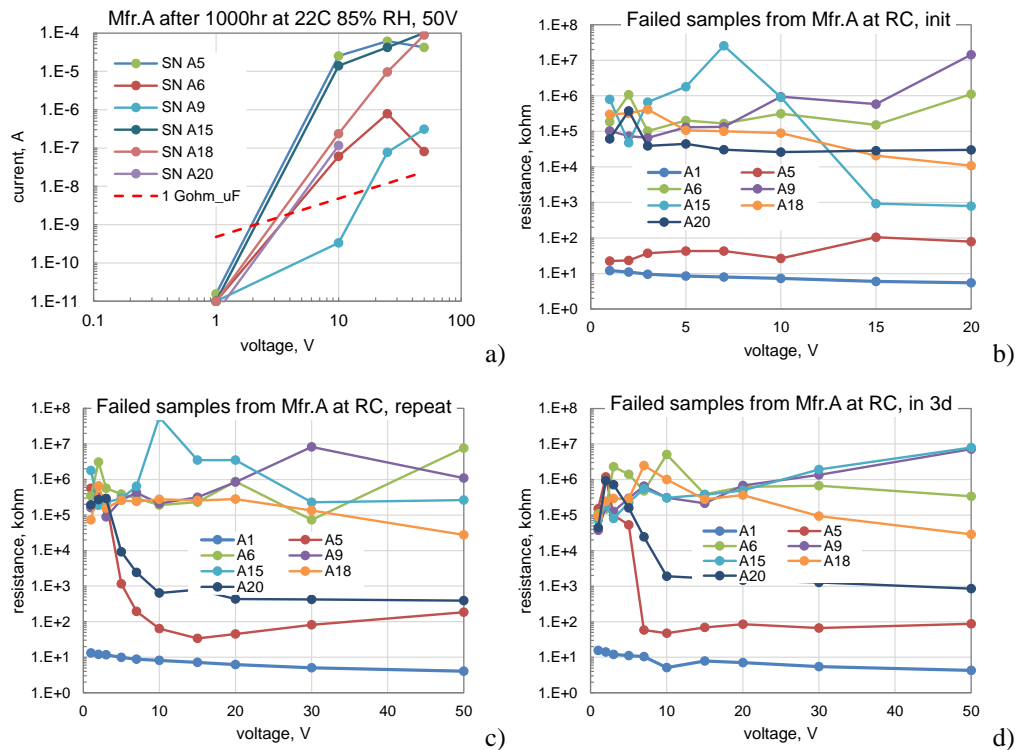
Approximately three hours after removal from humidity chamber, the parts were tested at room conditions at different voltages up to 20 V (see Fig. 17b). Only two samples, SN1 and SN5) had resistances in the kilo-ohm range, while all others had $R > 1$ Mohm. In some samples resistance did not change substantially with voltage, whereas in others R was unstable, increasing or decreasing with voltage, indicating that voltage application can change conductivity in the cracks with time under bias. This was also confirmed by repeat measurements made when voltage increased up to 50 V (Fig. 17c). Two samples, SN5 and SN20 increased R by approximately four orders of magnitude when measured at low voltages, ≤ 5 V, but decreased to 0.3 – 0.5 Mohm at 50 V. This is likely due to the conductivity increasing with time under bias. Measurements after 3 days of storage at room conditions did not change R - V characteristics substantially (compare Fig.17d and 17c).

Figure 17. Variations of leakage currents and resistance with voltage for failed capacitors from Mfr.A.

- a) Measurements of leakage currents inside the humidity chamber immediately after testing and depolarization for 1000 sec.
- b) Variations of resistance with voltage up to 20 V after removal from the chamber.
- c) Repeat R - V characteristics up to 50 V.
- d) Final R - V characteristics after 3 days of storage at room conditions.
