Capture Latch Assembly for the NASA Docking System

Abstract

This paper will present a summary of the Design, Development, and Qualification of the Capture Latch Assembly (CLA) for the NASA Docking System (NDS) Block 1 (NDSB1). The CLA is an integral part of the Soft Capture System (SCS) of the NDSB1, serving the purpose of connecting the mating SCS Rings of two docking vehicles. The paper will present an overview of the function of the CLA and its basic concept of operations, including a summary of the major components of the CLA. The development, qualification, and production of the CLA will then be described. Particular focus will be provided on two major issues that occurred during production and qualification of the CLA. The first issue was failures of the CLA Motor (CLM) during acceptance testing (AT). The failures of the CLM were ultimately determined to be due to design defects and manufacturing errors in the motor commutation sensor assembly. The second issue was failure of the secondary release mechanism, or Contingency Capture Latch Release (CCLR) mechanism during development and qualification testing. The CCLR failures were found to be a result of excess free play in t

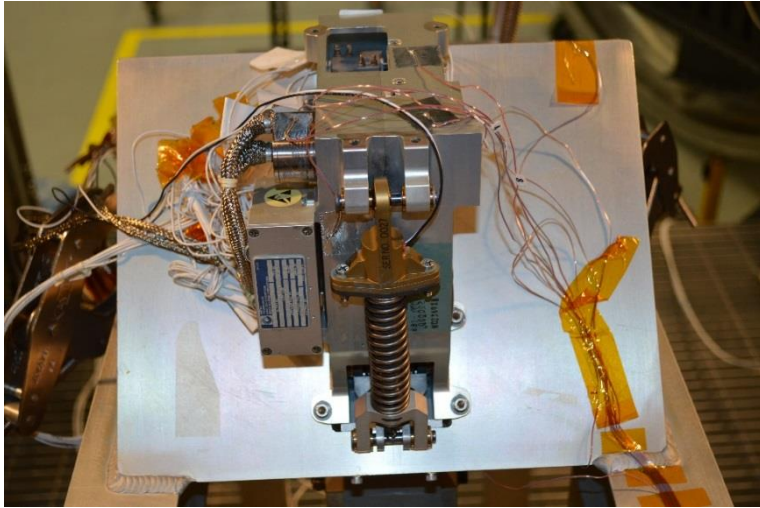
Figure 7. Qualification Capture Latch in CCLR Test Setup

The second CCLR failure occurred during qualification testing of the capture latch assembly. Similar to the development test, the qualification secondary release test occurred toward the end of the qualification program, to be followed only by the ultimate load test. However, for the qualification testing, the mechanism was tested under the thermal vacuum (cold) conditions. Like the development test, the unit had already been subjected to all other environmental tests, including random vibration. Additionally, the test load was lowered based on updated structural analysis of the worst case undocking conditions. The test setup for the qualification test was identical to flight except that a camera was added inside the thermal vacuum chamber to allow direct viewing of the NEA, and an oscilloscope was used to obtain high speed current data for the performance of the NEA. The test setup is shown in Figure 7.

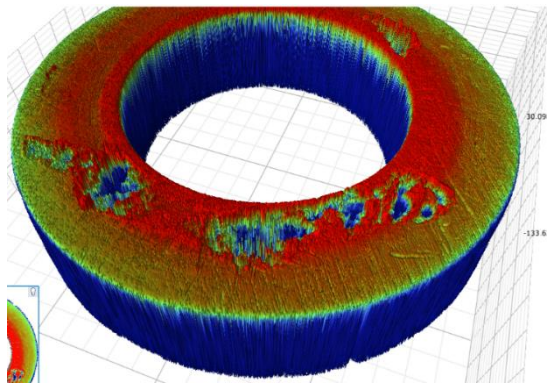
Figure 9. Load Washer Profile

Corresponding wear marks were also observed on the spool half that was located against this surface. Both parts were examined using a laser profilometer, light microscopy, and a scanning electron microscope to determine whether galling of the wear surfaces had occurred. As shown in Figure 9, the profilometry analysis showed that material on the load washer was displaced and removed. The light microscopy measurement confirmed the presence of fretting and galling, as shown in Figure 10. From these results, the investigation team concluded that the most likely cause of the failure to release was galling of the load washer to the spool inside the NEA. The team’s next task was to determine the cause of the galling.
