NASA/TM-2018-219829

A Summary of Results from Two Full-Scale Fokker F28 Fuselage Section Drop Tests

Justin D. Littell
Langley Research Center, Hampton, Virginia

May 2018

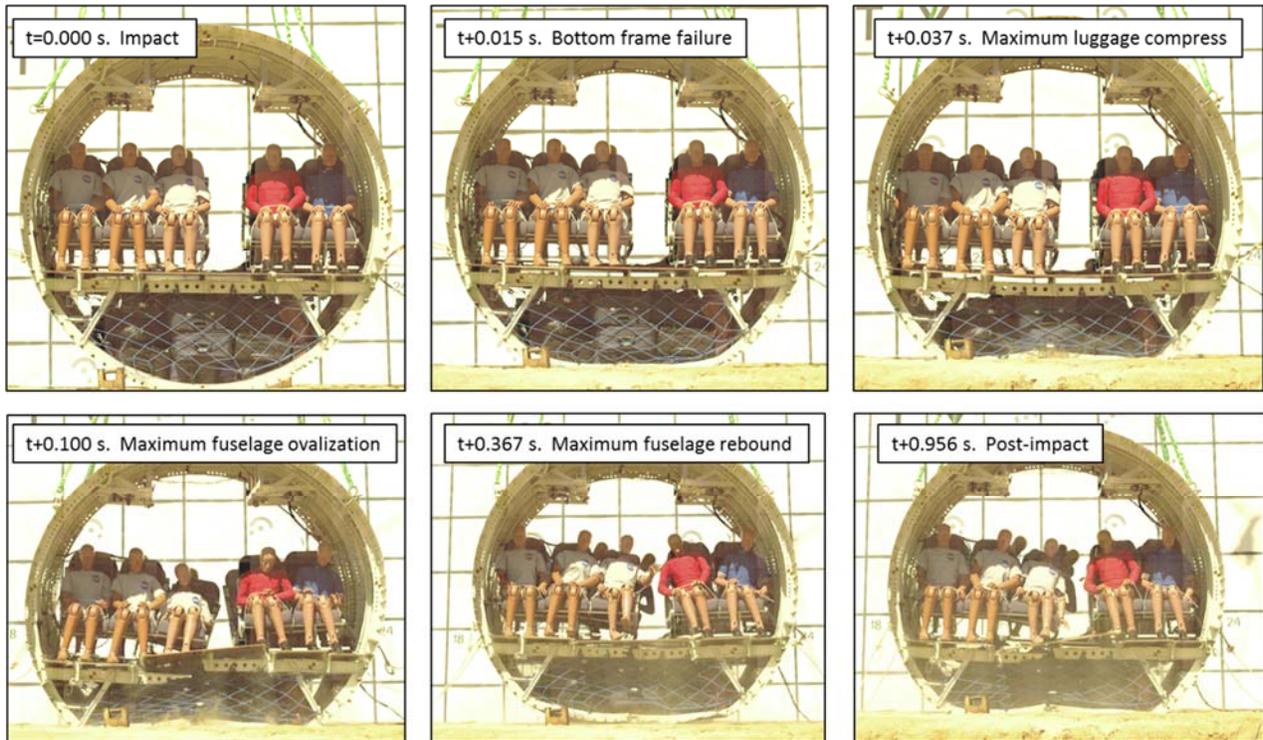
Figure 18 - Sequence of events for Forward Section test

The negative values shown before 0.06 s were a result of the inward motion of the port and starboard targets, which indicated an initial vertical ovalization of the fuselage at impact. This vertical ovalization was a result of the floor bending, which pulled the side walls of the fuselage inward. After the initial vertical ovalization, the sides of the fuselage deformed outward to a maximum value of 5.1 in at 0.103 s after impact. The late time history in Figure 17 showed that the fuselage sustained a permanent deformation of approximately 1 inch post-test. The test sequence as captured from the forward viewing high speed camera is shown in Figure 18, with notable events highlighted. Note that the initial floor bending can be seen in the upper right image.

The upper left image shows the test article at impact where first ground contact was made. This time was also the datum time used for the ovalization calculation. The upper middle image shows the first visible failure in the test article, which occurred at FS 5305 at the bottom skin / soil impact location. The upper right image shows where subfloor luggage underwent its maximum compression. This particular time was noted because it affected both the airframe and ATD responses. The lower left image shows the fuselage at 0.100 s after impact, which was where the maximum lateral ovalization occurred. This event was important due to its effect on the ATD response, described later in this section. The lower middle image shows the fuselage at the time where it underwent a small rebound. Finally, the lower right image shows the last acquired frame of the high speed camera almost one second after the impact event. This frame was beyond the time the major events occurred during the impact, even though the ceasing of all onboard motion after the test did not occur until a full 2.5 seconds after impact. Between these two times, there was additional gentle rocking back and forth of the fuselage due to the dynamics in the still attached, but slack, lifting straps.

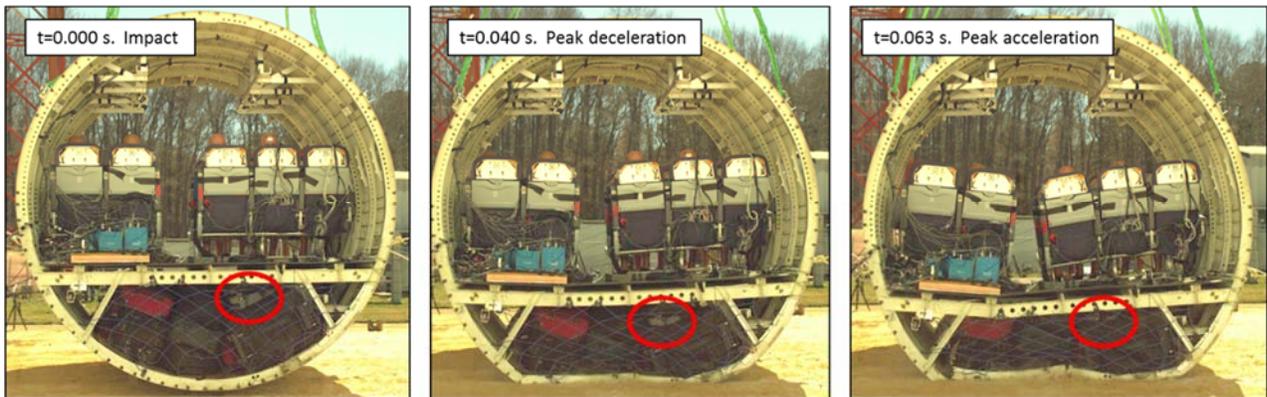
Figure 31 - Luggage response image series

The CDR measured two distinct peaks in the luggage response; the first at 0.040 s after impact and the second (in the negative direction) at 0.063 s after impact. These two events were the result of the luggage interaction with the soil (event #1) and the luggage rebound into the floor support lateral stiffeners (event #2). Three images were taken from the camera focused on the rear portion of the Forward Section. This camera was able to view the bag containing the CDR so correlation of the event data and video was possible. Figure 31 shows the image series of the luggage response using the two peak times identified from Figure 30, with the bag containing the CDR circled.

The first positive acceleration peak of 98 g shown in the data was the maximum deceleration due to the compression of the luggage including the particular bag containing the CDR at impact. The high spike at 0.040 s resembles a compaction portion of a reponse curve from typical materials that exhibit compaction such as foams or honeycombs. This timing also agreed within a few milliseconds to the image series obtained from of the forward view of the section, as shown the top right image in Figure 18. The second acceleration, shown as a negative 96.6 g value in Figure 30, was a result of the luggage rebound after maximum compression, acting as a bearing surface for the floor support lateral stiffeners to react against as they continued their downward motion through the impact event. This was also likely around the time in which the failures occurred in the floor support lateral stiffeners.

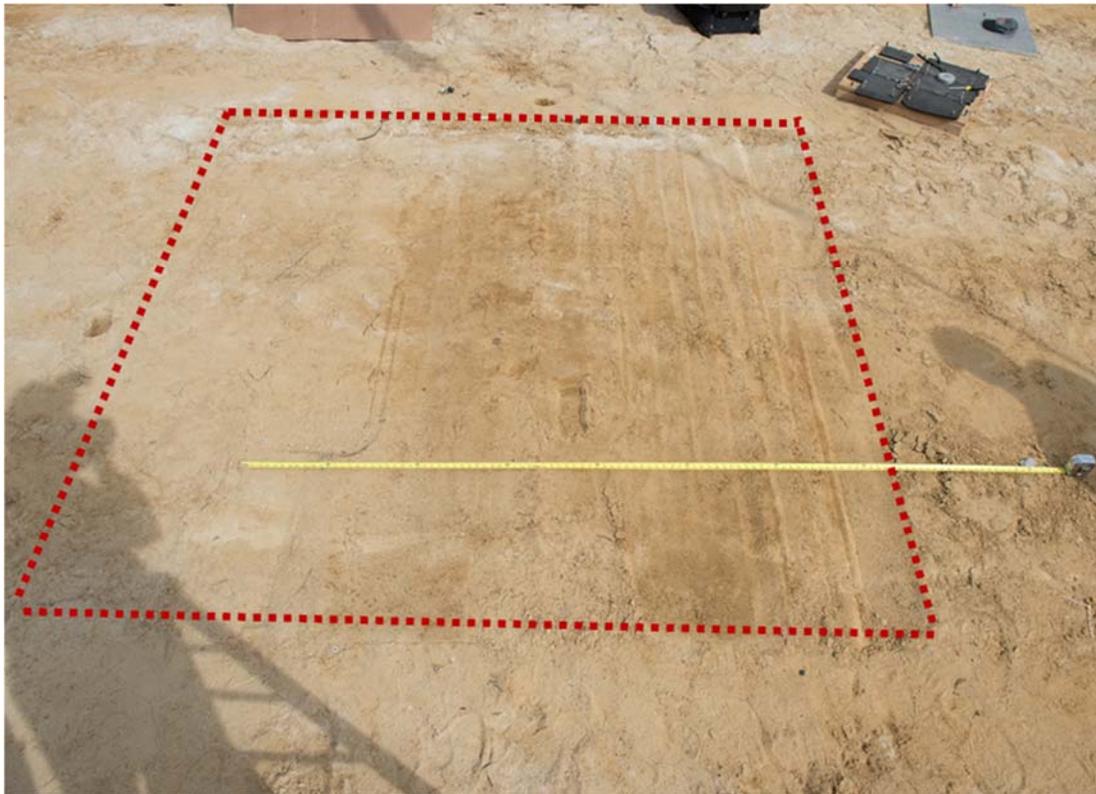
Figure 33 - Forward Section soil indentation results with test article outline

The soil indentation was measured once the test article was removed from the test area. Since the majority of the deformation was in the fuselage itself, a large indentation was not made in the soil. Only ripples in the soil were created from the stringers located on the bottom skin. Indentations ranging from 0.25 in to approximately 1.5 in were measured at locations around the impact site. As shown in the CBR measurements, it was also at this depth that the soil showed a jump in stiffness, so the deformations were primarily contained to the outermost layer of loose soil. Figure 33 shows the impact area with the outline of the fuselage footprint highlighted.

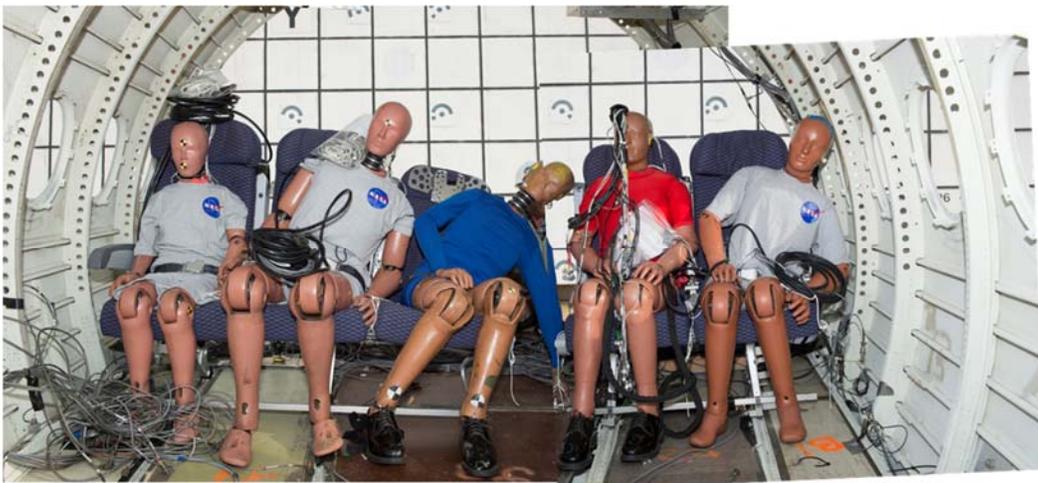
Figure 35 - Forward Section rear row ATDs (Seats 1 through 5)

A view of the rear row ATDs is shown in a pieced together composite view in Figure 35. A composite view was the only available view for the rear row ATDs since the section needed to be partially disassembled to examine the rear row in detail. In the rear row, the post-test ATD positions were similar to the front row. ATD 3 was leaning into the aisle, almost making contact with the ATD 4. The large amount of deformation in seat 3 was also noticeable, which included the headrest separating from the seat frame. The 95th percentile ATD 2 also showed a lean toward the center; however, ATDs 1 and 4 remained upright, while ATD 5 actually showed an outward lean toward the outside of the test article.

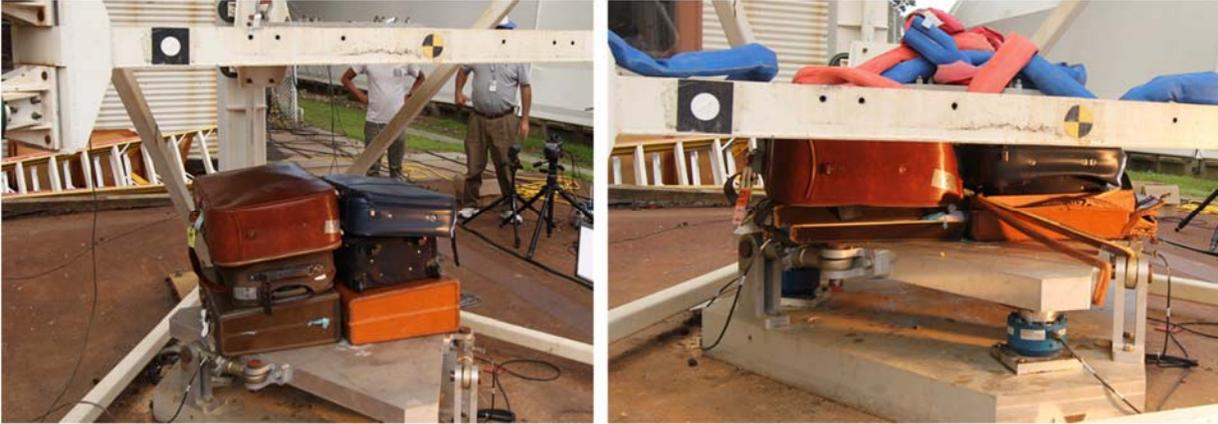
Figure 45 - Luggage test 2 pre- (left) and post-test (right)

Test 2 was conducted in a similar fashion as test 1. Six different bags were used; however the methodology in developing the crush curve was the same. In test 2; however, impact velocity was 24.5 ft/s, which was an increase of the initial kinetic energy at impact by 85%. The total luggage weight for test 2 was 147.4 lb. Figure 45 shows a pre- and post-test picture of test 2.

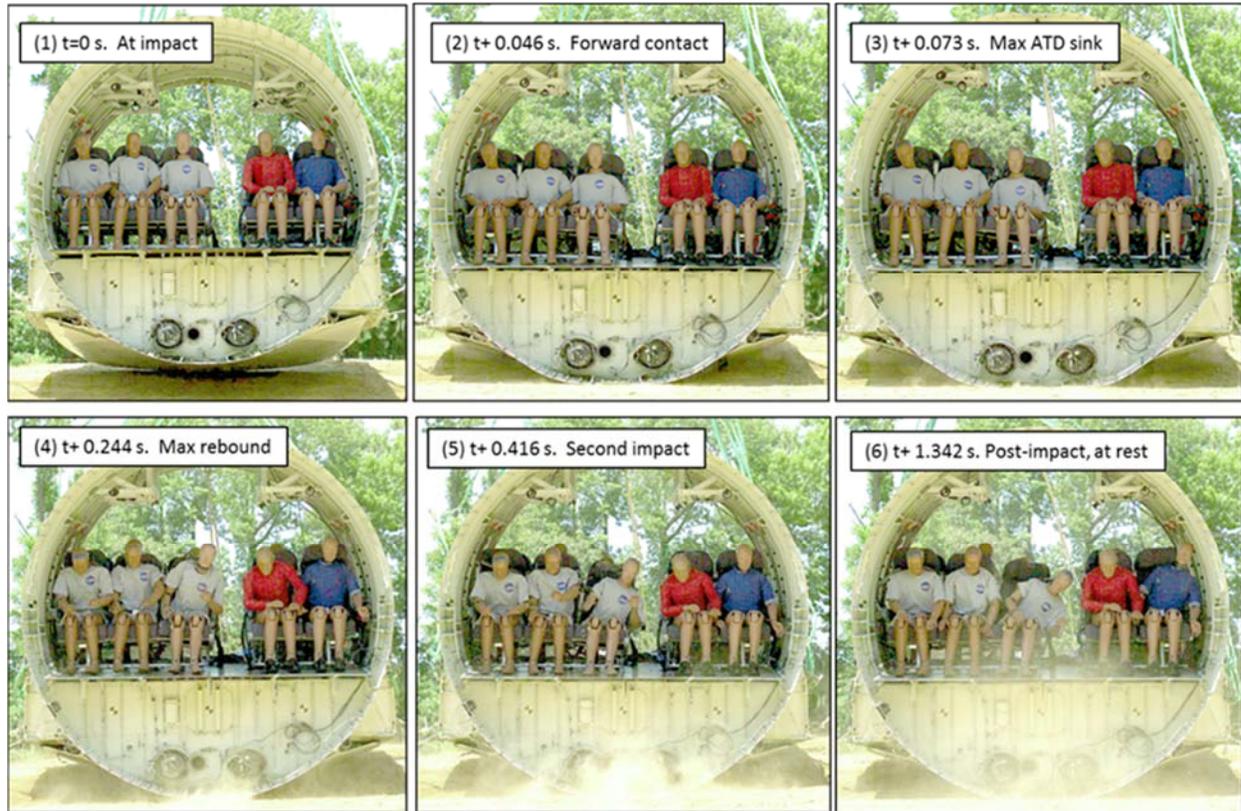
Figure 48 - Sequence of test events for the Wingbox Section test, forward view

The initial contact of the aft portion of the test article onto the sloped soil surface was considered the initial impact, and is depicted in the top left image of Figure 48. Between impact and $t+0.046$ s, the test article rotated about the rear impact point, terminating with the forward portion of the test article initiating ground contact at $t+0.046$ s, which is depicted in the top middle image. No sliding between impact at $t+0.046$ s was evident from the videos, so the horizontal acceleration between these two times was presumed to be from the test article rotation only. The next notable time occurred when the onboard ATDs experienced their maximum downward vertical motion, also known as their maximum sink position, occurring at $t+0.073$ s. The test article and ATDs appeared to exhibit uniform motion between $t+0.073$ s and $t+0.244$ s, until both test article and ATDs rebounded to their maximum unloaded positions. There was a second impact of the test article that occurred at $t+0.416$ s. During the second impact, the test article uniformly contacted the soil surface without rotational motion. The test article came to rest shortly thereafter. A final position of the test article is depicted in the lower right portion of Figure 48, and shows the test article at rest at a time well beyond where the final motion occurred during the test. An additional side view image

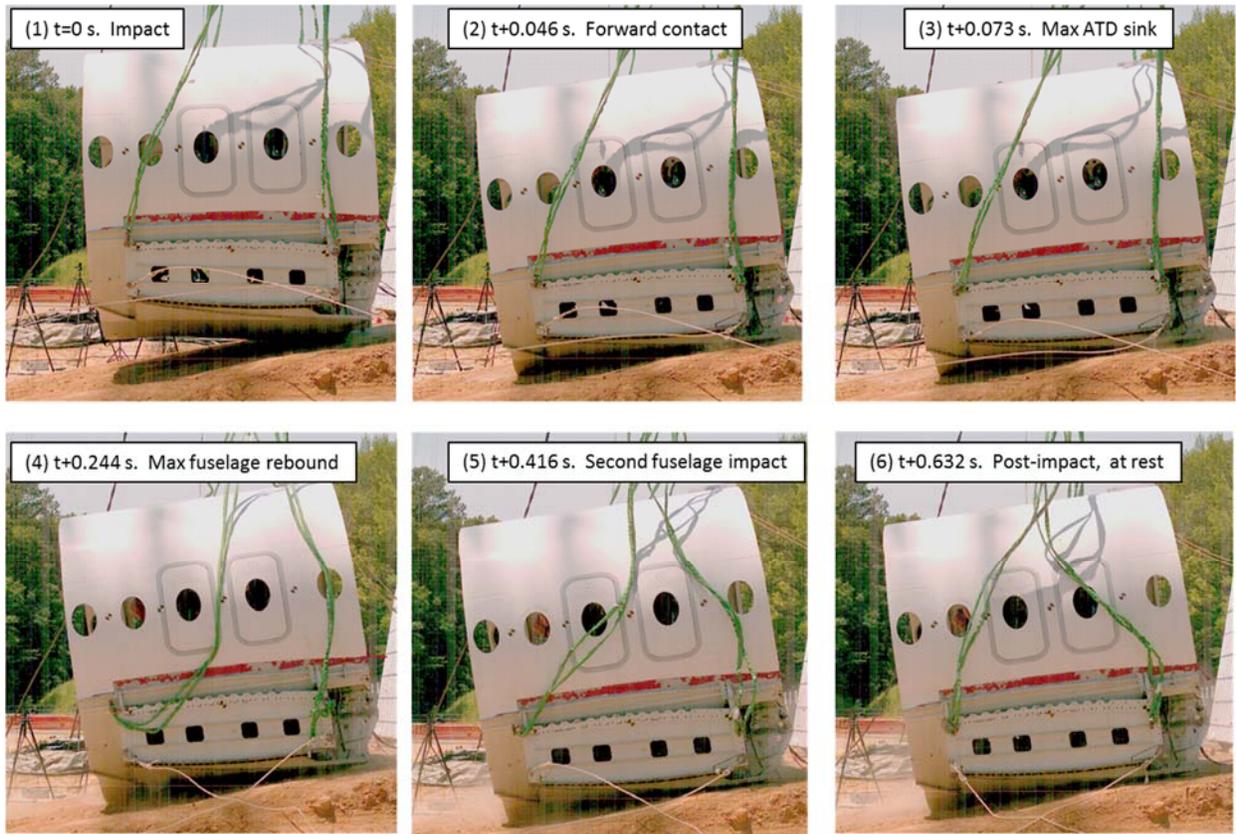
Figure 49 - Sequence of test events for the Wingbox Section test, port side view

The image sequence presented in Figure 49 depicts the motion of the Wingbox Section from the port side and corresponds to discrete times highlighted in Figure 48. The initial contact with the rear portion of the fuselage is shown in the upper left image. A gap underneath the forward portion of the section is also shown in this image. In the top middle image, the gap has closed due to the rotation about the rear portion of the fuselage. The top right image shows the section at ATD maximum sink, and is included for reference since the ATDs were not visible in the port side camera. At t+0.244 s, maximum upward rebound occurred in the test article, and the bottom middle image shows the second contact, occurring at t+0.416 s. The bottom right image shows the final frame of captured video from the camera after all of the major impact events have occurred.

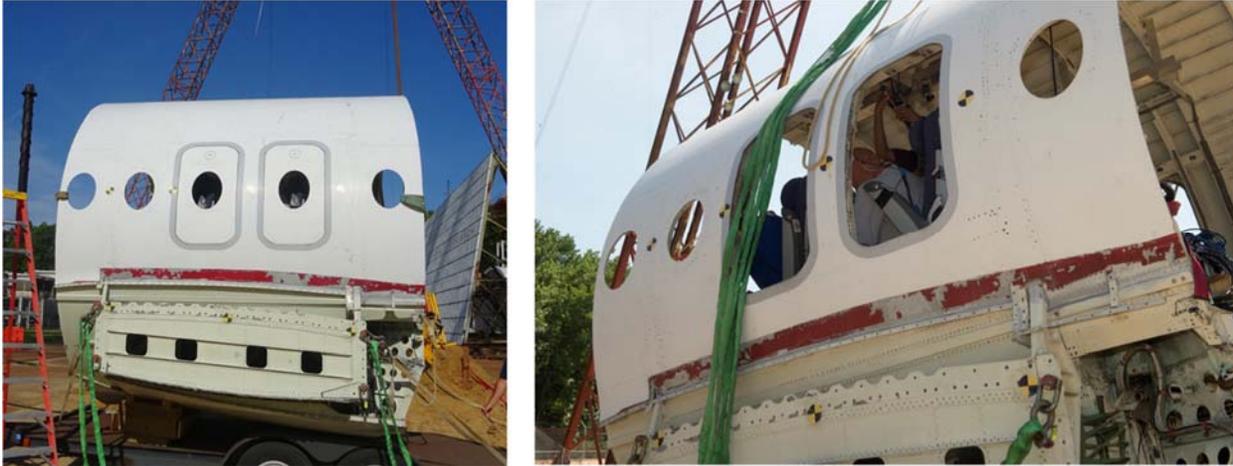
Figure 52 - Wingbox Section port emergency exit doors pre- (left) and removed post-test (right)

Other than the aft lower cavity region, the test article did not show noticeable signs of structural damage. The wingbox truss structure appeared to be undamaged, and the seat tracks did not show signs of fracture or tearing. Similar to the Forward Section, the structure above the floor did not appear damaged. Additionally, all four emergency exit doors opened nominally post-test, which indicated no permanent deformation or warpage around the door frames. Figure 52 shows the doors pre-test and the openings post-test on the port side of the test article.

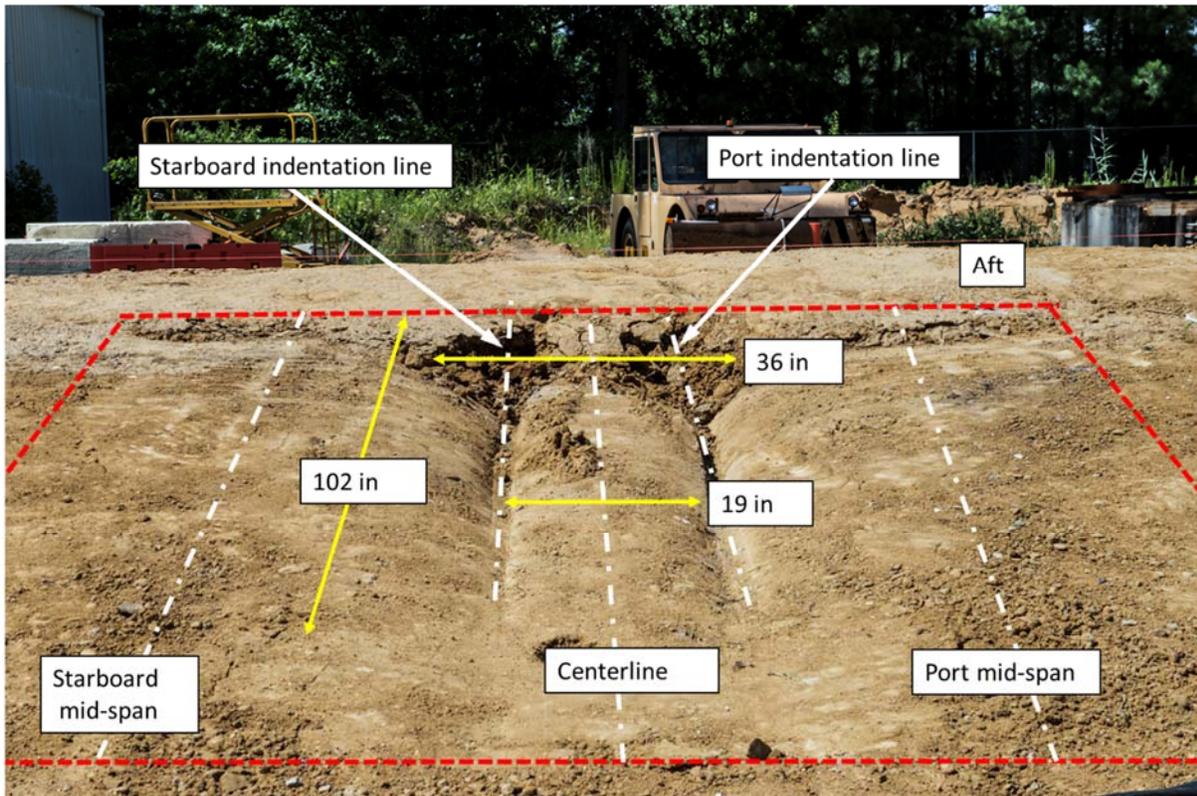
Figure 56 - Wingbox Section soil indentation results with test article outline

The impact caused a distinct impression in the soil. Specifically, the impression exhibited two distinct parallel vertical lines with the deepest penetration occurring near the aft of the test article and gradually becoming shallower when moving toward the front. The parallel lines were created by vertical stiffeners located at the bottom of the test article, approximately 9 in outboard from the test article's geometric centerline. Since the aft portion of the test article impacted first, the rear features, including the vertical stiffeners, made the deepest impression in the soil surface. Generally, the rest of the soil mound was undeformed due to the impact. Figure 56 shows the indentation of the soil surface from the test. The two vertical indentations are noted, and the top of the image is toward the aft end of the section.

Penetration measurements were taken at three locations in the crater, depicted in Figure 56. Measurements for the starboard indentation line, which is the vertical line on the left in Figure 56, the middle between the indentation lines, and the port indentation line, which is shown to the right in Figure 56 were taken and the results are shown in Table 2.

The soil crater measurement data marked differences between the vertical stiffener and bottom span locations. In the aft impact location, vertical stiffener penetration was 7 in deep on the starboard side and

7.25 in deep on the port side, while the location of the mid-spans corresponding to the lower cavity locations of the test article lightly penetrated the soil. The differences were notable because accelerations obtained at the different measured locations were able to provide a local loading profile. Using the aft subfloor accelerometer for the vertical stiffener accelerations and the CDR for the lower cavity accelerations, the acceleration data were compared. Figure 57, left, shows the locations of both accelerometers in the post-test damaged view to contrast the difference in their locations. The data obtained are shown in Figure 57, right. The data were not time synchronized so manual shifting was implemented on the CDR data to give a more direct comparison. The data in Figure 57 are filtered using a Channel Frequency Class (CFC) 60 low-pass filter for visualization.

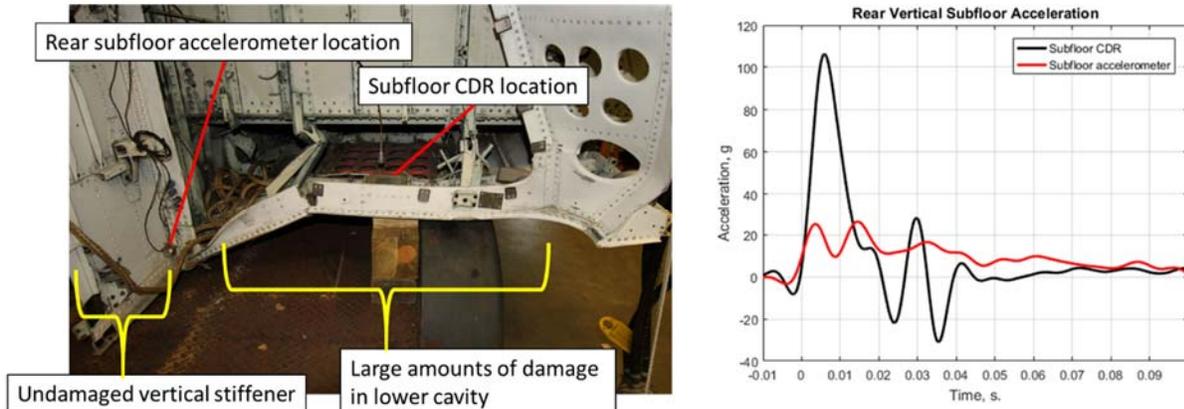
Figure 57 - Wingbox Section aft lower sensor locations (left) and acceleration results (right)

The filtered CDR data showed a triangular shaped pulse with a peak acceleration of approximately 106 g and duration of approximately 0.021 s, if using the first data point for which the acceleration trace crossed the zero-g mark after maximum. In contrast, the subfloor accelerometer located on the vertical stiffener produced accelerations that more closely matched the results from the airframe floor accelerometers. The vertical stiffener remained undamaged during the impact, but produced the deepest soil crater where penetration occurred, shown in Figure 56, in a controlled manner throughout the initial rotation, front impact, and through ATD max sink. The soil penetration, along with the rotation, limited the peak magnitude of 26.0 g, with a duration of 0.100 s.

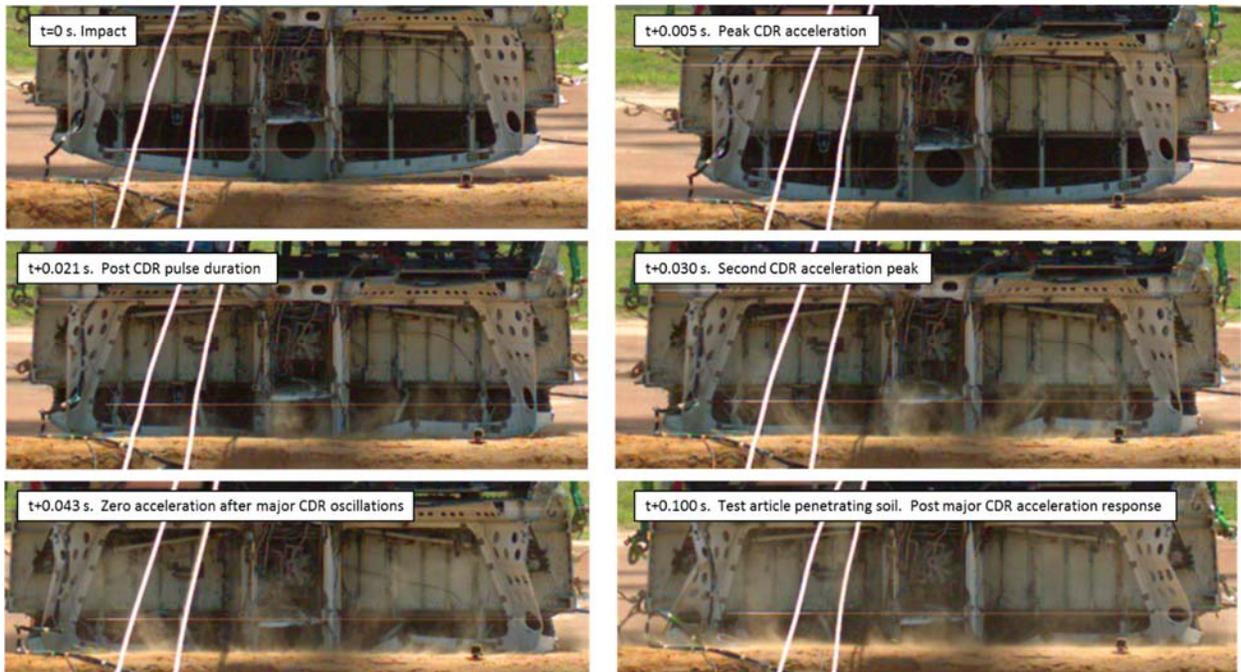
Figure 58 - Aft lower cavity deformation image series

Figure 58 shows an image series of the aft lower cavity crushing illustrating the differences in deformation at the two locations where the sensors were mounted. Note that the horizontal lines in the images were artifacts of the camera sensor not related to the test, test setup, or results, and ignored when interpreting the images.

The initial contact between the aft portion of the test article and the soil surface is shown in the upper left image in Figure 58. The peak CDR acceleration, shown in the upper right, was 106 g and occurred 0.005 s after initial contact. Between impact and this time, there was not any noticeable deformation in the lower cavity occurring. The impact shape and magnitude of the acceleration response were a result of contact between the bottom skin's large surface area and soil. It was only after the 106-g peak that the lower cavity deformation initiated. The CDR pulse shape crossed the first zero-g mark at 0.021 s, shown in the middle left image, and after 0.021 s the lower cavity deformation continued to occur. The oscillation in the CDR data was from the flexing of the panel where the CDR was mounted during the failure of the lower cavity, shown in the middle right and lower left images. After 0.100 s, the major acceleration pulses for both the data logger and the accelerometer on the vertical stiffener have concluded.

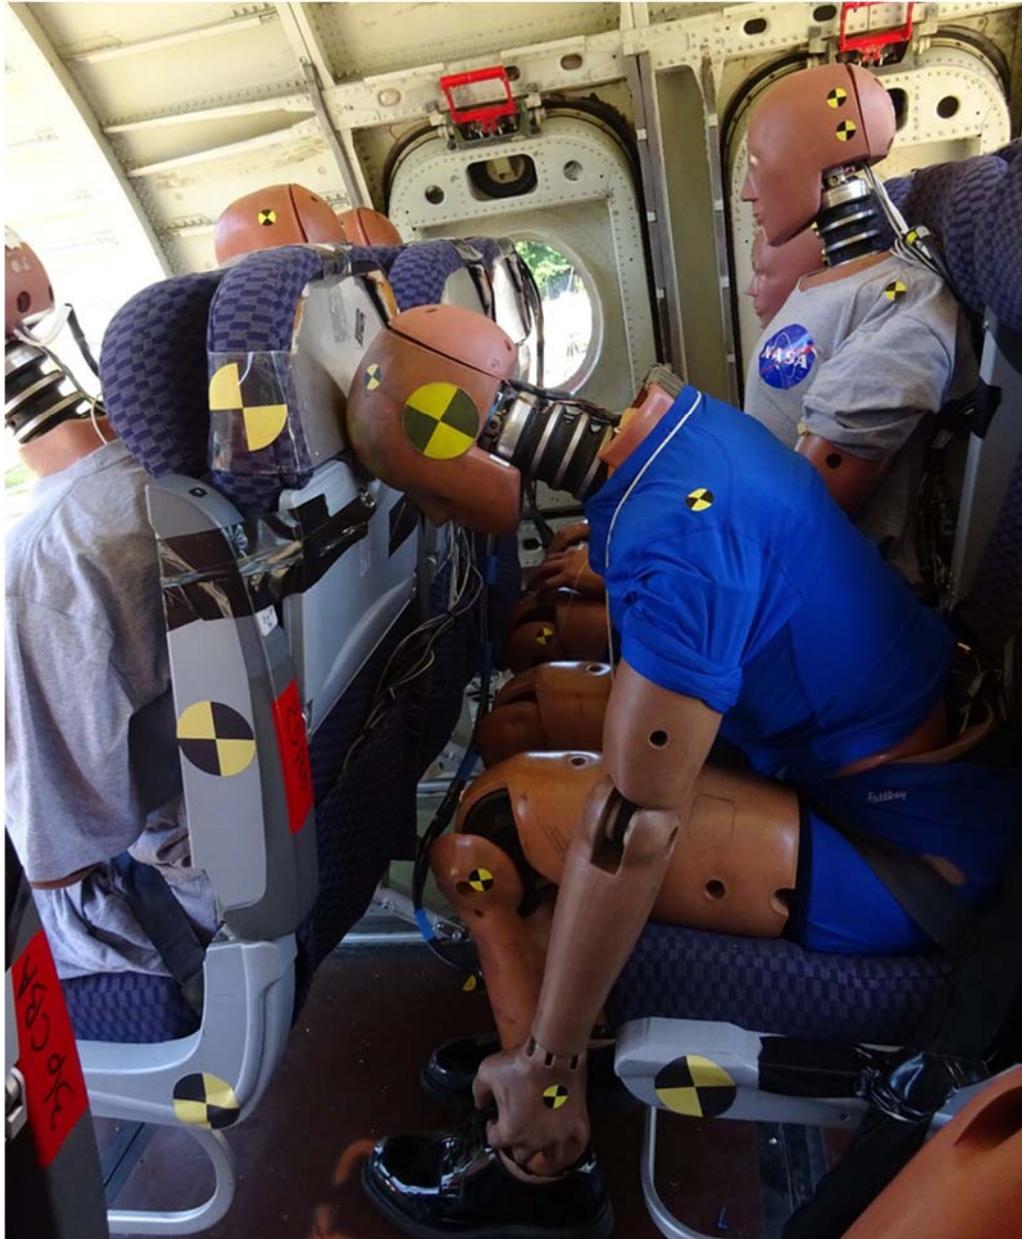
Figure 70 - ATD 3 in the brace position

ATD data were next examined. Nine of the ATDs were seated upright with their hands on their knees, in an identical position to that of the Forward Section test. ATD 3 was unique in that it was positioned in the “brace” position, configured by leaning its chest forward, and positioning its head such that it was nearly touching the seat #8 seat back. Its arms were down at its side resting below its knees with the hands located near its shins. Figure 70 shows a view of ATD 3, positioned in the brace position, just prior to impact.

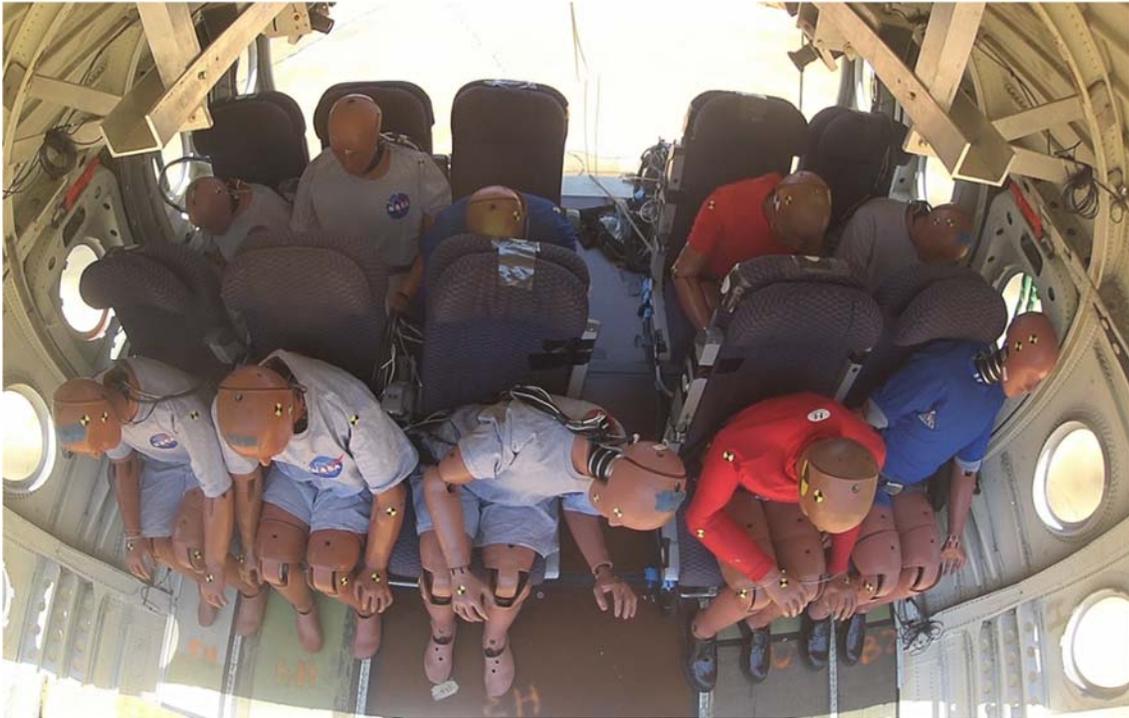
Figure 71 - Wingbox Section post-test ATD positions

On overhead view of the post-test configuration for the ATDs is shown in Figure 71. ATDs 1, 4, 6, 7 and 9 all appeared to be leaning directly forward. ATD 3 appeared to be in the same position as prior to the test. ATDs 5 and 10 were leaning both backward and sideways, toward the window, in a similar position that was observed for the Forward Section test. Finally, ATD 8 appeared to be leaning purely sideways, into the aisle.
