Space Shuttle Stiffener Ring Foam Failure Analysis, a Non-conventional Approach.

Philip M. Howard
NASA
Kennedy Space Center
Materials Science Division

KSC-MSL-2007-0136

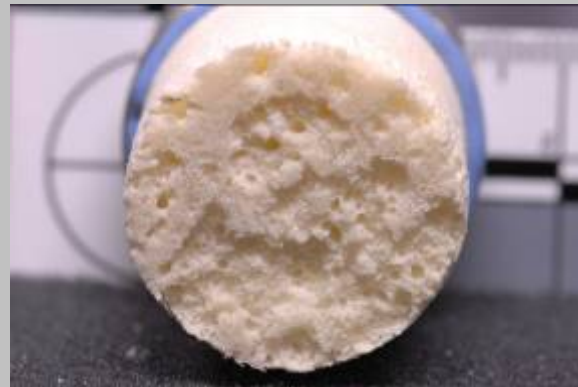
Qualitative Inspection

- ATK define the foam failures qualitatively by visual inspection of the presence or absence of foam residue on the de-bonded surface.
- Foam Failures fall into two categories
 - Adhesive
 - Cohesive
 - Mixture of both
