# Fractographic Analysis of 60-Nitinol Bearing Races

*Malcolm K. Stanford*  
*Glenn Research Center, Cleveland, Ohio*

Fracture surfaces on a failed bearing race made from 60-Nitinol (60 wt% Ni – 40 wt% Ti) were analyzed. The bearing had experienced excessive localized heat due to an issue during machining that may have resulted in dimensional distortion. However, the classical fracture features that were identified by scanning electron microscopy and the fracture origins coincided with high concentrations of TiC-based contamination. Lessons learned for processing and quality control are discussed. An attempt to use x-ray diffraction to directly measure residual stresses imparted from the required heat treatment is also discussed.

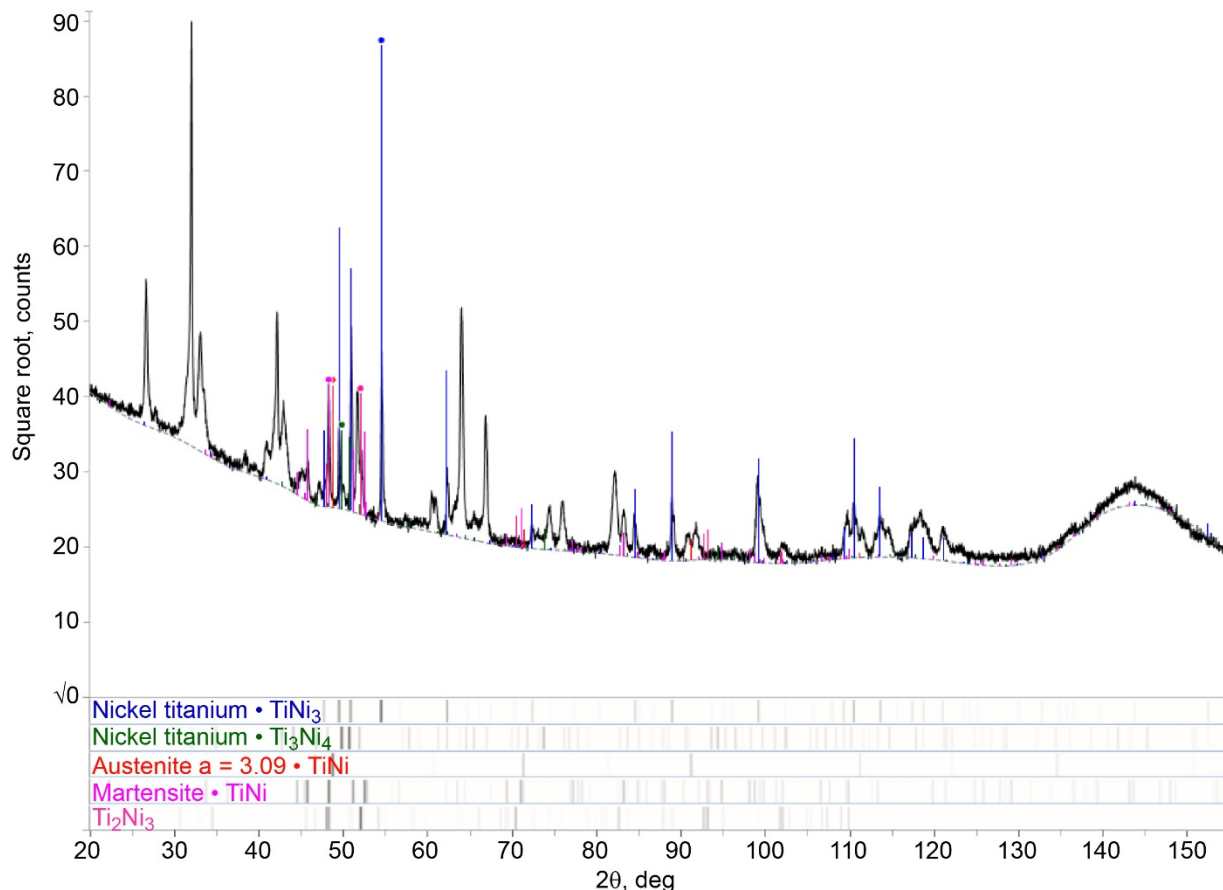
The x-ray diffraction spectra showed multiple peaks representing separate phases that could not be isolated for identification. With the available instrumentation, isolated peaks are required at angles in the range of approximately  $2\theta = 120^\circ$  to  $150^\circ$  for accurate classification (Ref. 17). However, as illustrated in Figure 18, multiple peak markers appear in the lower angle region from approximately  $2\theta = 45^\circ$  to  $115^\circ$ . Therefore, the phases could not be identified and their lattice parameters could not be determined.

Figure 18.—X-ray diffraction spectrum (with phase identification near  $2\theta$  axis) for a 60-Nitinol bearing blank.
