Lessons Learned from
Accidents Involving
Remotely Piloted and
Autonomous Aircraft

Crash Course

Peter W. Merlin

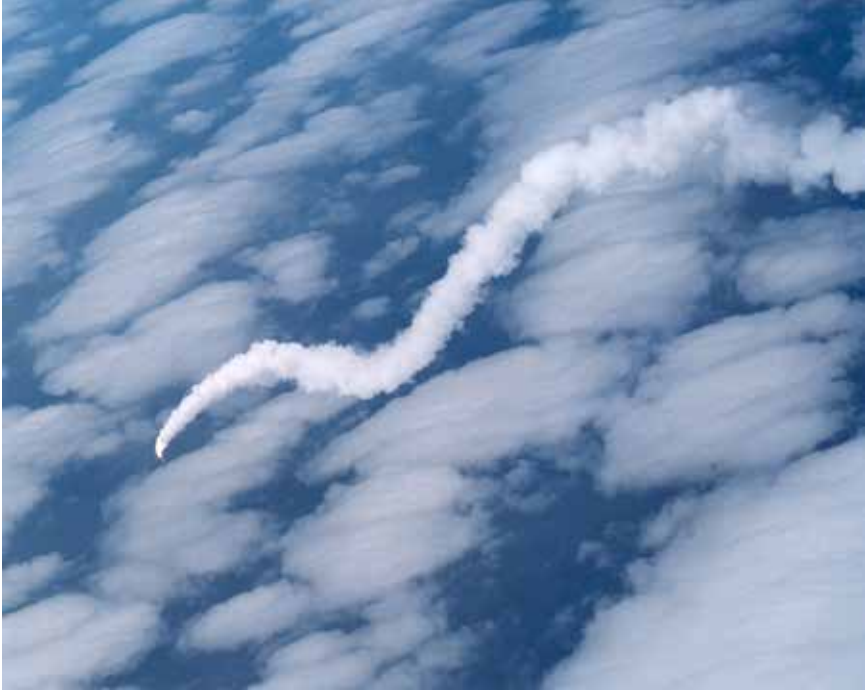
Divergent roll oscillatory motion caused by excessive control-system gain resulted from inadequate analytical modeling that allowed engineers to overestimate system safety margins. NASA

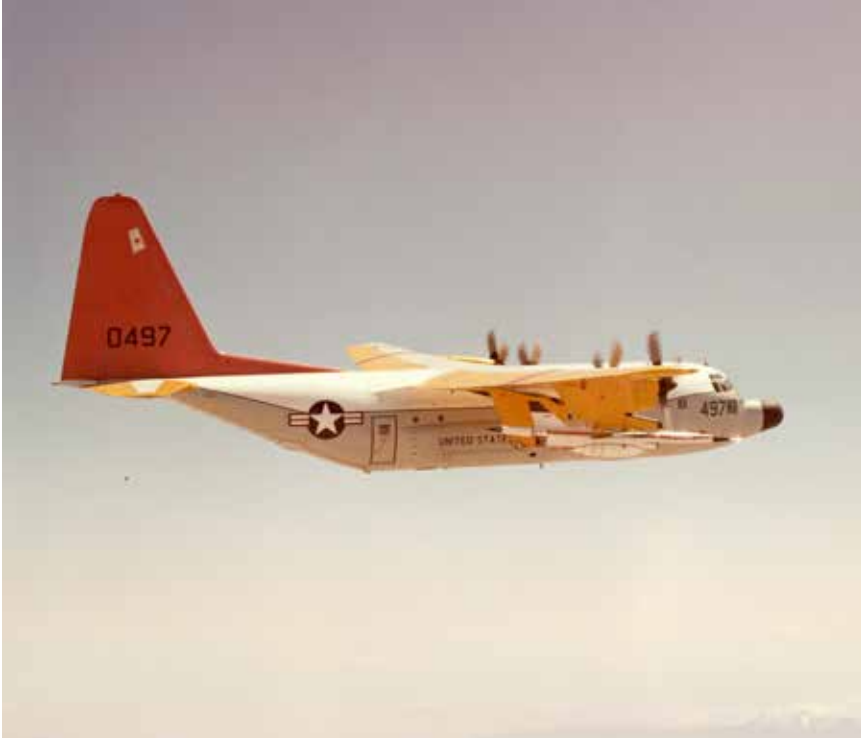
In 1983, a DC-130A was used as a mother ship for the DAST-2. Following two captive flights, the first launch attempt ended in failure. NASA

The next three flight attempts were also aborted, the first due to a drone engine temperature warning, the second because of the loss of telemetry, and a third for unspecified reasons prior to taxi.²⁸

The board recommended that all future DAST launches be conducted from the NASA B-52. This would insure adherence to NASA maintenance practices and policies.³⁸

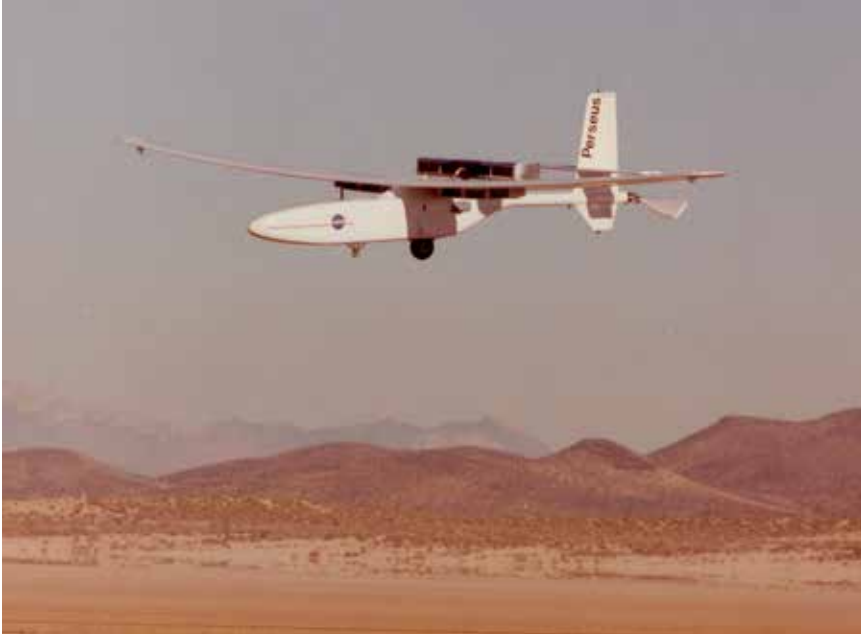
The Perseus-A had a maneuver speed limit of 61 knots indicated airspeed (KIAS) and a never-to-exceed speed limit of 71 KIAS. NASA

The pilot reduced the throttle setting and began descent procedures that included a normal engine shutdown. As the Perseus-A descended through 34,000 feet, the aircraft experienced slight vertical oscillations that went unnoticed in the control room because personnel were focused on flying the aircraft through a band of high winds and establishing a positive ground speed. Indicated airspeed was increased from 52.5 to 62.4 knots. The Perseus-A had a maneuver speed limit of 61 knots indicated airspeed (KIAS) and a never-to-exceed speed limit of 71 KIAS.⁷

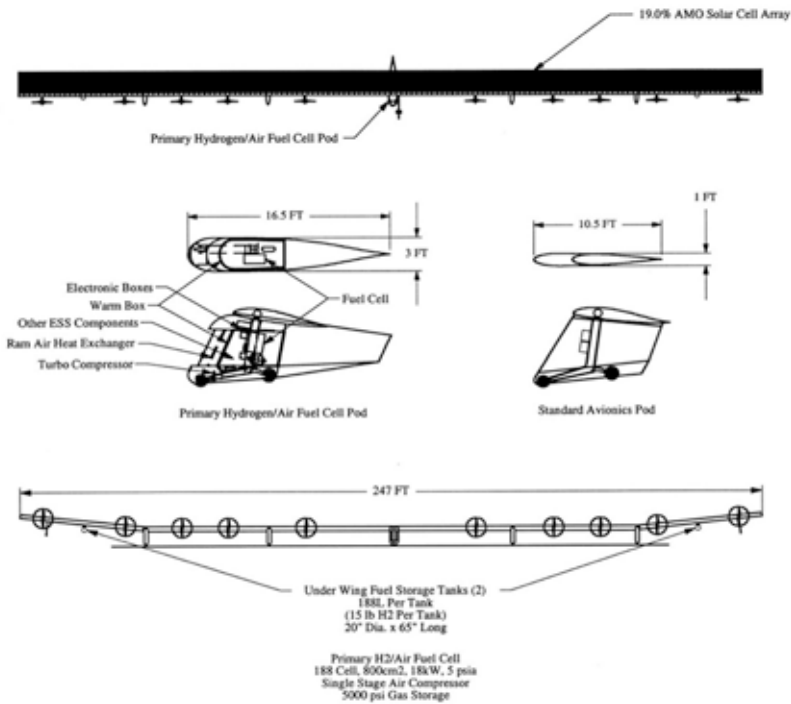
Addition of a center-mounted 520-pound fuel cell and two 165-pound fuel tanks beneath the outer wing panels changed the Helios Prototype from a span-loader to a point-loaded configuration. NASA

would have required only two regenerative fuel cell pods located about one-third the distance from aircraft centerline to the wingtips. Installation of three pods for the PFCS configuration resulted in increased point loading.

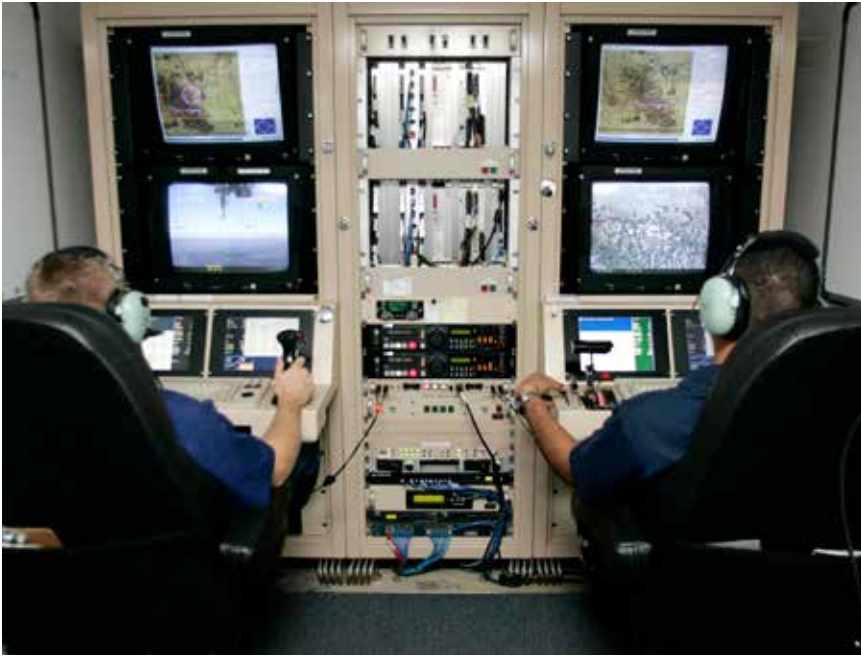
| <i>Introduction</i> | vii |

“This investigation has raised questions about the different standards for manned and unmanned aircraft and the safety implications of this discrepancy,”⁸ said Rosenker. He noted that the pilot’s console had been known from past experience to lock up frequently, but this issue was not resolved. In fact, a logbook in the ground control station revealed 16 lockups in the 4½ months prior to the accident. No data had been recorded to explain these deficiencies. “Such conditions would never be tolerated in the cockpit of a manned aircraft.”⁹

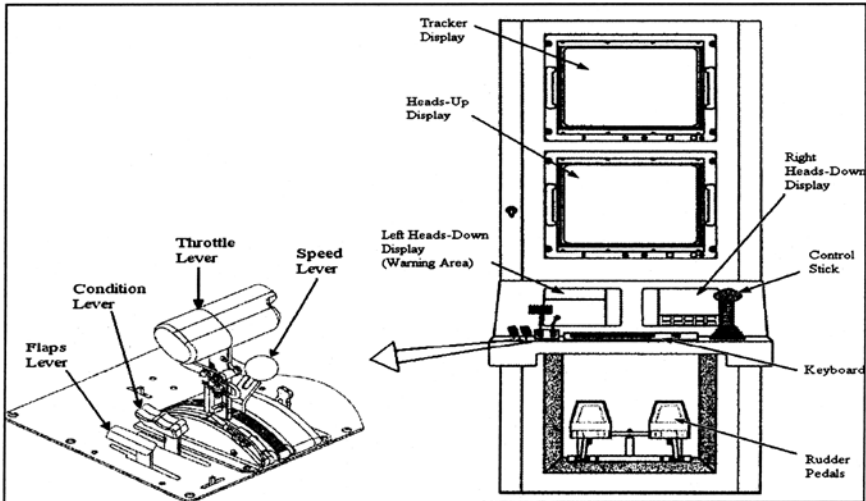
| Chapter 2: HiMAT 17 <i>Increasing Aircraft Performance Capabilities</i> | 17 |

When the pilot switched control to PPO-2, the condition lever was still centered. In camera-control mode, this locked the iris, but in flight-control mode, it cut off fuel flow to the engine. As the engine sputtered to a halt, the MQ-9 began to descend. The pilot noticed the change in altitude but failed to discern the cause. Also unaware of the situation, the avionics technician advised him to shut down the ground-data terminal so that the MQ-9 would begin its programmed lost-link procedure. Normally, this would cause the MQ-9 to autonomously climb to 15,000 feet and fly a predetermined course until uplink could be reestablished. Without engine power, however, the aircraft descended until it was below the range of line-of-sight communications and contact was lost. The MQ-9 crashed in a sparsely populated residential area, but there were no injuries or damage to private property.⁶

Investigators also examined the switch configuration on the PPO consoles. In the pilot configuration, the control lever was used to control both the fuel valve and propeller feather servo. This lever had a linear analog range running from zero to 100 percent, divided into thirds for normal operation, engine shutdown, and propeller-feather/engine-shutdown. A shutdown engine could be restarted if the switch was positioned in the normal range and engine controls were in auto mode. The system was programmed to attempt automatic restart if propeller speed fell below 1,488 rpm and the condition lever was in the normal run range. The engine could not be restarted with the lever in the shutdown range because this closed the fuel valve, shutting off fuel flow to the engine.

As is frequently the case, this mishap might have been easily avoided. A simple switch lockout could have prevented the pilot from inadvertently shifting aircraft control from one console to the other until the condition lever positions matched. Such a device—used effectively in everything from automobiles to nuclear weapons—would have provided a final opportunity to avoid disaster.¹⁶
