# **Fatigue Life of a NiCr-Coated Powder Metallurgy Disk Superalloy After Varied Processing and Exposures**

**1. NASA Glenn Research Center, 2. DVTI, Inc., 3. Vantage Partners, LLC**

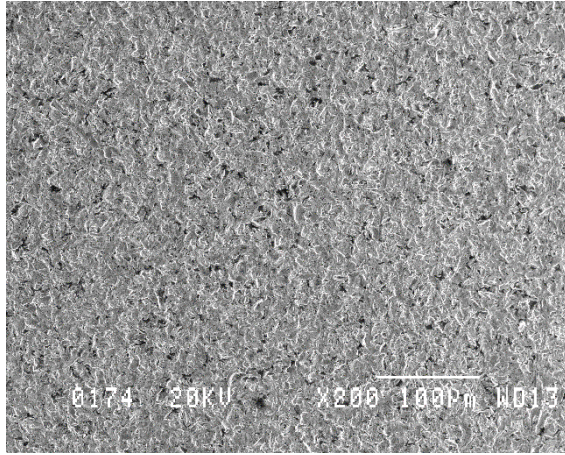
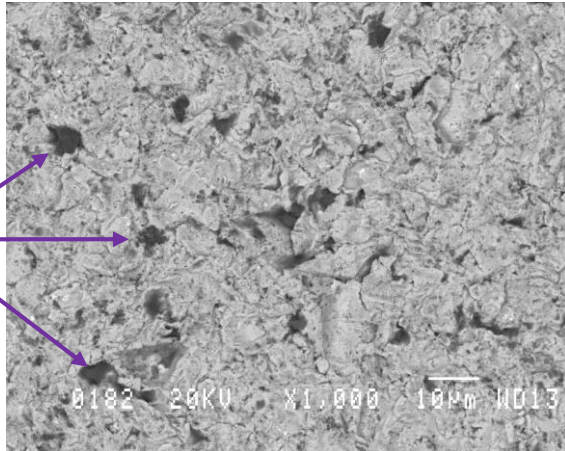
**Grit Blasted 220 grit Alumina**

**Grit:**

Dark particles  
are embedded  
alumina grit

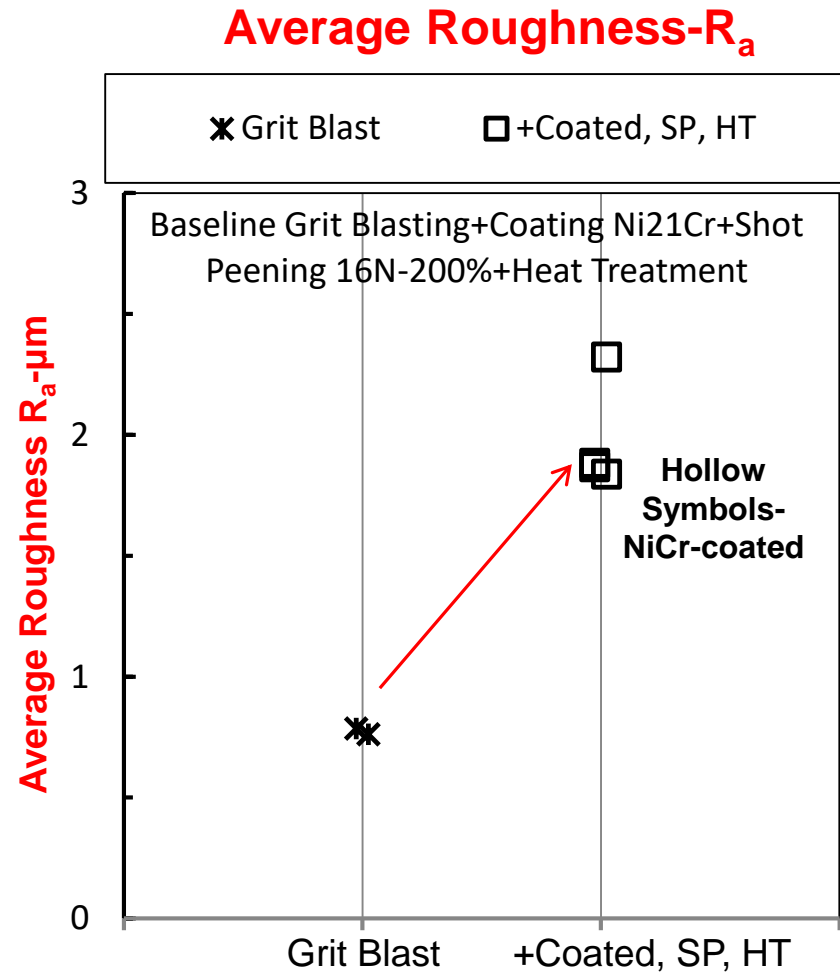
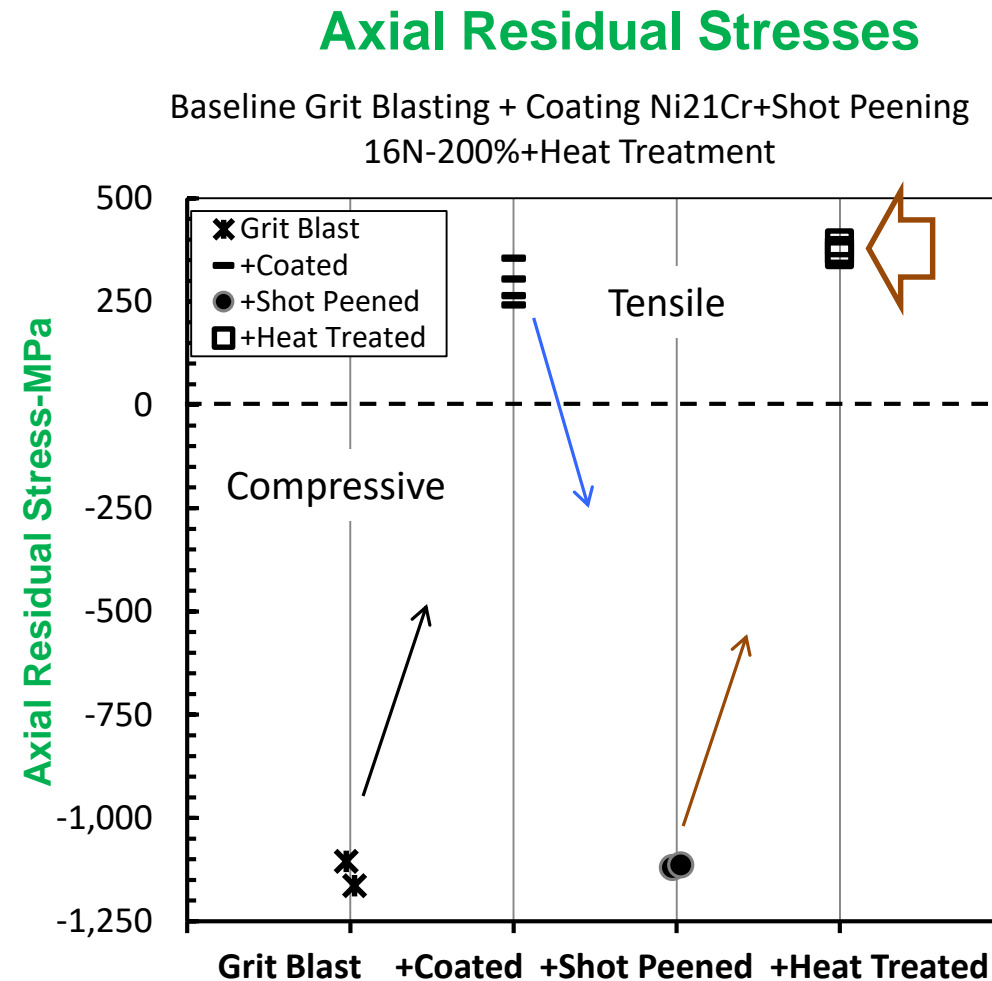
## (A) Baseline Processing: Pre-coat Grit Blast + Coating + Shot Peen + Heat Treat

# Surface Roughness Was Increased After Coating + Shot Peen + Heat Treat

- The coating was in tension, but shot peening produced large compressive residual stresses at the surface of the coating.
- Heat treatment at 760 °C for 8 h relaxed out the compressive residual stresses, resulted in tensile stresses at the surface.

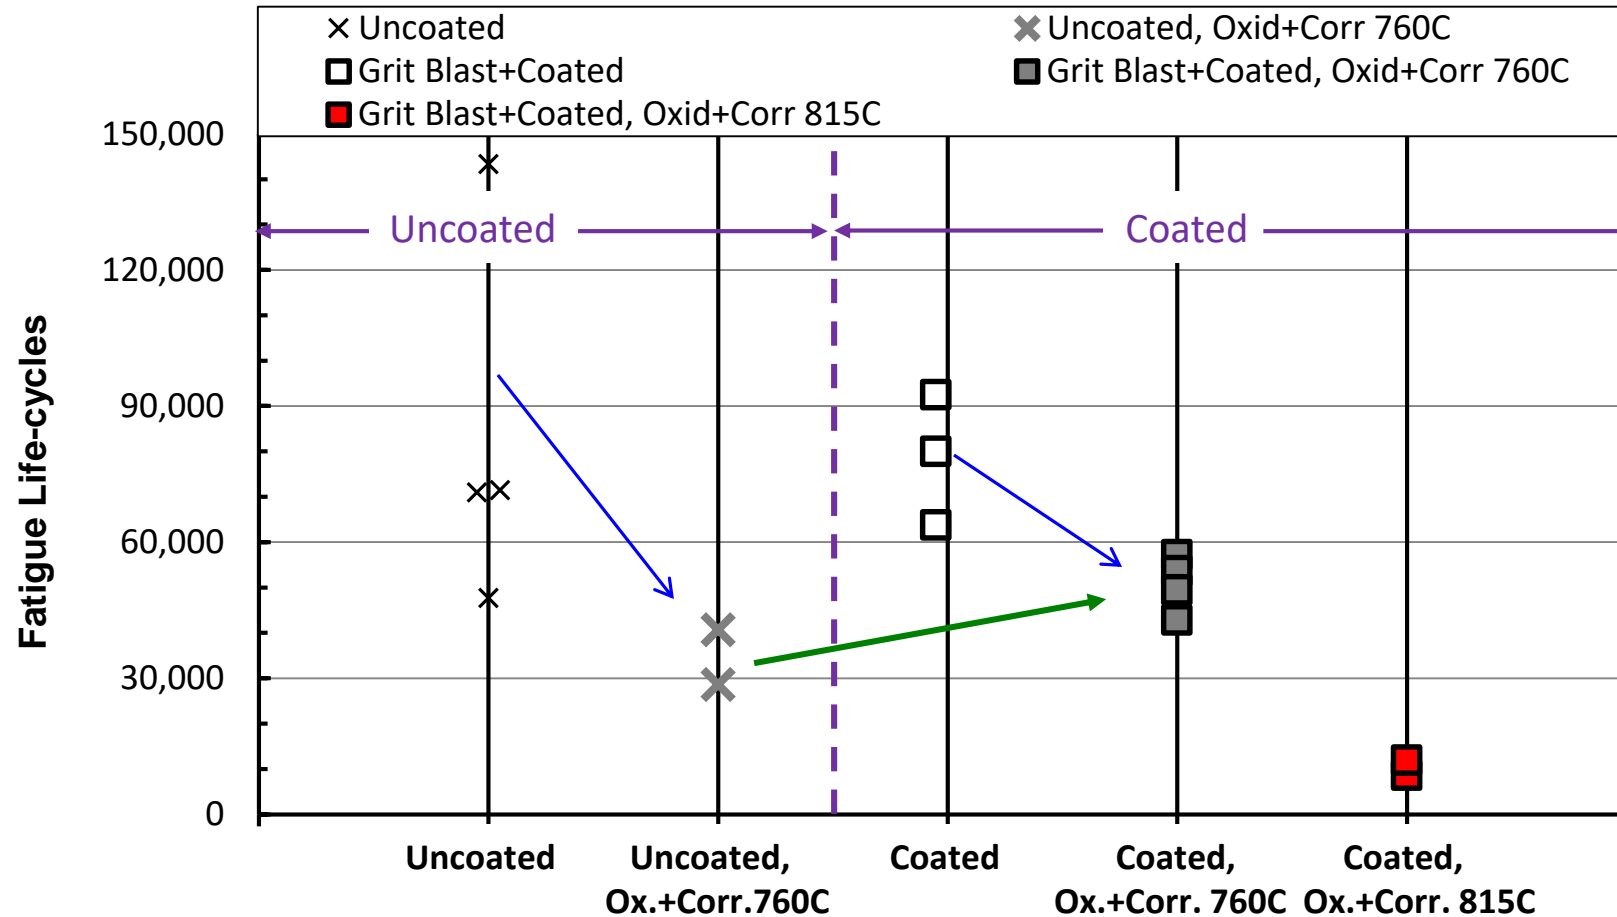
# Comparison of Fatigue Lives For Uncoated Versus Coated Specimens Prepared Using the Baseline Process

- Combined oxidation plus corrosion exposures reduced fatigue lives for uncoated and coated specimens.
- Coating gave a modest benefit after oxidation + corrosion

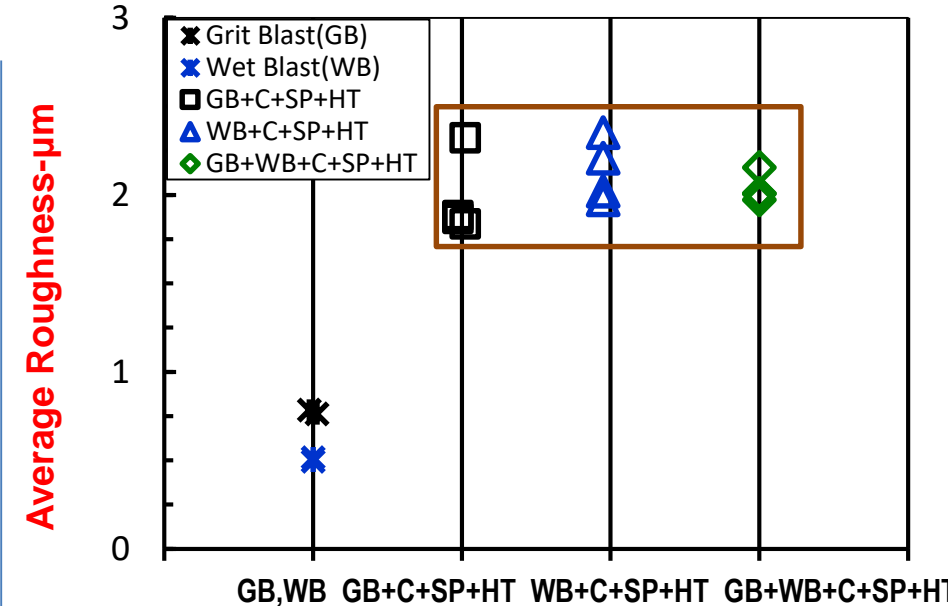
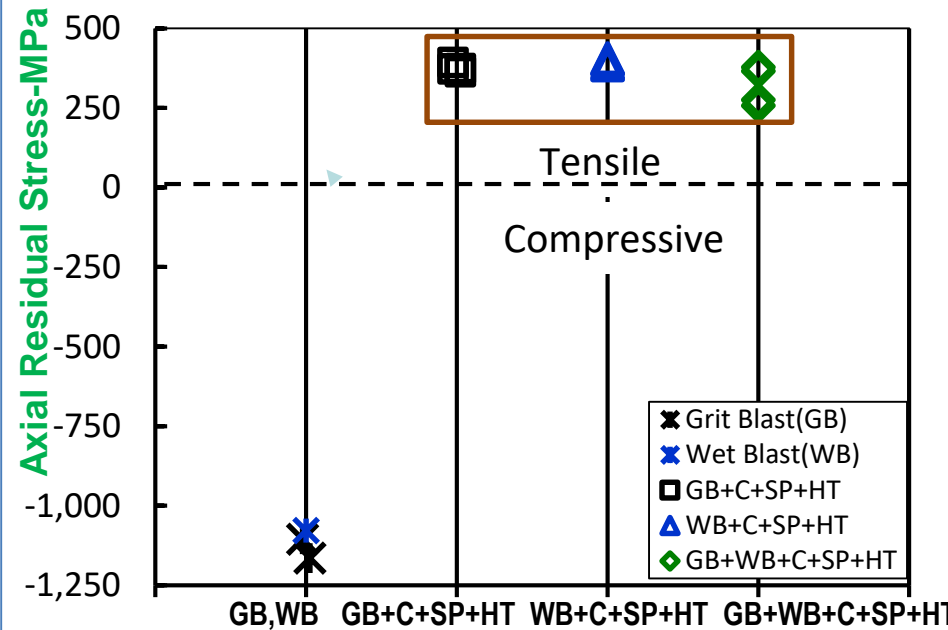
- After baseline coating (C), shot peening (SP), and heat treatment (HT) processes, similar tensile residual stresses were measured at the surface for all conditions.

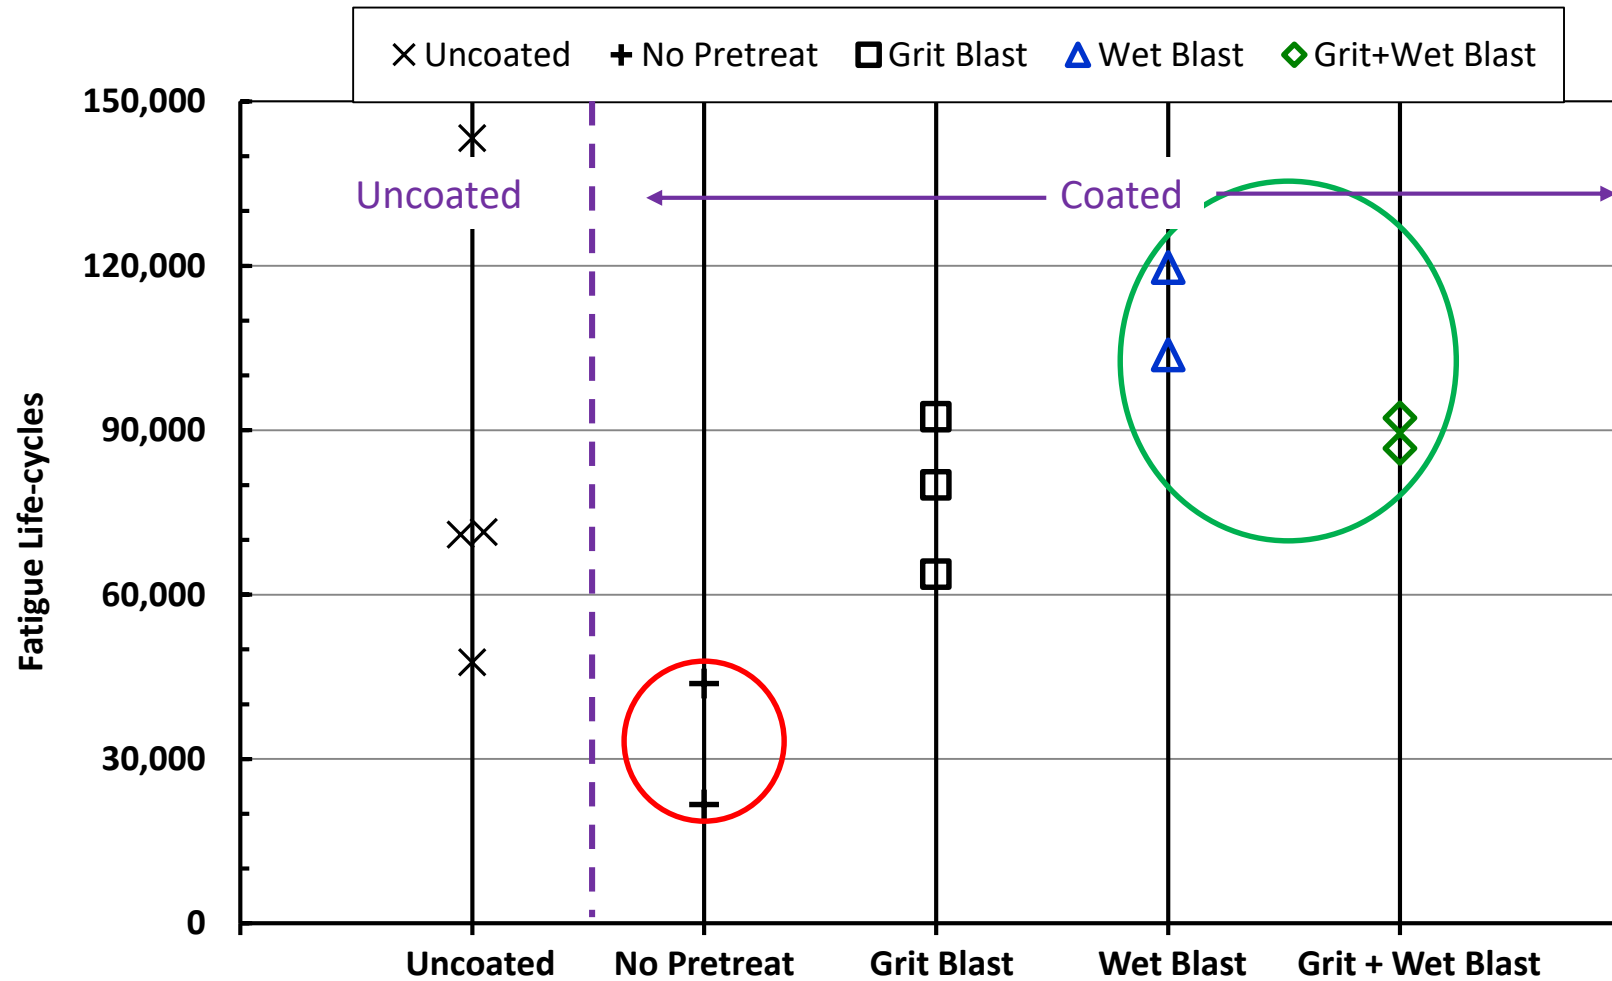
# After Different Pre-Treatments, Fatigue Lives of Coated Specimens With No Exposures Varied

- Coated with no pre-coat treatment had unacceptable fatigue lives.
- Coated with wet blast pre-coat treatment gave highest coated fatigue lives.

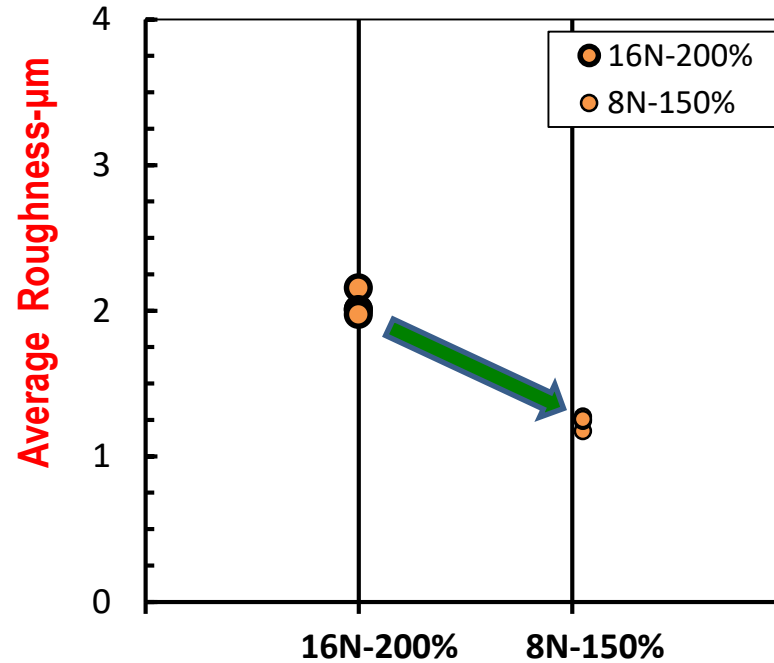
-Average roughness after shot peening reduced about 40 %.

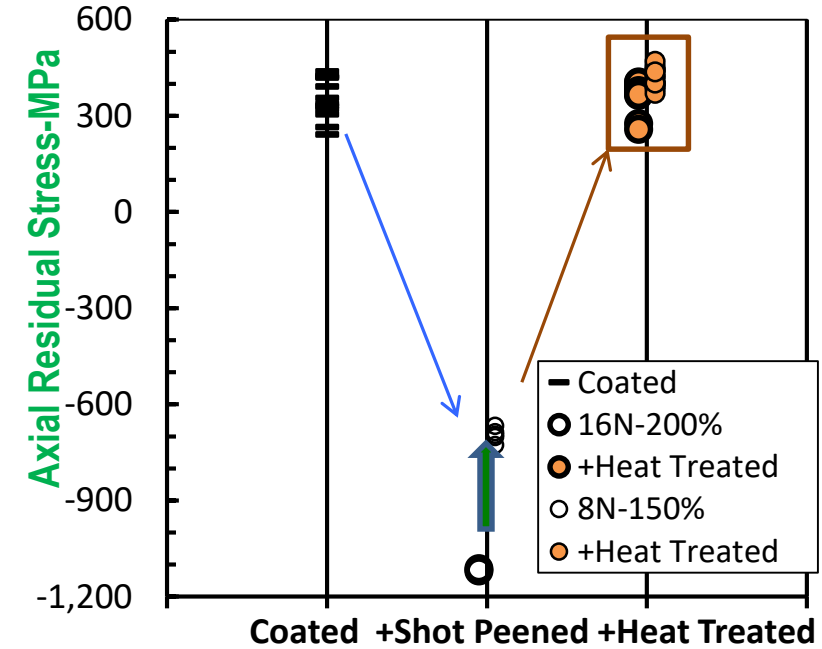
-Magnitude of axial compressive residual stress from shot peening reduced about 35 %.

- Alternative post-coat shot peen treatment reduces roughness and compressive residual stress.

- Yet, heat treatment still relaxed residual stresses to comparable values.

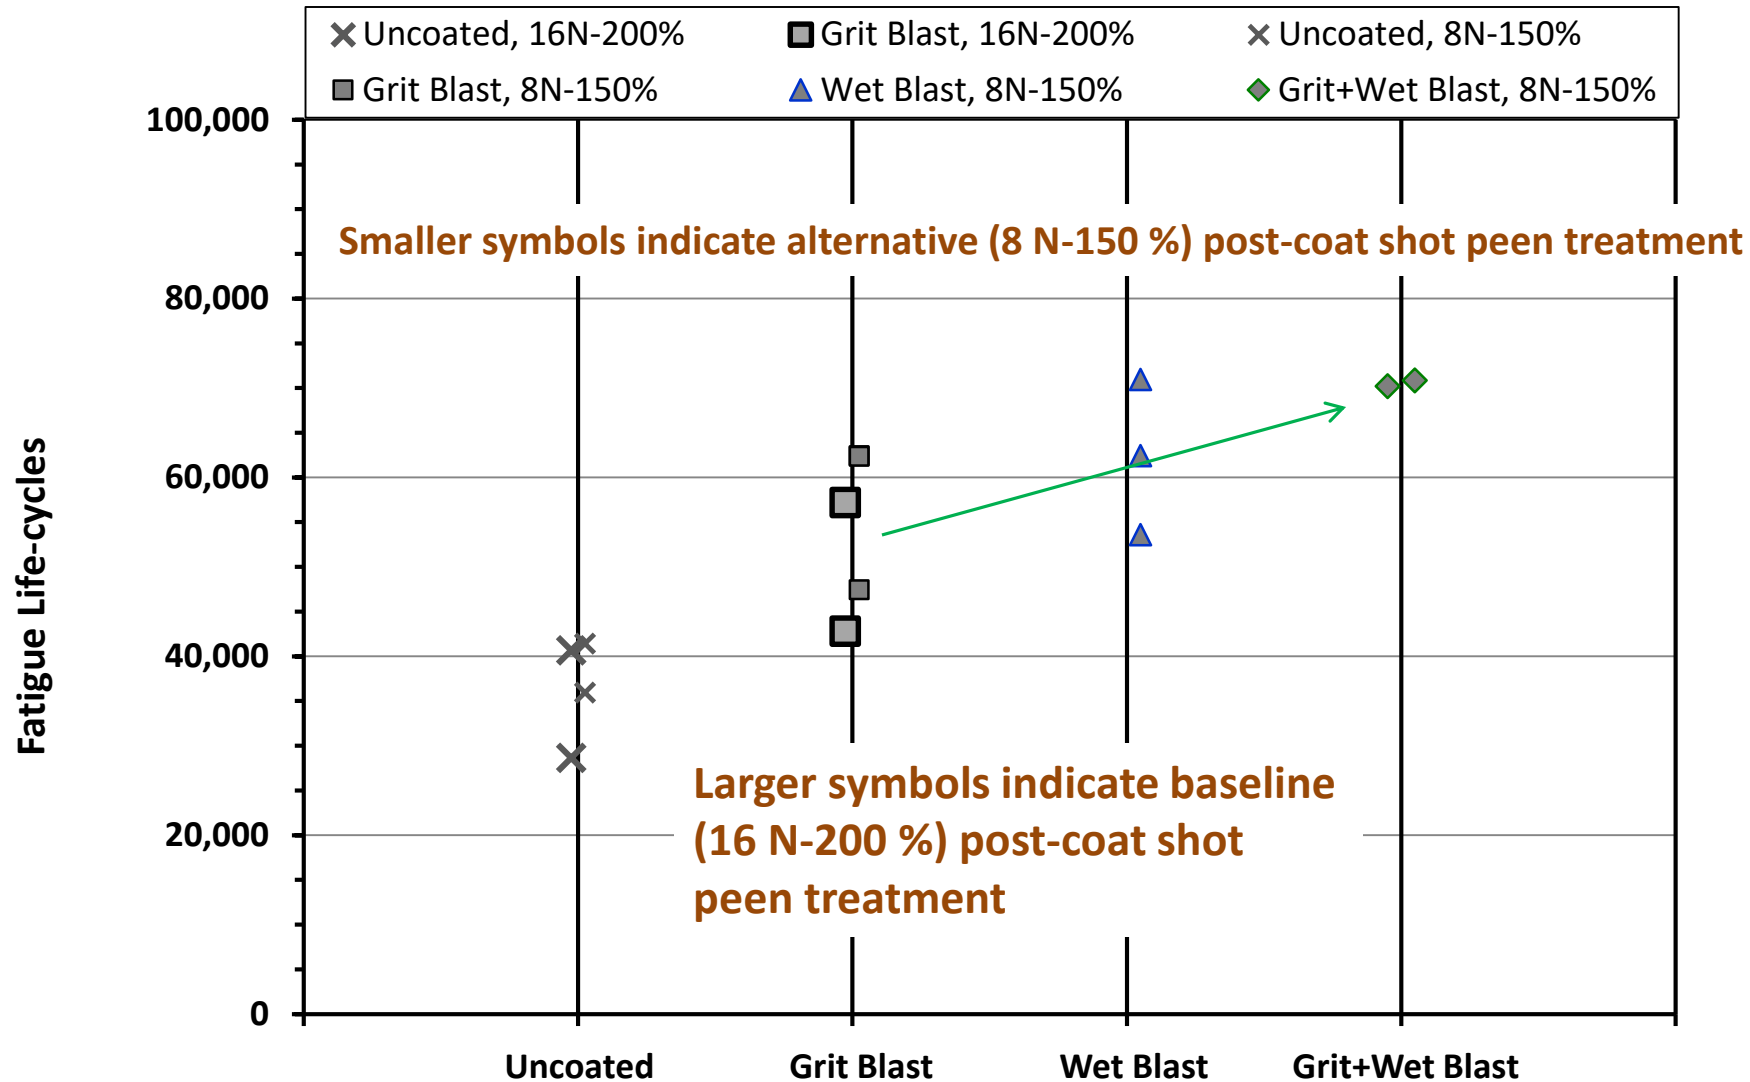
# Comparison of Fatigue Lives After Oxidation + Corrosion

- Alternative post-coat shot peen treatment gave modestly improved coated fatigue lives after oxidation plus corrosion.
