Freezing Damage to Coolers at the NASA-GRC 10x10 Supersonic Wind Tunnel

Prepared by: Jim Roeder, 10x10 SWT Facility Engineer
Jonathan Kubiak, 10x10 SWT Facility Manager

For the 130th Semi-Annual Meeting of the Supersonic Tunnel
Association, International (October 7-10, 2018)

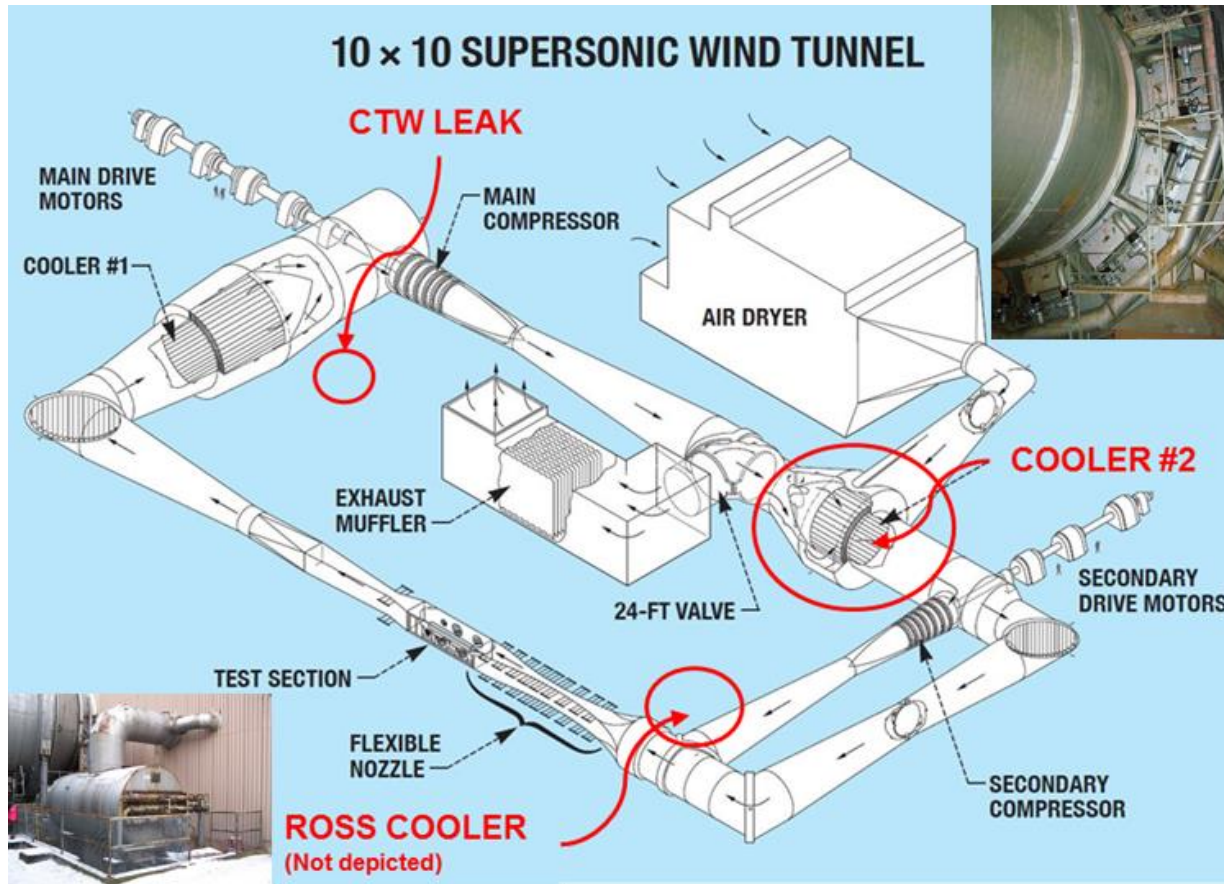
- Circular arrangement of 14 tube bundles each containing 312 finned copper tubes and weighing ~17,000 lbs each.
- Reduces air temperature prior to entering secondary compressor.
- Cooling tower water (CTW) flowing through tubes cools up to 2680 lbm/s of tunnel circuit air flow from 310°F to 100°F.

- Visual inspection of Cooler 2 found multiple signs that freezing damage had occurred (icicles, split tubes).
- A water level sensor in the air-side of the Ross cooler indicated that it too sustained damage.

- Seven (of 14) tube bundles from cooler 2 and all three Ross cooler tube bundles have been removed from service and sent off-site for repairs.
- Replaced all supply and return valves on Cooler 2 and the Ross Cooler.
- Bundles are being completely re-tubed (copper tubes with embedded aluminum fins)
- Impact to wind tunnel test schedule: ~14 months.
- Current schedule anticipates completion of cooler repairs by end of February 2019, including one month of checkout and tunnel reactivation.
