LESSONS LEARNED FROM FLIGHT OBSERVATIONS OF THE GOES-R MAGNETOMETER

The The Geostationary Operational Environmental Satellite (GOES)-16 observatory was launched on 19 November 2016. During daily on-orbit operations, shadowing of the inboard magnetometer sensor unit occurs due to spacecraft geometry and solar angle. Throughout the shadowing periods of the inboard magnetometer, anomalous excursions of 20 nanotesla (nT) are observed. In addition to the excursions during shadow events, the measurement difference between the inboard and outboard magnetometer varies over the day, indicating erroneous measurements by one or both magnetometers. In addition, based on the deployment rotations, the zero offsets of the X and Y axes were found to be significantly different, ~30nT, from ground calibration data.

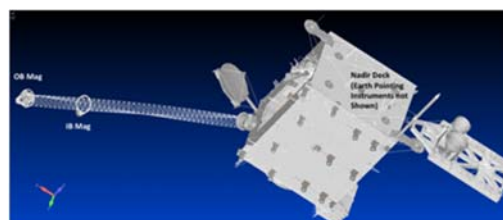
magnetometer boom deployment. During daily on-orbit operations, shadowing of the inboard magnetometer sensor unit occurs due to spacecraft geometry and solar angle. Throughout the shadowing periods of the inboard magnetometer, anomalous excursions of 20 nanotesla (nT) are observed. In addition to the excursions during shadow events, the measurement difference between the inboard and outboard magnetometer varies over the day, indicating erroneous measurements by one or both magnetometers. Fig. 2 shows the variation in the difference between the inboard and outboard magnetometers over multiple days. For a nominal system the difference between the two magnetometers should be small (<2 nT) with small variances in the spacecraft field causing diurnal variation [1].

Figure 1. GOES-16 Observatory depicting Magnetometer Boom and Magnetometers

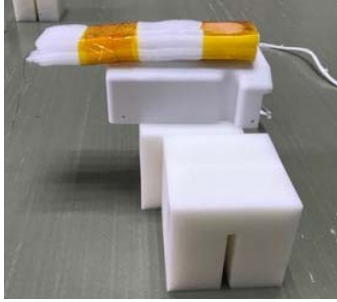
In order to bound the expected change in magnetic field due to temperature change, a piece of tape was sandwiched between foam and dunked into liquid nitrogen until it was colder than -130 $^{\circ}\text{C}$. It was then placed on a polyetherimide cover with a test magnetometer thermally isolated underneath as shown in Fig. 13. The magnetic field from the tape was measured as the foam/tape sandwich was allowed to warm in ambient air. Control cases were run without tape to demonstrate the magnetometer was not being thermally influenced.

The change in the field over the test temperature was approximately 0.05 nT/C. For the cited temperature range, a change in field of approximately 12 nT is possible.

Figure 13 Test Setup to Measure Magnetic Field with Changing Temperature of Tape Sample.
