Troubleshooting Challenges on the James Webb Space Telescope (JWST)

July 23, 2019

John McCloskey

NASA/GSFC Chief EMC Engineer

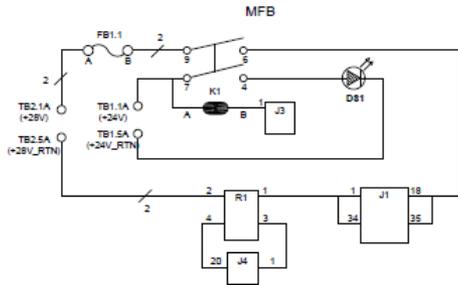
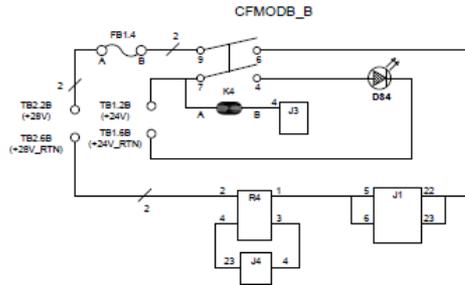
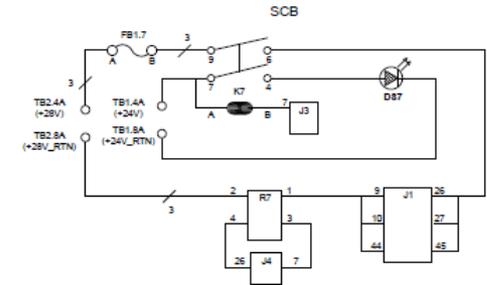
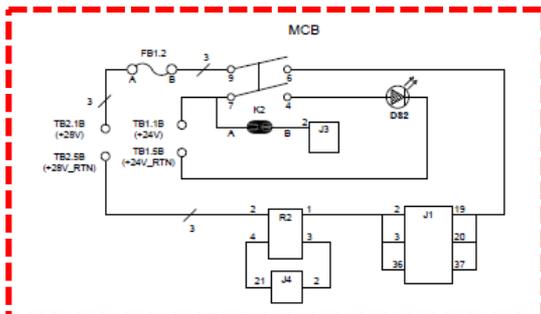
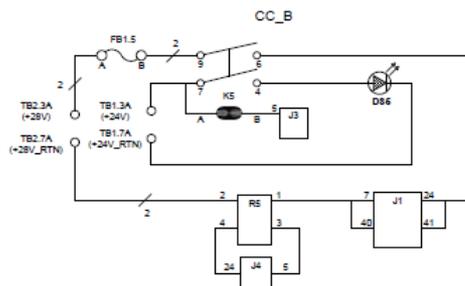
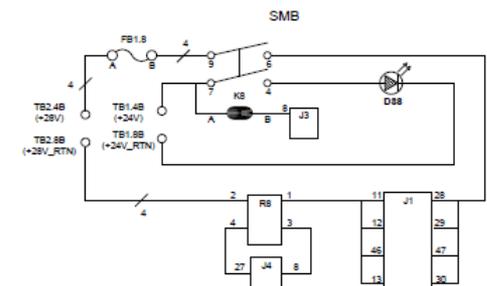
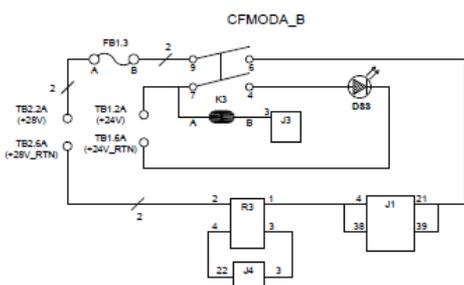
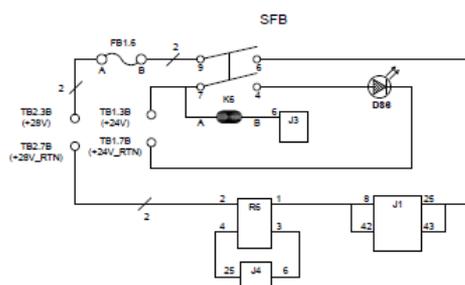
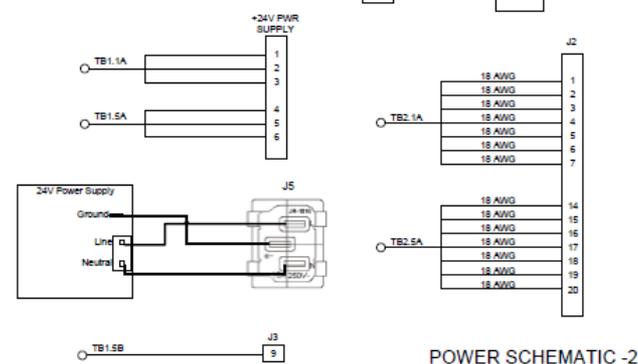
SI Redundant Power Drawer Block Diagram

MIRI ICE B feed
(identical to all others)

No transient suppression elements on relay contacts or coils

~3 meters of cable provides ample opportunity for transient energy to couple throughout SCSim rack

Limited transient suppression (~3 meters of cable from relays)

- **Mechanical relays**
 - Inherently noisy (contact bouncing, etc.)
 - No transient suppression elements (transorbs, etc.)
- **Long cables and large current loops**
 - Increased risk of coupling
- **Measurements show significant noise generated by relay switching transients, but...**
 - These relays were not operating when 1553 events occurred (relays close to turn on box and stay closed)
 - Transient energy couples EVERYWHERE; no credible explanation for why only one side of one box would be affected
 - Ringing in switching transients has resonant frequency of ~1 MHz
 - MIRI ICE B has robust input filter with lots of attenuation at 1 MHz
 - **RELAY SWITCHING TRANSIENTS UNLIKELY ROOT CAUSE**

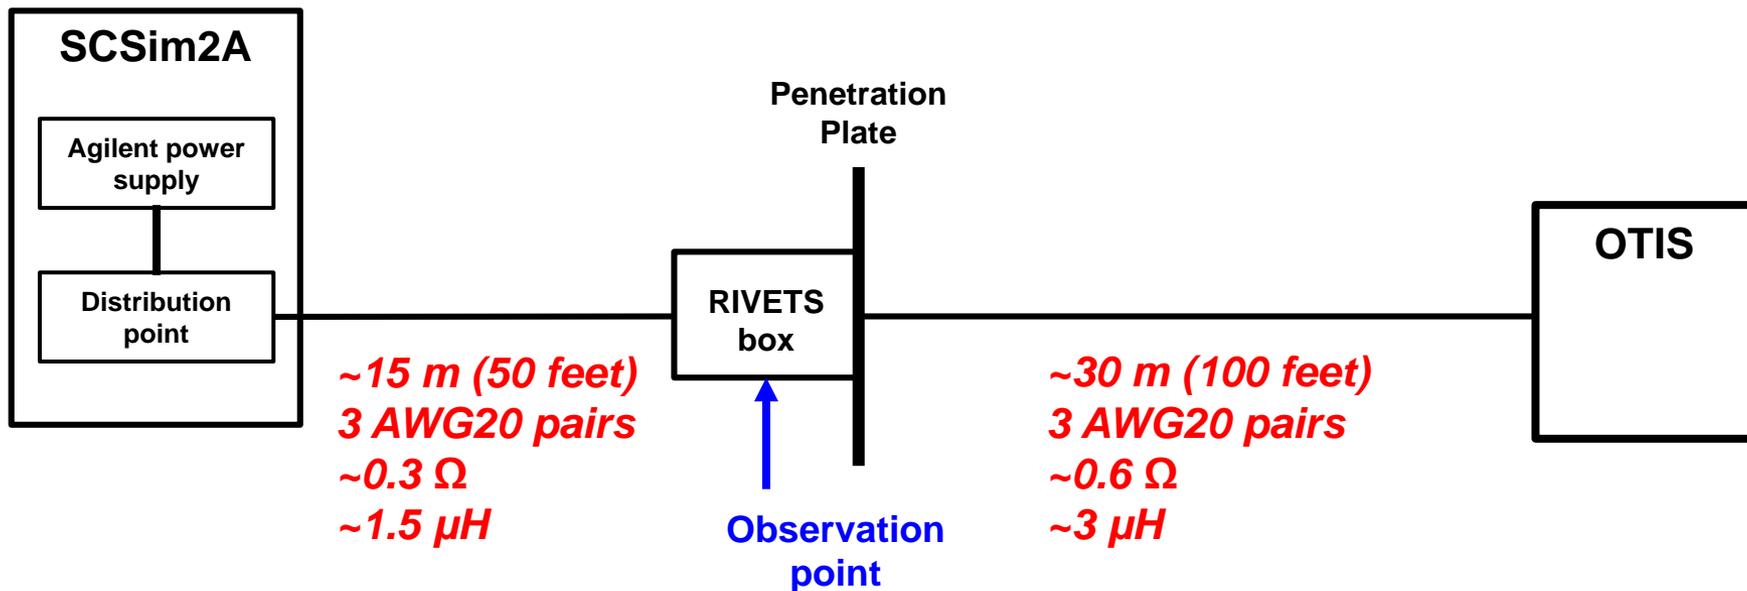
- Using “RIVETS” box (Remote Interface Verification Electrical Test System) at penetration plate, observed voltage and current on power feed to MIRI ICE-B

- **During 1553 transactions:**
 - $\Delta I \approx 120 \text{ mA}$, $\Delta V \approx 200 - 300 \text{ mV}$
- **Effective $Z \approx 1.7 - 2.5 \Omega$**

- **HARNESS RESISTANCE DOES NOT FULLY ACCOUNT FOR OBSERVED VOLTAGE DROPS**

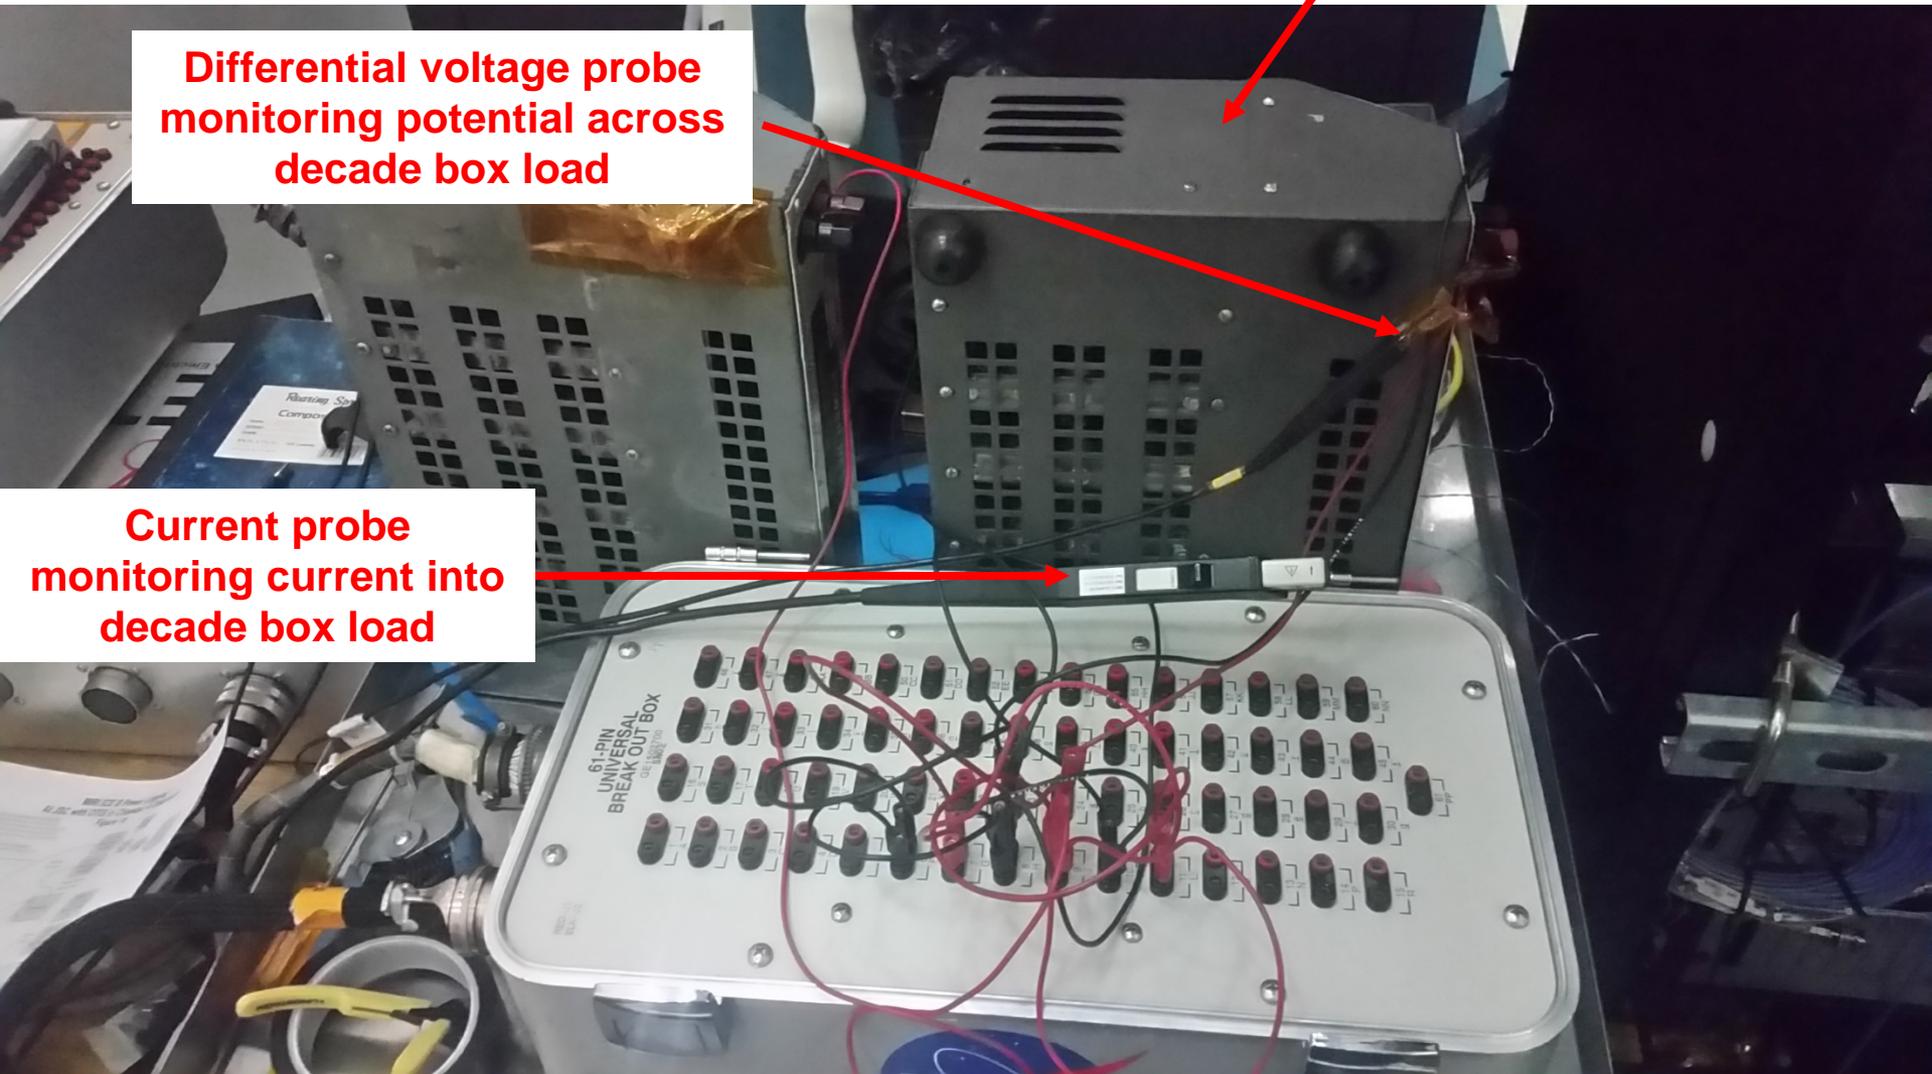
Setup

Decade box
Set to 30 Ω for 1 A load

Differential voltage probe
monitoring potential across
decade box load

Current probe
monitoring current into
decade box load

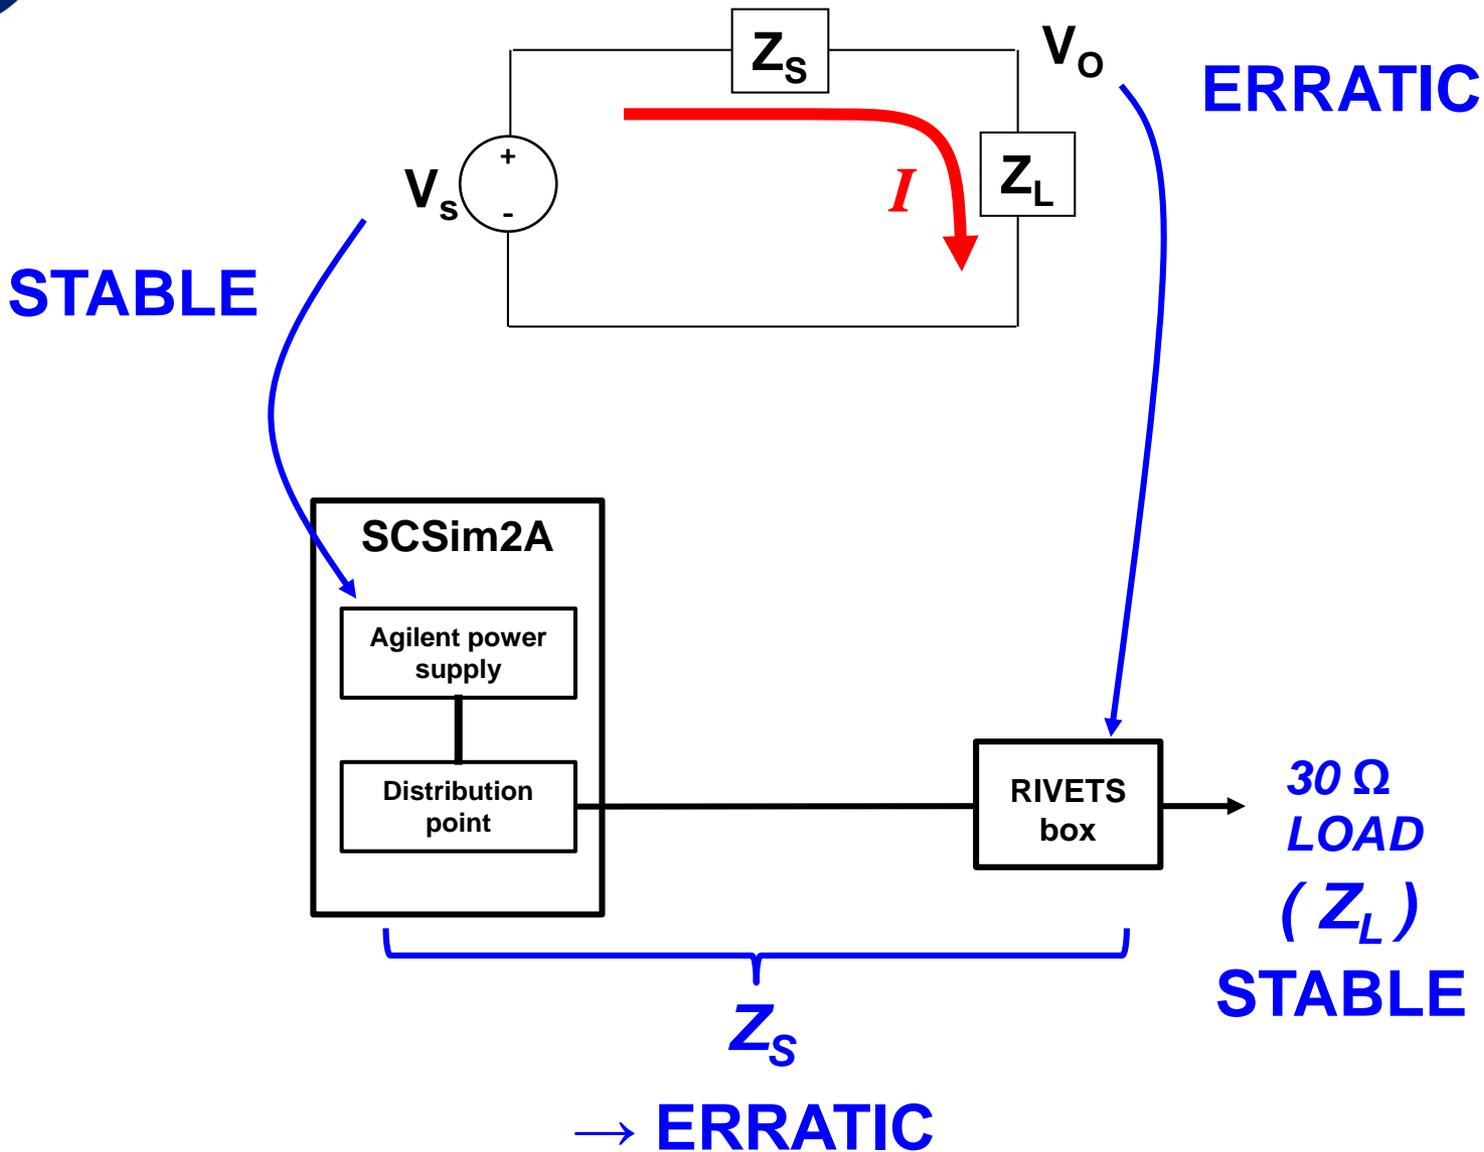
Power Feed Voltage Drop

Higher than expected ΔV

Not so clean, not so stable...

This noise will easily get through input filter

- Per GSFC Parts Branch (Code 562), erratic behavior is consistent with previously observed behavior of corroded relay contacts (SCSim has been in near continuous use for > 5 years)
- May contribute to instability in power interface
- May correlate to previously observed events

- **All relays and sockets replaced in SCSim2A**
 - All power feeds now “clean”; show no trace of erratic behavior
 - Relays provided to GSFC parts branch for evaluation; could not reproduce erratic behavior 🙄

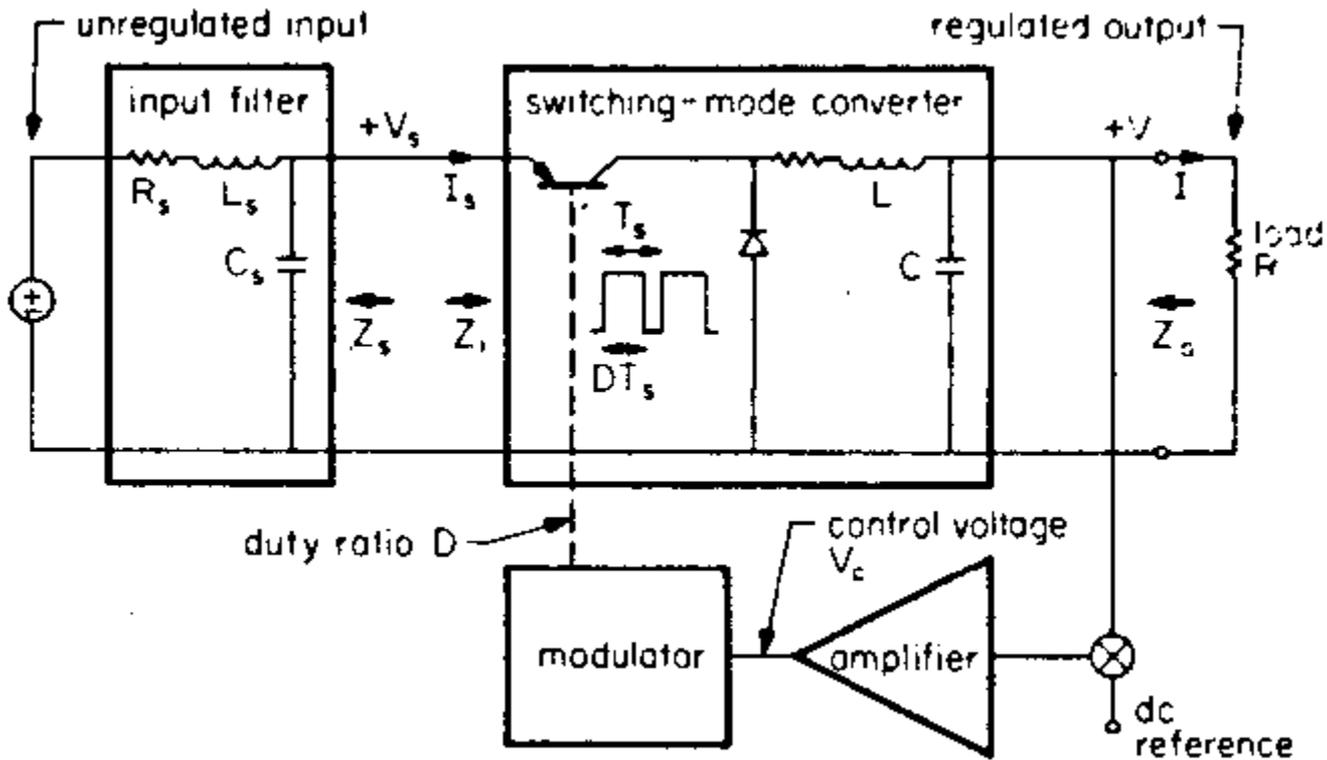
Load Stability - Power Converter Interface Model

- From R.D. Middlebrook, "Input Filter Considerations In Design and Application of Switching Regulators" (1976)

- **Though not proven, instability is leading theory for root cause**
 - Middlebrook magnitude criteria violated from ~500 Hz to ~50 kHz for increasing values of relay contact series resistance
