NASA Electronic Parts and Packaging (NEPP) Program

Cracking Failures in Ceramic Capacitors and the Existing Screening and Qualification Procedures

Alexander Teverovsky

This presentation gives a review of recent project failures caused by cracks in ceramic capacitors and discusses deficiencies of the existing screening and qualification procedures that can reveal the propensity to cracking and effects of soldering stresses.

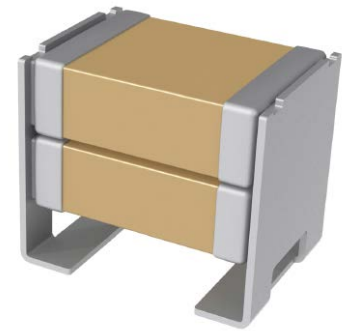
History Case 2

- ❑ A lot of commercial BME capacitors rated to 250V that had reduced microphonic noise was intended to use at low voltage (~ 5 V) applications.
- ❑ The lot had multiple failures during qualification life testing.
- ❑ Analysis of distributions of VBR revealed a substantial proportion ($\sim 15\%$) of defects.
- ❑ Failures at voltages close to the rated can be explained by the presence of shallow cracks near terminals.

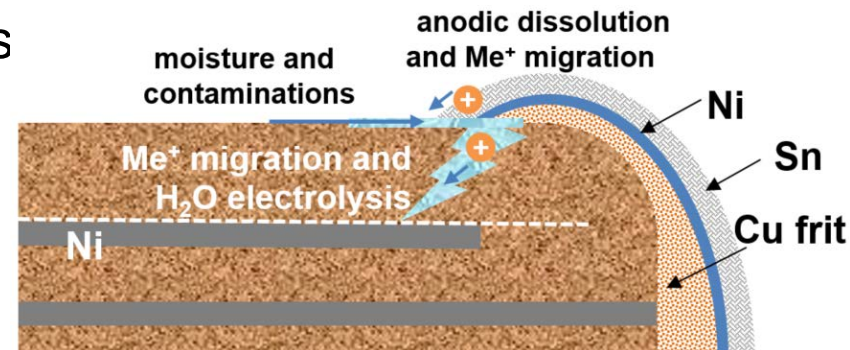
Post-THB delamination

✓ Derating might not help in cases of failures related to cracking.
