FAILURE of Nd:YVO₄ AMPLIFIER CRYSTALS

Jon Salem
NASA GRC
Cleveland, Ohio

Fractography of Advanced Ceramics VI
2019

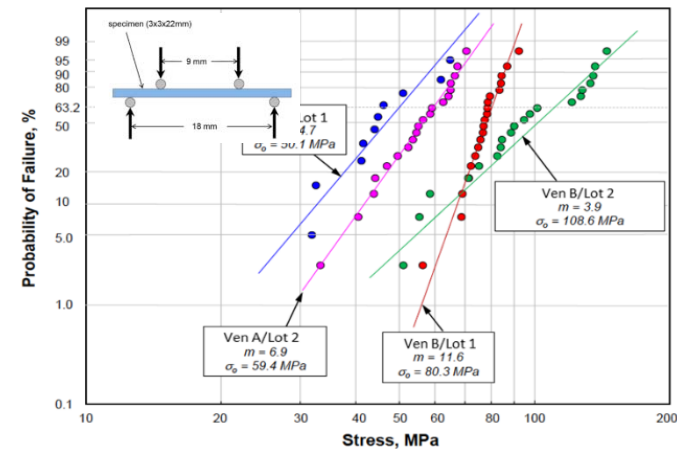
- The YVO₄ single crystals are laser “slabs”
- Elastic modulus = 220 GPa <a> axis
- Fracture toughness = 0.48 MPa√m
- Fracture strength = 46 MPa (~7 ksi)

➤ Very brittle!!

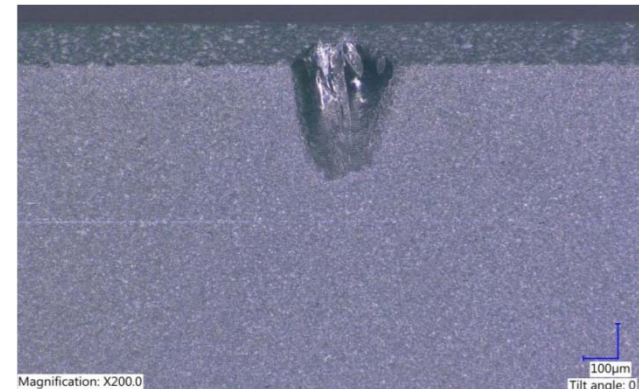
- Diamond ground, with surfaces that tend to be damaged (chips, scratches, etc.):

- One would expect surface failure.

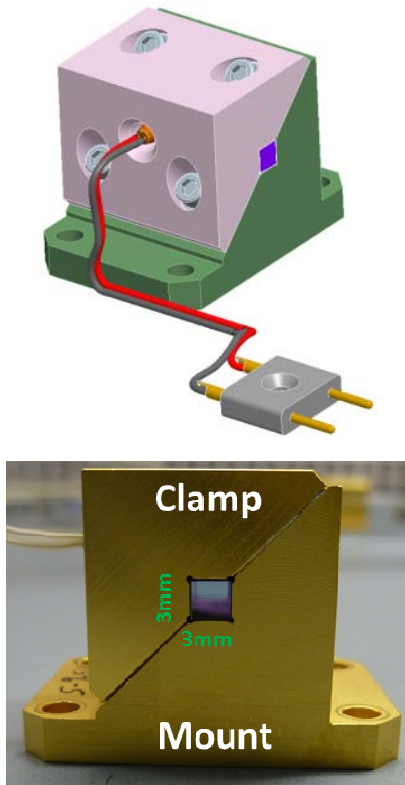
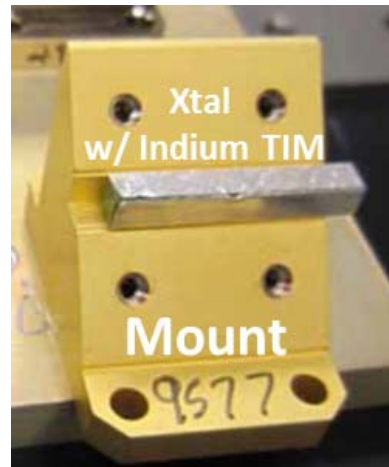
- The Nd:YVO₄ crystals are clamped between two gold plated heat spreaders with an indium foil thermal interface material.
- The indium foil thickness was custom selected to achieve uniform and simultaneous contact between all five planar surfaces.
- Four bolts are used to attach the clamp to the mount securing the crystal.

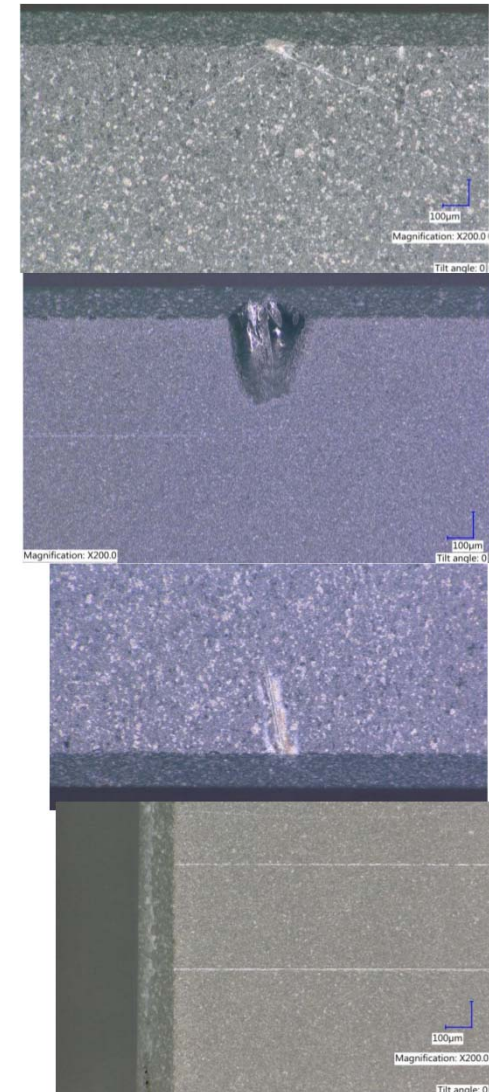
- Failure resulted from several sources:
 - Au-In reactions (worst element)
 - poor crystal finishing and handling
 - low toughness and slow crack growth
- Re-design & qualification was needed:
 - Lowed the stresses
 - Quantified the transient reliability:

- Weakest Link Behavior:

- Structure is analogous to a chain with many links of differing strength
- Catastrophic failure occurs when the weakest link is broken
- A longer chain is weaker
