FAILURE of Nd:YVO₄ AMPLIFIER CRYSTALS

Jon Salem
NASA GRC
Cleveland, Ohio

Fractography of Advanced Ceramics VI
September 9th, 2019
Smolenice, Slovakia

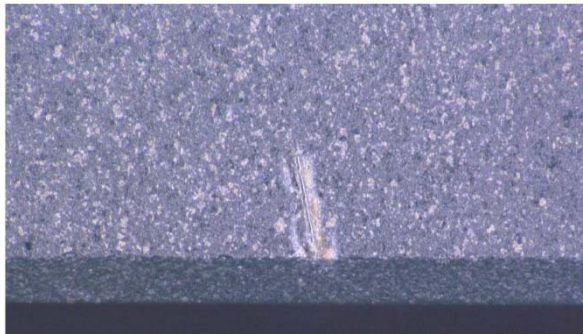
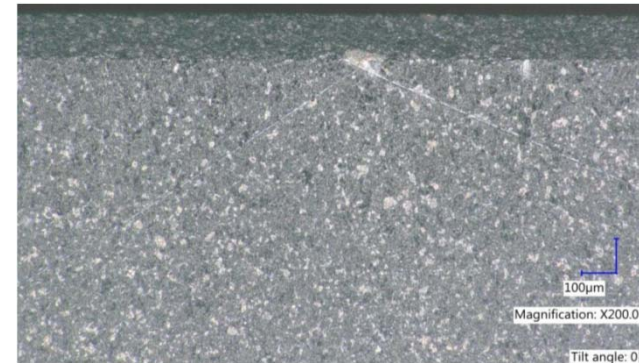
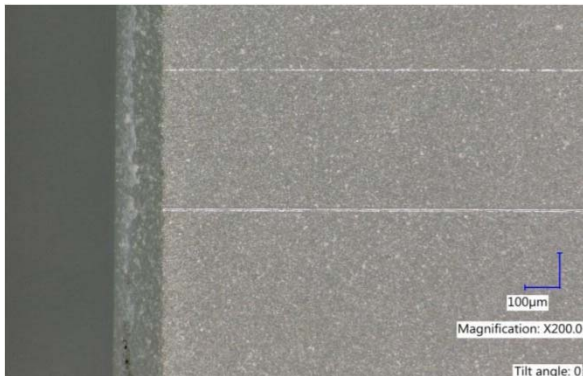
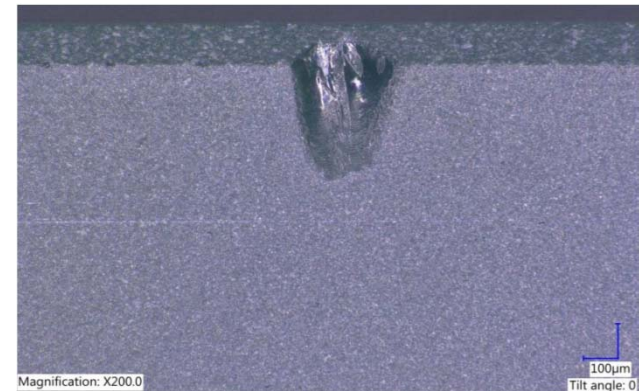
- Diamond ground, with surfaces that tend to be damaged (chips, scratches, etc.):

➤ One would expect surface failure.

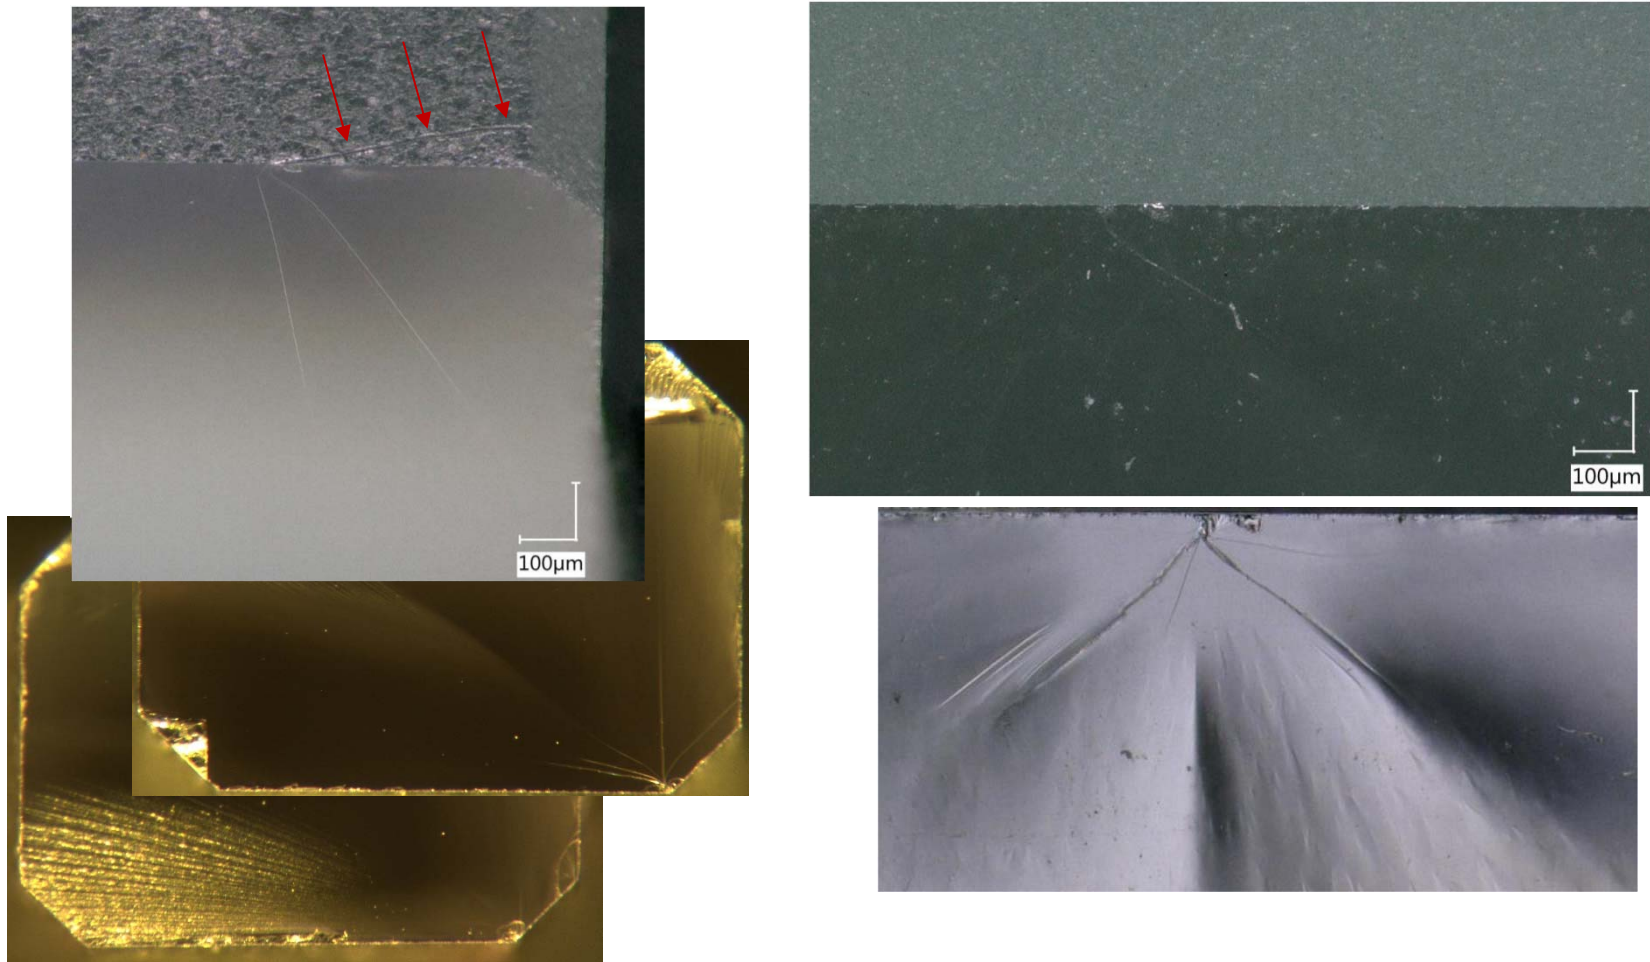
- Indeed, strength test specimens fail from surface flaws:

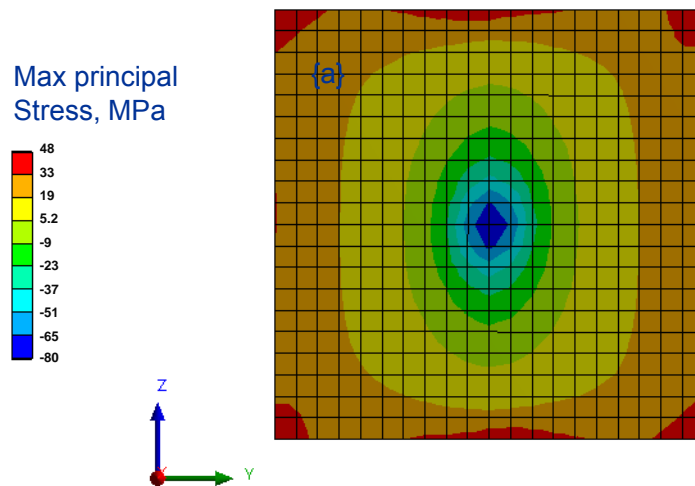
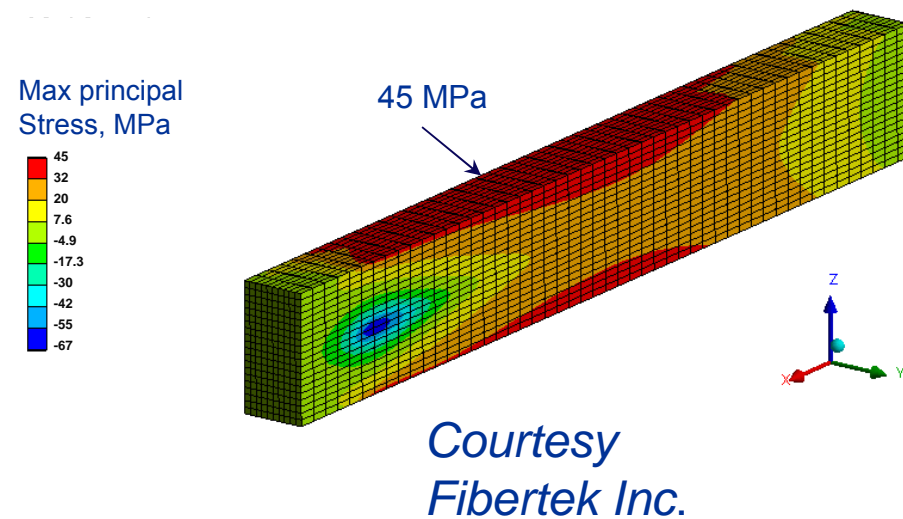
- X-axis, <a>, principal stresses:

- Center compression with edge tension, where the worst flaws are often located.
- Compressive strength is \gg tensile strength.

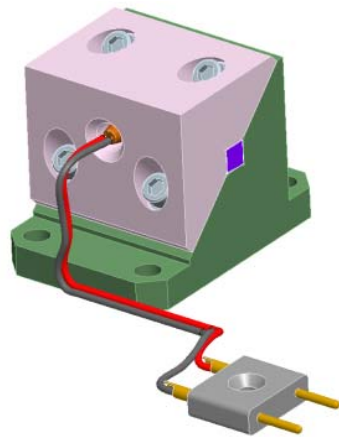
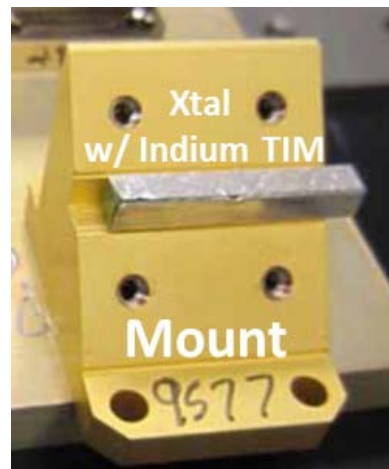
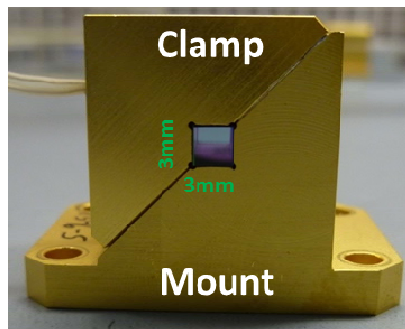
- The Nd:YVO₄ crystals are clamped between two gold plated heat spreaders with an indium foil thermal interface material.
- The indium foil thickness was custom selected to achieve uniform and simultaneous contact between all five planar surfaces.
- Four bolts are used to attach the clamp to the mount securing the crystal.

- The crystal fractured about 10 mm inboard of the input face and originated in the middle of the c-facet.
- There were no obvious surface defects or corresponding mount defects at the fracture origin.
- Applied stresses were low.
- Implies that the crystal was under higher mechanical loads (pressure).
- But why?

- Fractography indicated that gold and indium were forming gold-indide (AuIn_2) over time.
- The resulting AuIn_2 material is stiffer, harder and more brittle than indium; and more significantly, occupies 15% more volume.
- Intermetallic and indium are incompressible. The additional volume is displaced, resulting in higher preloads on the crystal, and eventual fracture.
- Failure was not due to overpumping...

- Failure resulted from several sources:
 - Au-In reactions (worst element)
 - poor crystal finishing and handling
 - low toughness and slow crack growth

- Re-design & qualification was needed:
 - Lowered the stresses
 - Quantified the transient reliability:
