NASA/TM-2020-220573  
NESC-RP-12-00823

# Recurring Causes of Human Spaceflight Mishaps during Flight Tests and Early Operations

An analysis of recurring causes underlying human spaceflight mishaps that occurred during flight tests and early operations was performed. Eight mishaps from the Apollo, Soyuz, Skylab, Space Shuttle, and Constellation Programs (i.e., the Ares-1X test flight) and commercial suborbital systems were included in the study. Detailed event analyses were performed for the historical mishaps and aggregate data analyses conducted to identify recurring issues. The nine most frequent issues were inadequate technical controls or risk management practices, incomplete procedures, system design and development issues, inadequate inspection or secondary verification requirements, failures of organizations to learn from previous incidents, inadequate schedule controls, inadequate task analyses or design processes, flaws in the design of organizations, and issues with organizational safety cultures.

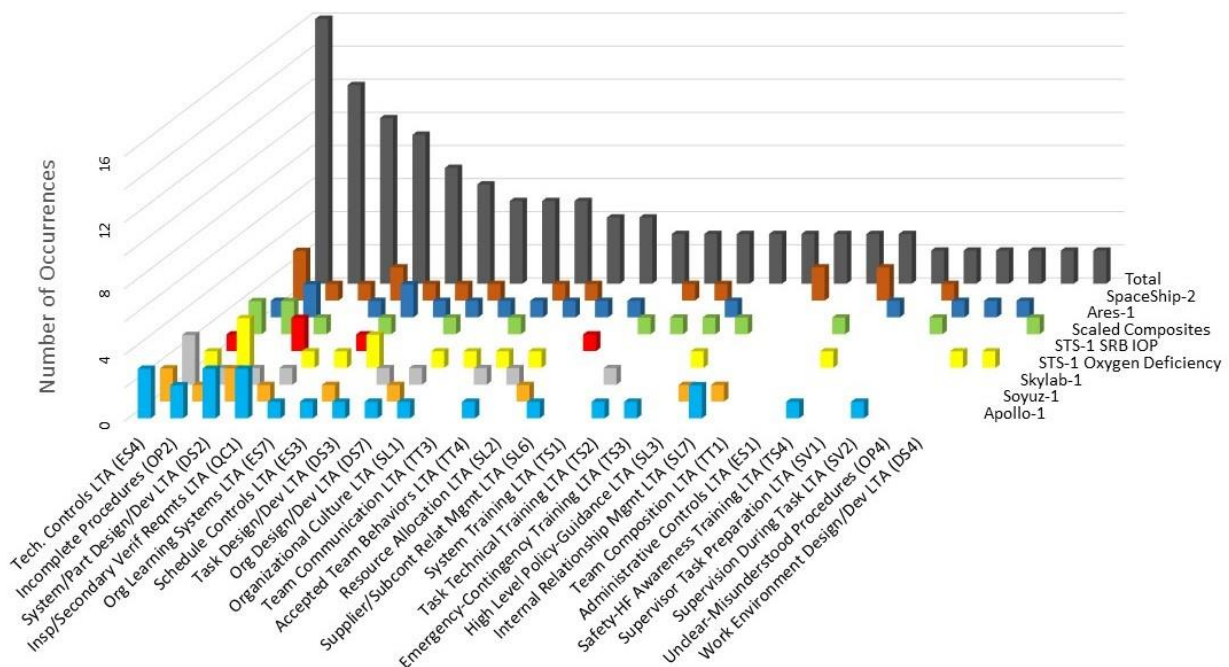
**Figure 8.1-2. Pareto Analysis of Recurring Cause Types**

Figure 8.1-2 shows the recurring organizational system and dual role causes identified in the study, as discussed in Section 8.1. The recurring causes ranged from a maximum of 16 occurrences in all eight of the mishaps (“technical controls and technical risk management practices less than adequate (LTA)”) to a minimum of two occurrences in two of the mishaps for six cause types (“administrative controls LTA,” “safety-human factors awareness training LTA,” “supervisor task preparation LTA,” “supervision during task LTA,” “unclear/misunderstood procedures,” and “work environment design/development LTA”).

**F-2.** Twenty-five cause types occurred at least twice (or recurred at least once). The top nine most frequent recurring cause types occurred at least five times total in five different mishaps. Seventy-five of the 117 (65%) organizational and dual role recurring causes are included in the nine most frequently recurring cause types.

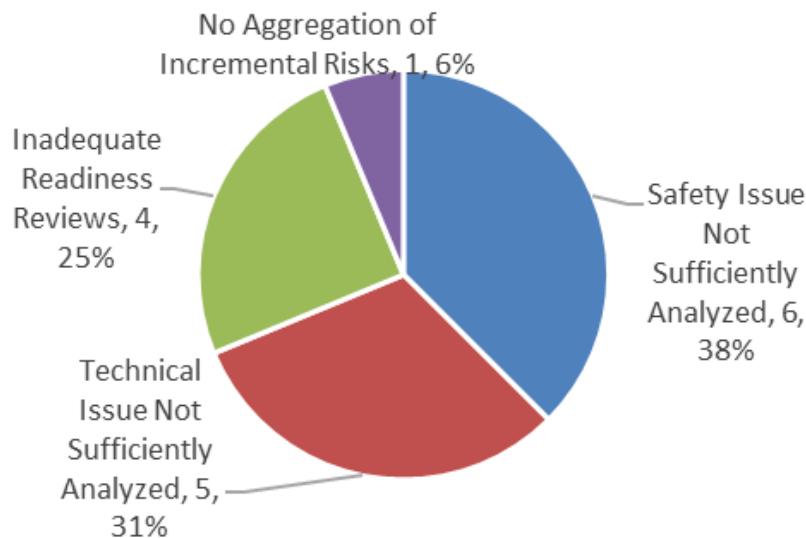
**Figure 8.2-1. Breakdown of “Inadequate Technical Controls or Technical Risk Management Practices”**

**F-3.** Sixteen occurrences of “inadequate technical controls or technical risk management practices” contributed to all eight (100%) of the incidents studied. Six of the 16 occurrences (37.5%) were inadequate safety reviews/analyses (e.g., inadequate hazard analyses or system safety analyses). Five of the 16 (31.3%) were due to technical issues not being sufficiently analyzed (e.g., inadequate failure modes and effects analyses (FMEAs), process-FMEAs, and quantitative risk assessments). Four of the 16 occurrences (25.0%) were inadequate readiness reviews. The remaining single occurrence (6.2%) was a case where an aggregation of incremental technical risks was not performed (see Figure 8.2-1).

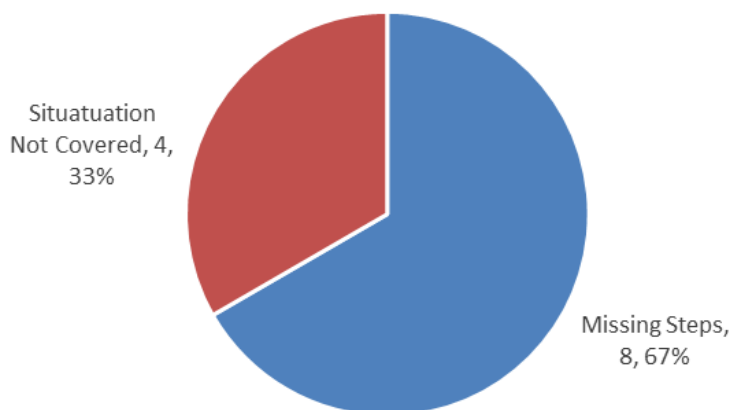
***Figure 8.2-2. Breakdown of “Incomplete Procedure Issues”***

**F-4.** Twelve occurrences of “incomplete procedures” affected seven of the eight incidents studied (87.5%). When issues with incomplete procedures were identified as a cause of an incident in this study, eight (67%) of those occurrences were attributed, more specifically, to missing steps in the procedure to satisfy hazardous constraints, describe the test setup, and communicate cautions and warnings. The remaining four (33%) occurrences were attributable to the situation not being covered by a written procedure (e.g., emergency or contingency situation) (see Figure 8.2-2).

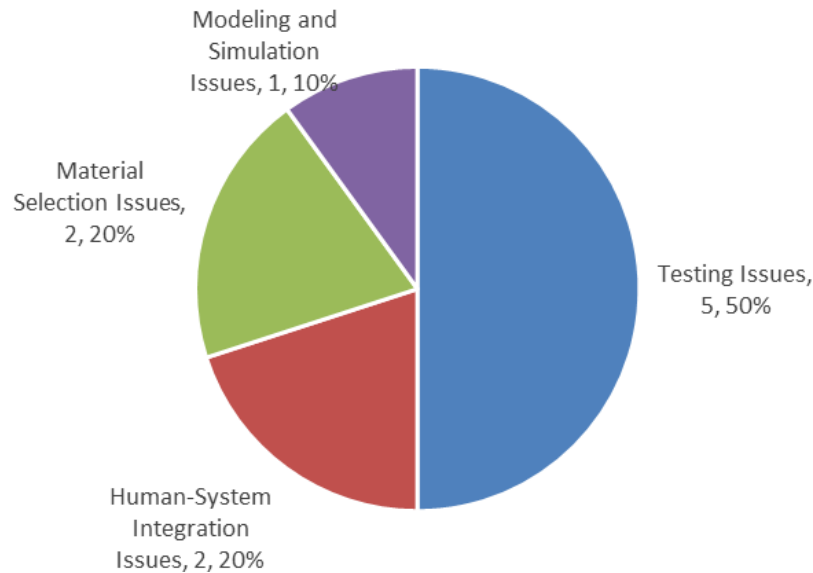
**Figure 8.2-3. Breakdown of “System Design and Development Issues”**

**F-5.** Ten occurrences of the “system design and development issues” cause category were found to contribute to six of the eight (75%) incidents studied. Five of the ten (50%) system design/development issues were related testing issues (e.g., inadequate testing and verification of system interfaces). This finding included several violations of the “test like you fly and fly like you test” approach. Inadequate system design and development included two of ten (20%) human-system integration issues, and two of ten (20%) material selection issues. The final issue occurred once (one of ten, 10%), and was a modeling and simulation issue related to using subscale testing data to anchor the launch vehicle environments model (see Figure 8.2-3).

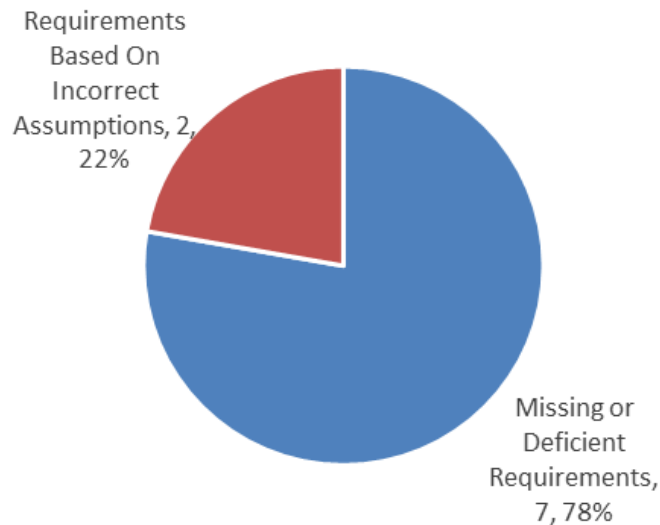
***Figure 8.2-4. Breakdown of “Inadequate Inspection or Secondary Verification Requirements”***

**F-6.** Nine occurrences of “inadequate inspection or secondary verification requirements” affected six of the eight (75%) incidents studied. Seven of nine (77.8%) of those occurrences were attributed to absent or inadequate inspection requirements for known issues related to material safety and contamination (see Figure 8.2-4). The remaining two of nine (22.2%) occurrences were attributable to basing inspection requirements on incorrect assumptions.

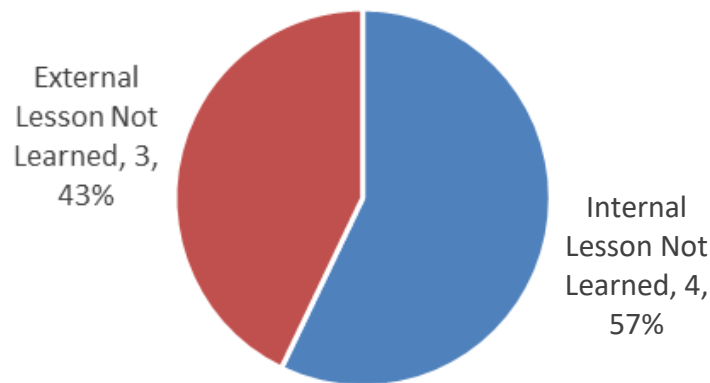
**Figure 8.2-5. Breakdown of “Inadequate Organizational Learning Systems”**

**F-7.** Seven occurrences of “inadequate organizational learning systems” affected six of the eight (75%) incidents studied. The lessons were present within human spaceflight programs or in related industries but were not shared, found, and/or heeded. Four of seven (57.1%) occurrences were internal lessons not learned, where “internal” refers to current or previous human spaceflight programs. This failure was sometimes due to restricted or classified information. Three of seven (42.9%) of the occurrences were external lessons not learned, where “external” refers to lessons outside the human spaceflight programs and related aerospace industry (see Figure 8.2-5).

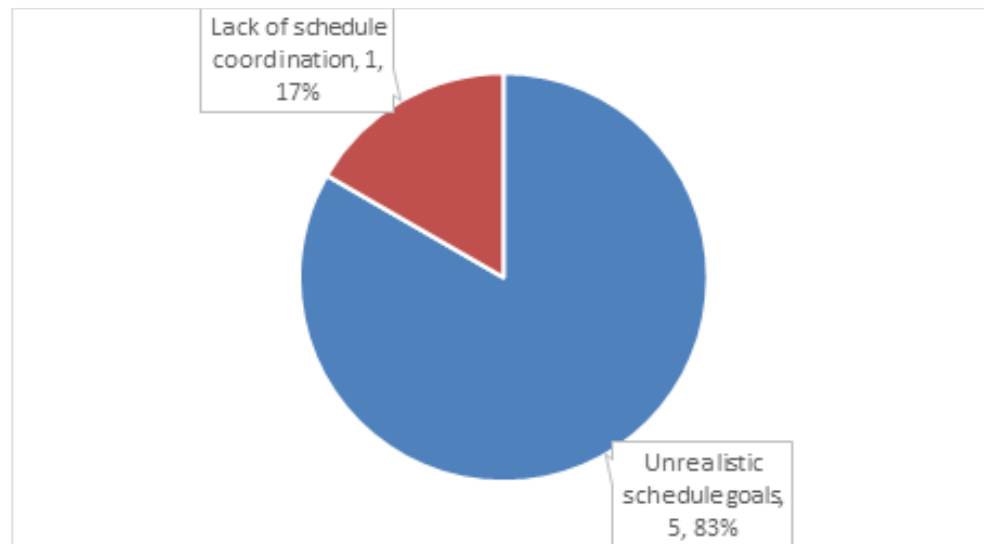
**Figure 8.2-6. Breakdown of “Inadequate Schedule Controls”**

**F-8.** Six occurrences of “inadequate schedule controls” affected five of the eight (62.5%) incidents studied. Five of the six (83.3%) occurrences were related to overly optimistic/aggressive schedules, and the remaining (one of six, 16.7%) occurrence was related to a lack of communication/coordination between the overall master schedule and local shop area schedules (see Figure 8.2-6).

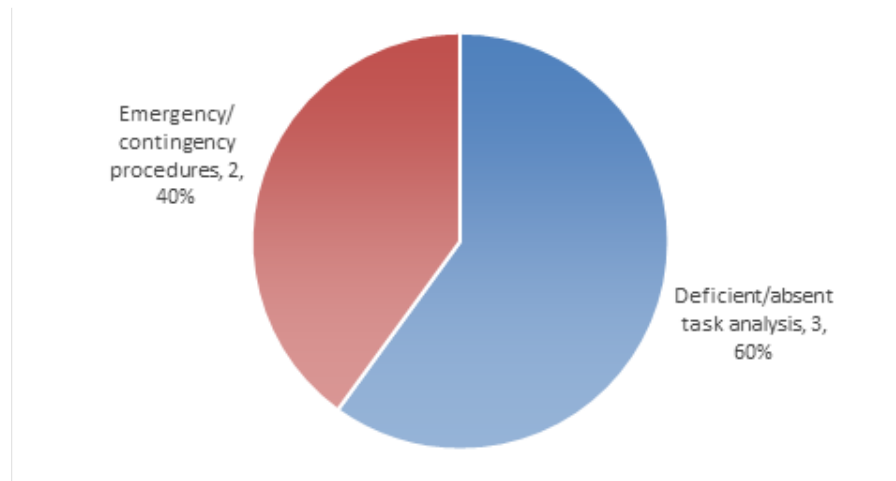
**Figure 8.2-7. Breakdown of “Inadequate Task Analysis and Design Processes”**

**F-9.** Five occurrences of “inadequate task analysis and design processes” affected five of the eight (62.5%) incidents studied. Three of the five (60%) occurrences were related to missing or deficient task analyses, and the remaining two of five (40%) occurrences were related to inadequate task designs for emergency, contingency, or nonstandard operations (see Figure 8.2-7).

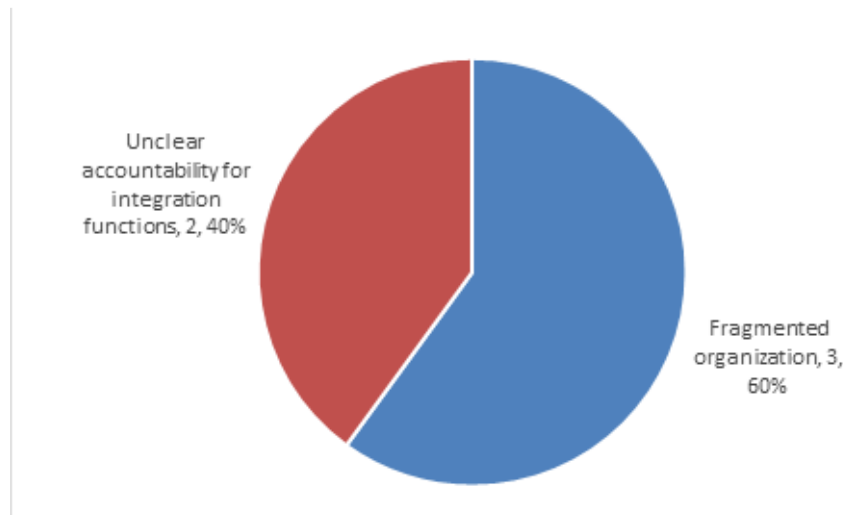
**Figure 8.2-8. Breakdown of “Organizational Design Issues”**

**F-10.** Five occurrences of “organizational design issues” affected five of the eight incidents studied (62.5%). Three of the five (60%) occurrences were related to fragmented organizations, sometimes due to competing projects and priorities. The remaining two of five (40%) occurrences were related to unclear accountability of technical integration functions during design and operations (see Figure 8.2-8).

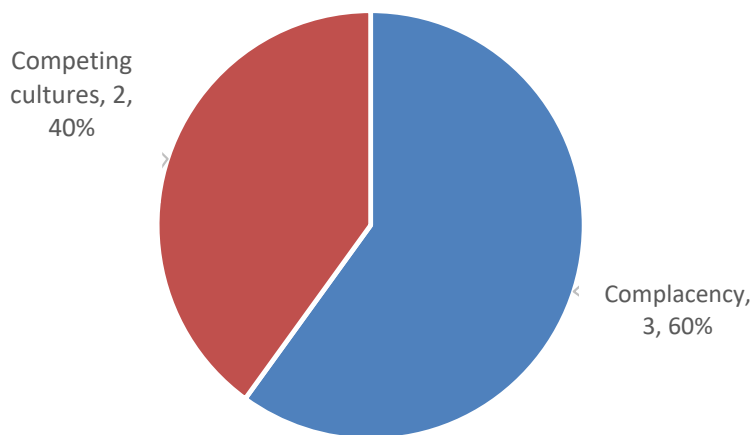
**Figure 8.2-9. Breakdown of “Organizational Safety Culture Issues”**

**F-11.** Five occurrences of “organizational safety culture issues” affected five of the eight (62.5%) incidents studied. Three of the five (60%) occurrences were related to organizational complacency regarding known, documented safety issues. The remaining occurrences (two of five, 40%) involved competing cultures regarding centralized versus distributed command and control during ground tests and a research culture (see Figure 8.2-9).

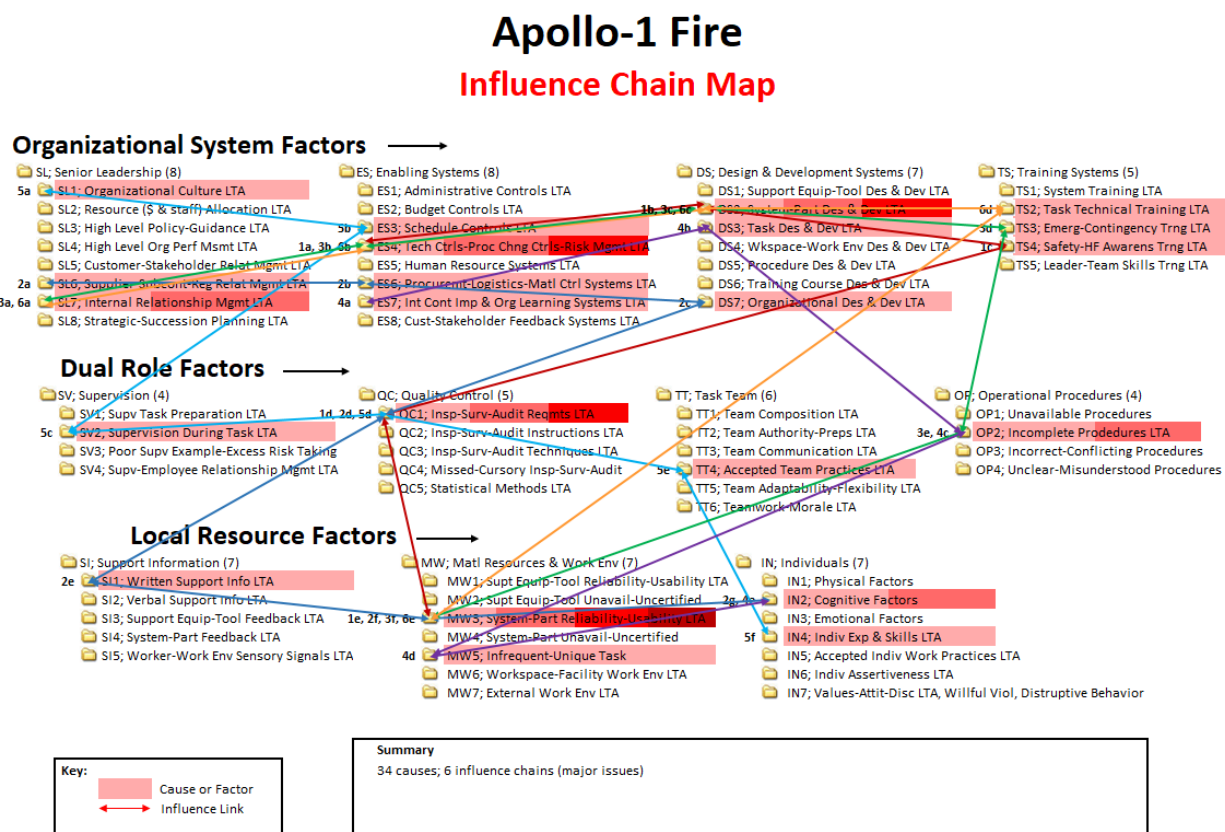
**Figure B-1. Apollo 1 Mishap Influence Chain Map**

<b>Chain 6: Poor plumbing design on the ECS, design of the soldered joints in plumbing led to leakage of water/glycol.</b>	
6a	Internal Relationship Management. Astronauts were openly concerned with the large volume of open work and the overall reliability of the vehicle. The three astronauts posed for a crew picture with their heads bowed and their hands clasped as if in prayer because of their concerns with the vehicle's quality and integrity. <i>See p. 31, Finding 10, NASA Apollo 204 Review Board</i>	SL7
6b	Risk Management. Deputy Administrator Seamans wrote that NASA's single worst mistake in engineering judgment was not to run a fire test on the command module prior to the plug-out test. NASA almost scrubbed the block 1 spacecraft—all of them were scrubbed except spacecraft 012/Apollo 1.	ES4

#	Description of Cause	Type
6c	System Design and Development. Grissom was so frustrated by the many technical failures of the spacecraft during testing that he hung a lemon on the simulator.	DS2
6d	System Training. There were continual leakage problems with the ECS due to design issues. After the fire, workers were required to be trained and certified for soldering plumbing repair operations.	TS2
6e	System Reliability. Numerous hardware problems diminished the reliability of the command module's systems.	MW3
	<b>Summary: 34 causes, 6 chains</b>

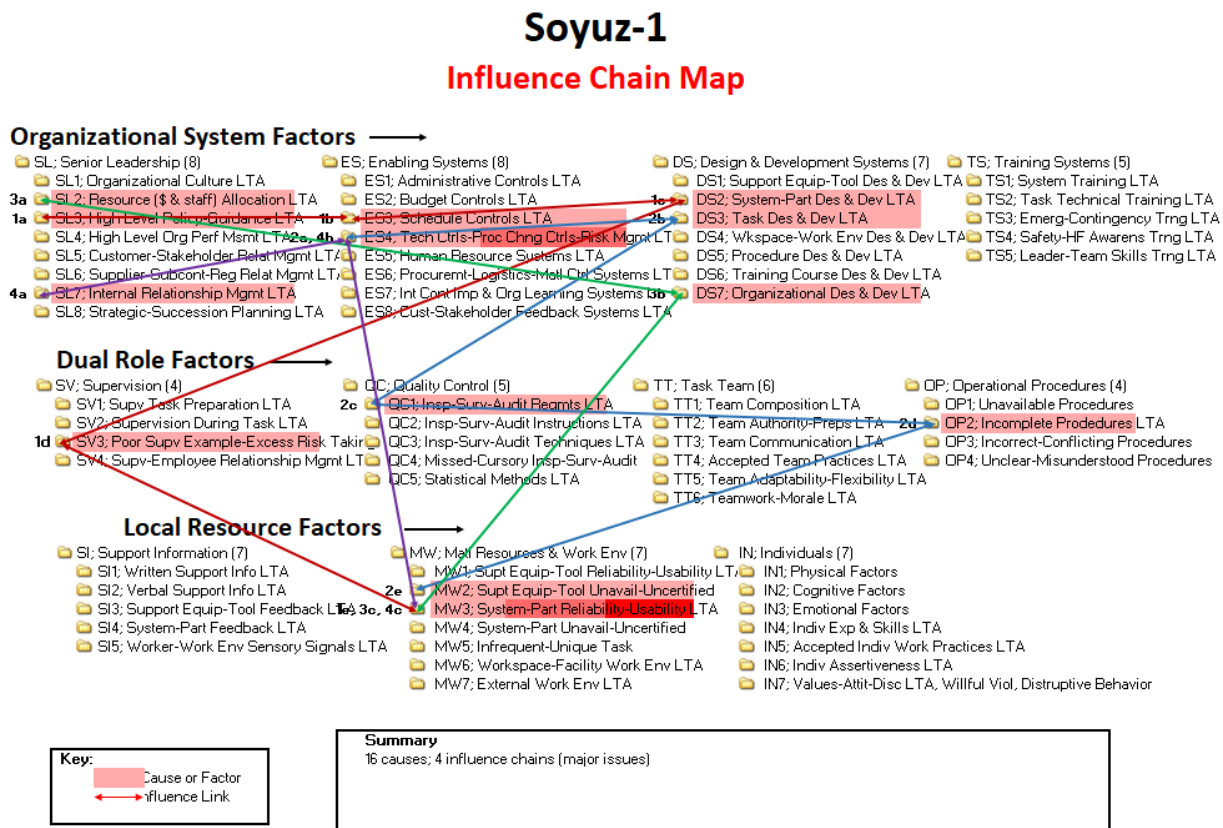
**Figure C-1. Soyuz 1 Mishap Incident Influence Chain Map**

3b	<p>Organizational Design. The Soviets had multiple concurrent space projects, so their budget and resources were spread thin across these various programs. There was less emphasis on the manned programs.</p> <p><i>Excerpt from Kamanin Diary: 1965 September 8 - "Kamanin reviews a speech by President Johnson to the US Congress. From 1954-1965 the USA spent \$34 billion on space, \$26.4 billion of that in just the last four years. The Soviet Union has spent a fraction of that, but the main reason for being behind the U.S. is poor management and organization structure, in Kamanin's view."</i></p> <p><i>Excerpt from the Kamanin Diary: 1965 October 22 - Gagarin writes a letter to Brezhnev complaining of the poor organization of the Soviet space program. The letter specifically cites the multitude of space projects (5) and the de-emphasis of manned efforts.</i></p>	DS7
3c	<p>System Reliability. Parachute system was unreliable; two of seven drop tests failed.</p> <p><i>Excerpt from the book "Challenge to Apollo" by Asif A. Siddiqi, page 569: "The engineers began the ground testing of the first flight model of the Soyuz spacecraft on May 12, 1966. There were many problems. Instead of the anticipated thirty days, it took four months to debug the ship. There were as many as 2,123 defects in the vehicle, significantly affecting the pace of the project. The official history of the design bureau states that the testing of the Soyuz spacecraft: Among the factors that the engineers had to face were problems with the parachute system. Serious defects were identified when two out of seven drop tests from the An-12 aircraft at Feodosiya failed. After one test on August 9, when the reserve parachute failed to open, Kamanin prophetically wrote in his diaries: One has to admit that the 7K-OK parachute system is worse than the parachute system of the Vostoks."</i></p>	MW3

#	Description of Cause	Type
	<b>Chain 4: Cosmonauts' Frustration with Vehicle Defects and being Ignored by the Hierarchy of the Ministry of Defense</b>	
4a	Internal Relationship Management. Cosmonauts' concerns were ignored by the Soviet's military hierarchy. Manned missions did not receive the same attention as the unmanned satellite programs.	SL7
4b	Risk Management/Technical Controls. There was no risk roll-up process to highlight the many defects and system test failures and make a solid case against the decision to launch. From the point of view of the military quality assurance inspectors, there are 100 unresolved discrepancies on Soyuz 1.	ES4
4c	System Reliability. The Soyuz 1 was an unreliable vehicle and was not ready to fly a manned mission.	MW3
	<b>Summary: 16 causes, 4 chains</b>

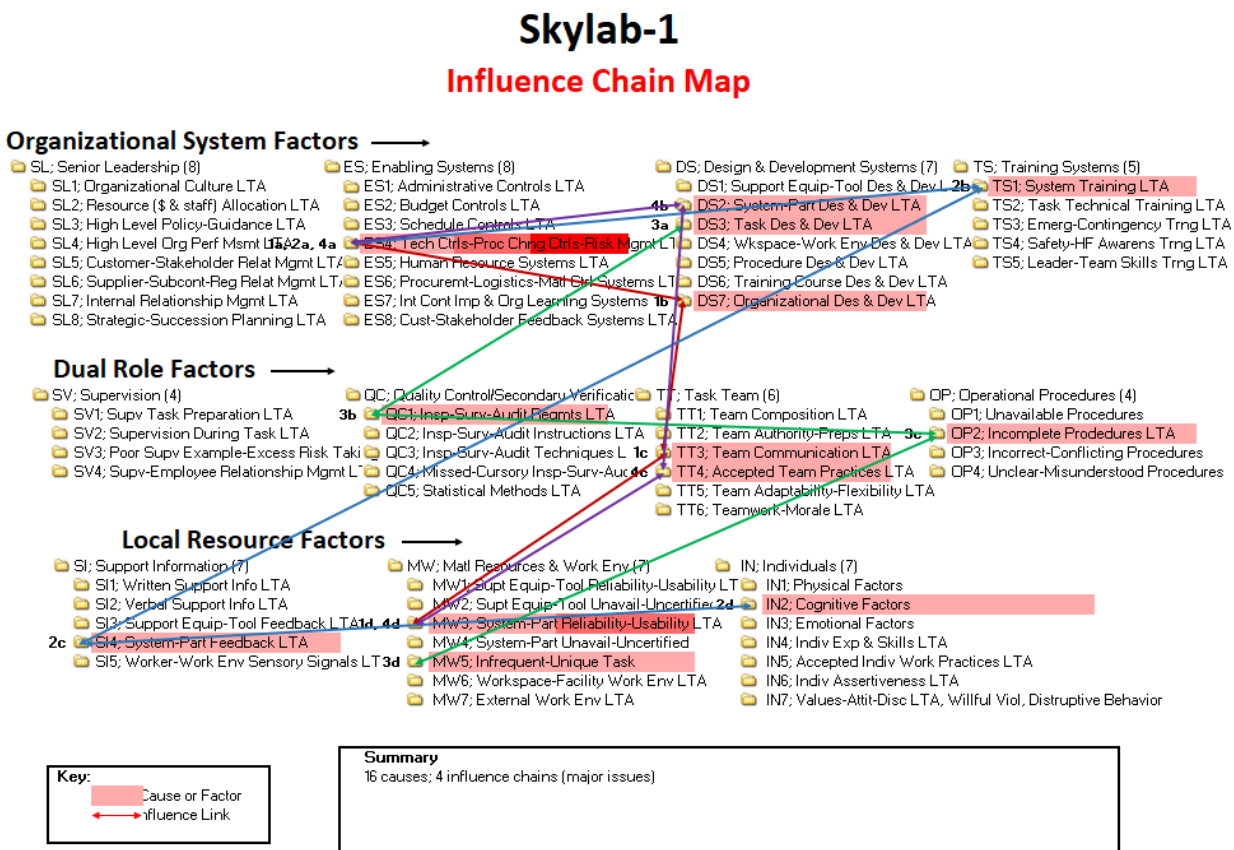
Figure D-1. Skylab 1 Mishap Incident Influence Chain Map

4d	System-Part Reliability/Usability LTA. The MS, as designed, built, and assembled was not a reliable system.	MW3
	<b>Summary: 16 causes, 4 chains</b>

The most probable cause of the failure of the meteoroid shield was internal pressurization of its auxiliary tunnel. This internal pressurization acted to force the forward end of the tunnel and meteoroid shield away from the OWS and into the supersonic air stream. The resulting forces tore the meteoroid shield from the OWS...The pressurization of the auxiliary tunnel resulted from the admission of high-pressure air into the tunnel through several openings in the aft end. These openings were: (1) an imperfect fit of the tunnel with the aft fairing; (2) an open boot seal between the tunnel and the tank surface; and (3) open stringers on the aft skirt under the tunnel. ((10 – 1), page 141)

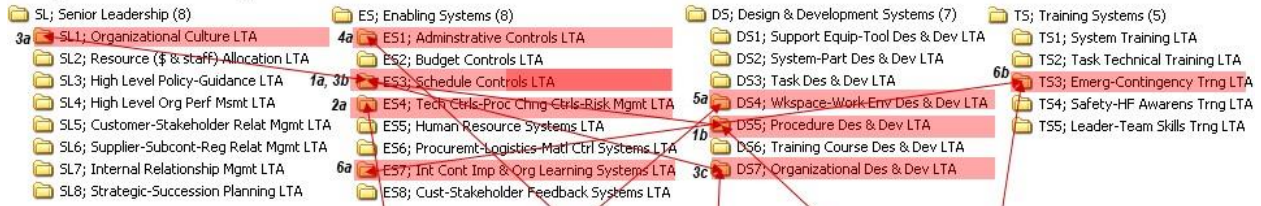
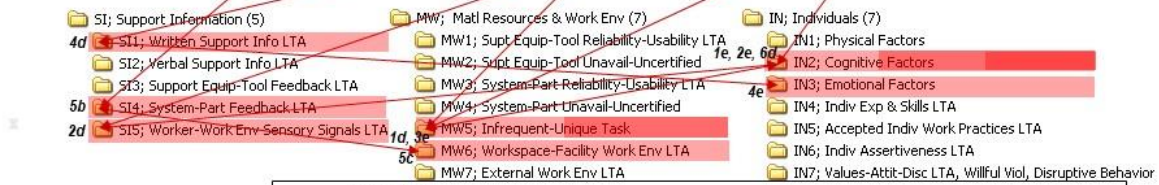
Figure E-1. STS-1 Oxygen Deficiency Mishap Influence Chain Map

1. Last-minute dev not ID'd as hazardous
2. Inadequate safety controls/procedures
3. Underlying organizational issues
4. Communications breakdown
5. Limited portable air bottles, no O2 deficiency monitoring
6. Previous warning signs not heeded, and lessons not learned

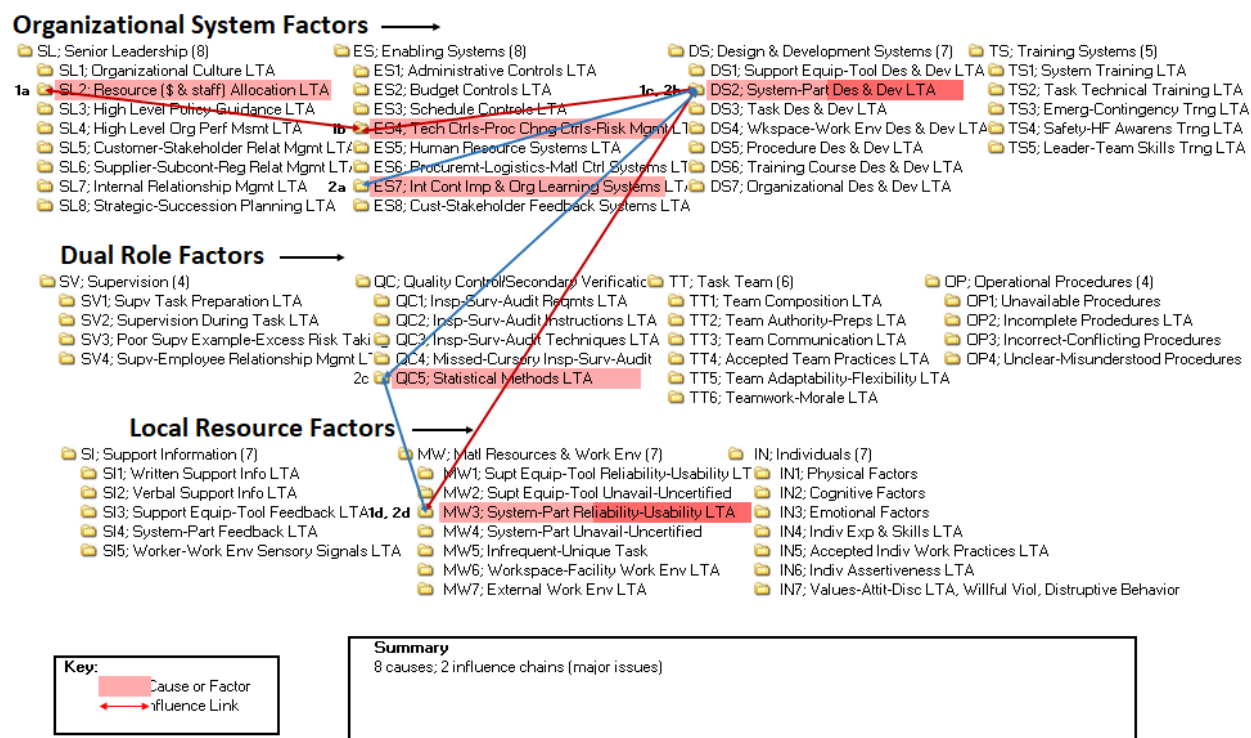
Figure F-1. STS-1 SRB IOP Close Call Influence Chain Map

A significantly low estimate of the SRB ignition IOP resulted in nearly catastrophic damage to the orbiter during STS-1 on March 19, 1981. The prelaunch modeling was conducted using Tomahawk missile motors, but the SRBs have much higher ignition pressures. The pressure wave buckled a strut that supported an RCS oxidizer tank and overextended the body flap used during reentry. Had the oxidizer tank ruptured, the vehicle would have been destroyed and the crew would have been killed. The various influence chains for this incident are detailed in Table F-1 and are displayed graphically in Figure F-1.

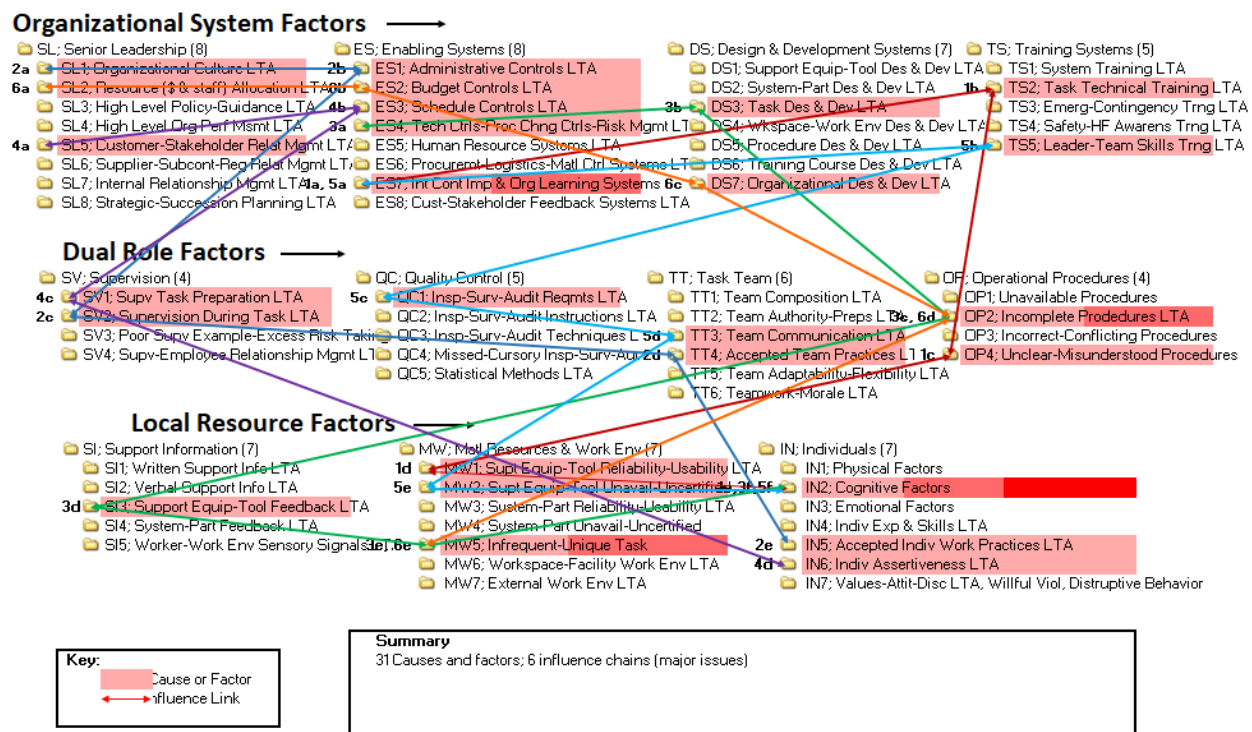
**Figure H-1. Ares 1-X Mishap Influence Chain Map**

#	Description of Cause	Type
6e	Unique Task. This was the first Ares 1-X parachute static strip test.	MW5
<b>Summary: 31 causes, 6 chains</b>

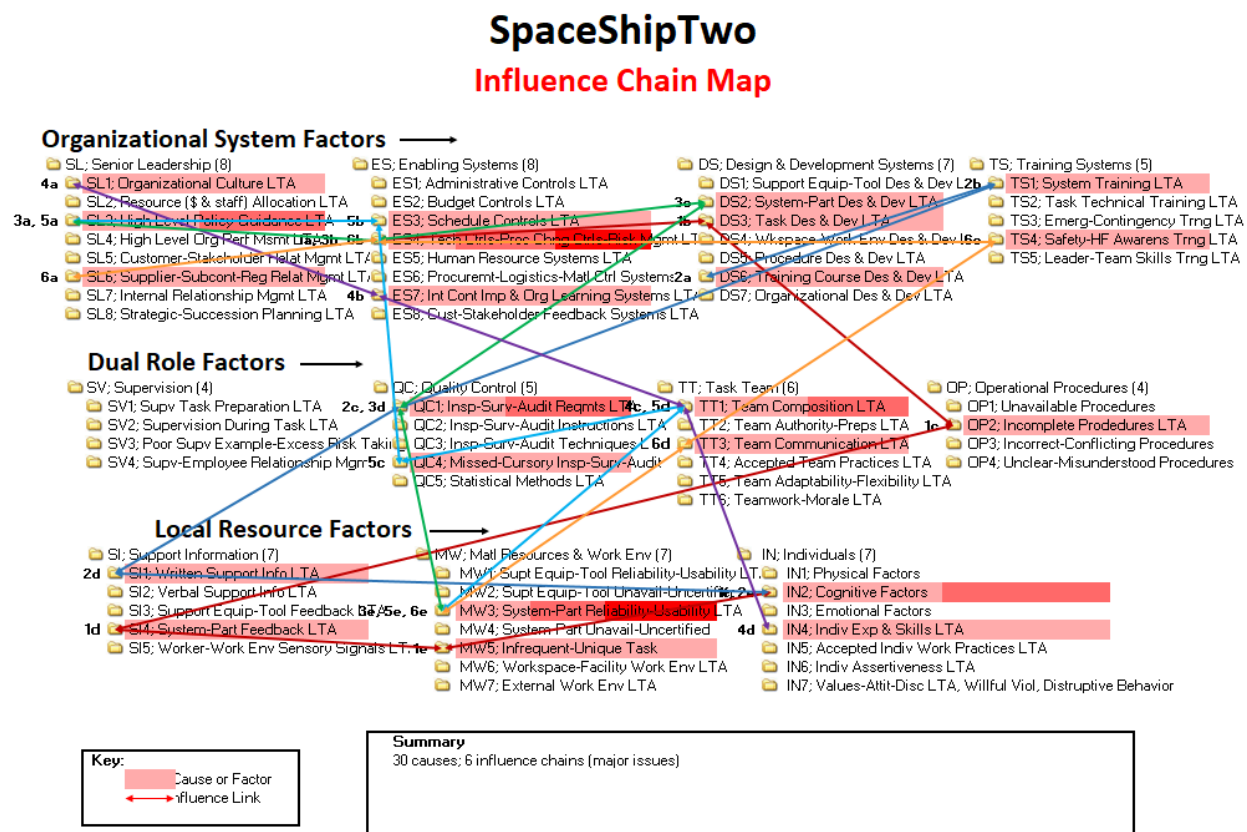
**Figure I-1. SpaceShipTwo Mishap Influence Chain Map**

#	Description of Cause	Type
6d	Team Communication LTA The lack of direct communication between FAA Office of Commercial Space Transportation technical staff and Scaled Composites technical staff interfered with the FAA's ability to thoroughly evaluate the SpaceShipTwo experimental permit application. [ref. 16, Finding #11]	TT3
6e	System Reliability or Usability LTA Due to inadequate design considerations of the pilot-system interface, the feather system design was not reliable.	MW3
	<b>Summary: 30 causes, 6 chains</b>

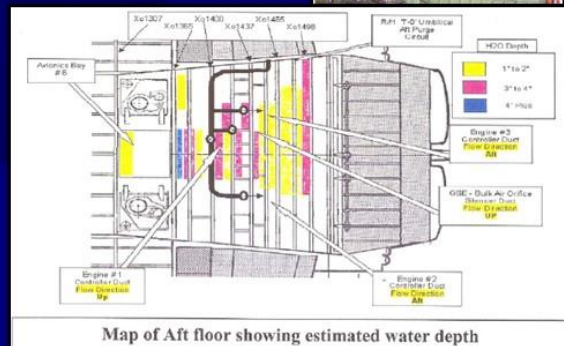
Shuttle Mini Portable Purge Unit (MPPU)

Map of Aft floor showing estimated water depth

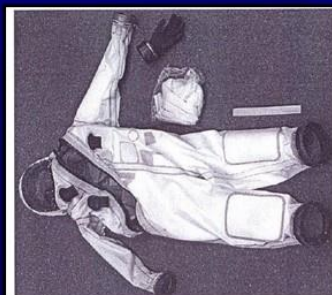
Figure 1  
As-received PHE, left hand glove, and undershirt in bag.

Impose strict limits on the number of suit repairs and/or implement a used suit validation/certification procedure. For example, pull suit off-line every ten patches to recertify the suit.

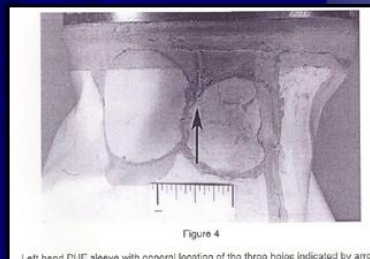
Figure 4  
Left hand PHE sleeve with general location of the three holes indicated by arrow

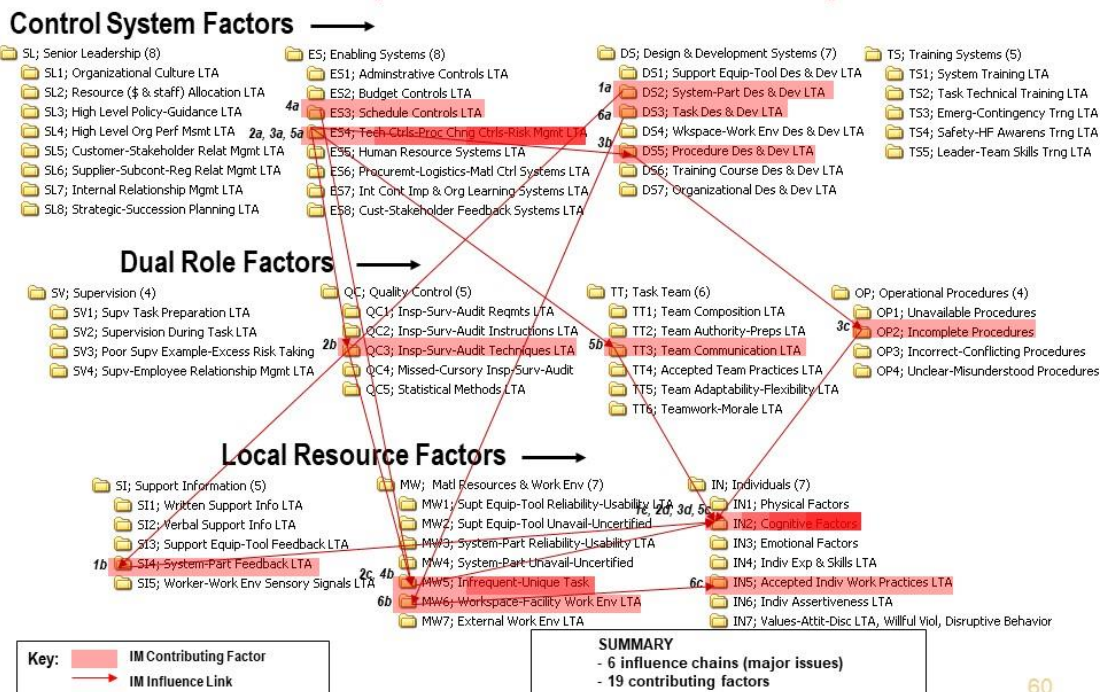
## OV-105 NLG Movement Close Call Completed Influence Chain Map

- Influence Map**
  - 6 influence chains (major issues)
  - 19 contributing factors
- SAIB Report**
  - Findings and Observations**
    - 4 findings *identify* 3 contributing factors in 3 influence chains

- Perform task analyses for mechanical tasks where visual inspections may be impaired by visual angle, obstructions, etc.
  - Ensure only work stands or ladders that allow visual verification of hardware are used to support jack transfer operations
