# Emergency Locator Transmitter Survivability & Reliability (ELTSAR) *Phase 1: Research & Work Plan*

**Briefing to SC-229/WG-98  
CNES Toulouse  
3-5 Sept 2014**

**Chad Stimson, *Project Manager***  
*NASA Langley Research Center*  
[Chad.M.Stimson@NASA.gov](mailto:Chad.M.Stimson@NASA.gov)  
(757).864.3787

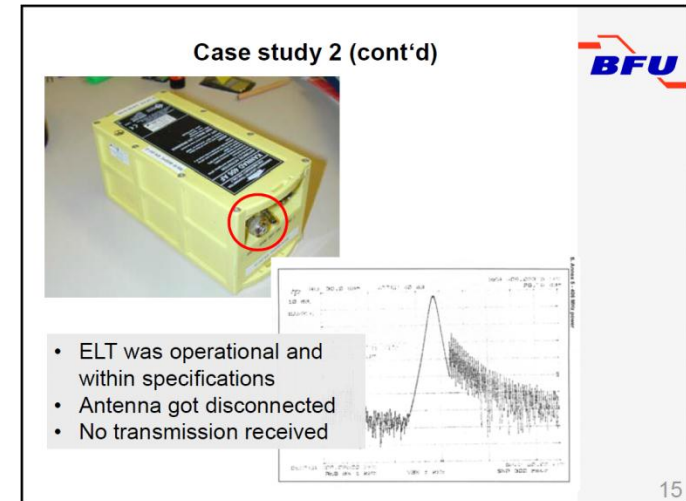
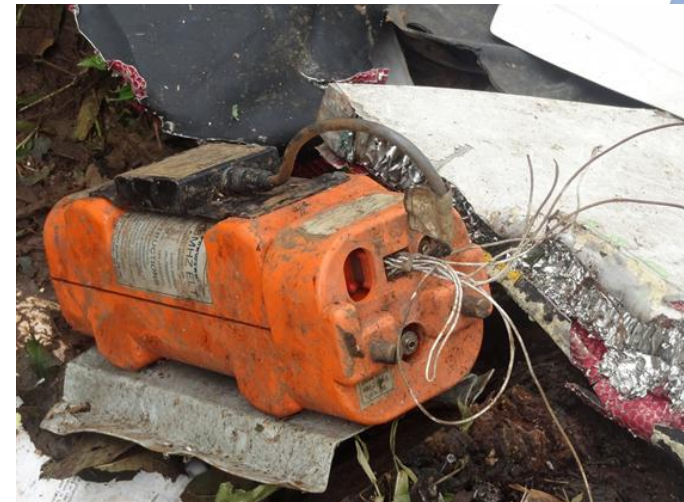
- **German** BFU presentation to Cospas-Sarsat in 2011 detailed 6 accidents in which the beacon ejected from its mounting tray & concluded that the antenna connection is the weak link (top right)
- Helicopter crash report from Mumbai, **India**, in which the beacon ejected from its mounting tray, severing the antenna connection (bottom right)
- **Cospas-Sarsat** proceedings in 2010 cite small sample size regarding beacon reliability statistics. 90% of aircraft accident reports involving substantial damage contain no ELT info at all, leaving a sample of 20 out of 400 accidents annually
- Defense Research & Development **Canada** report published in 2009 claims a success rate of 74% but also states that only 174 of 1,301 cases analyzed contained sufficient ELT data (13% of cases)

Similar failure modes & data collection issues

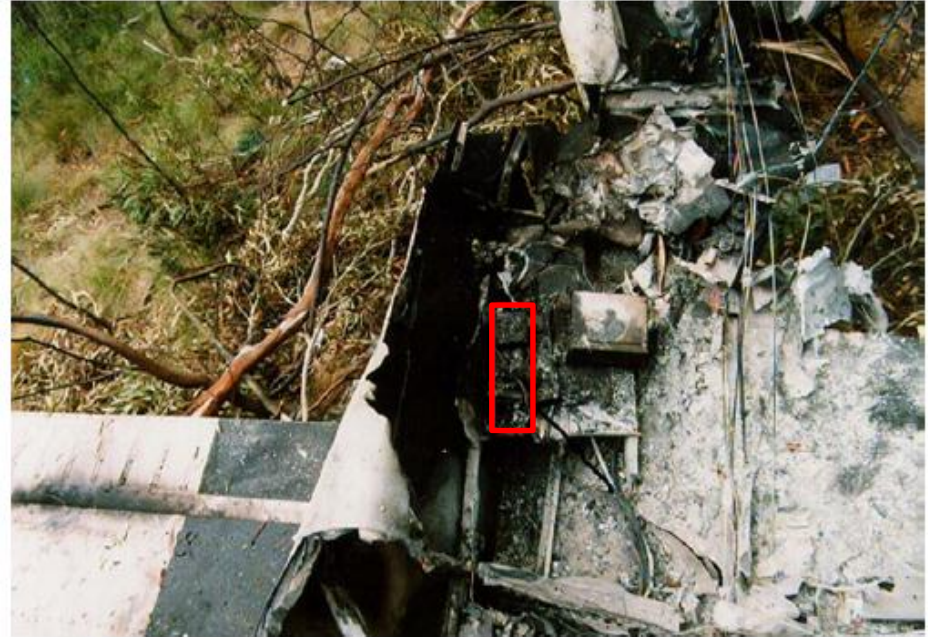
➤ **DO-204A Table 2-2 requires the flame test for all types of ELTs, while the fire test is optional or not applicable depending on type**

- **Flame:** 15 second exposure at a distance of 1 m from source
- **Fire:** 2 minute engulfment in 1,100° C minimum flame

➤ **Note, current system operations include a 50 sec delay between ELT activation and burst #1**

Flame test duration should at least be extended to cover ELT operational specs plus a safety factor and/or the fire test should be mandated for ELTs

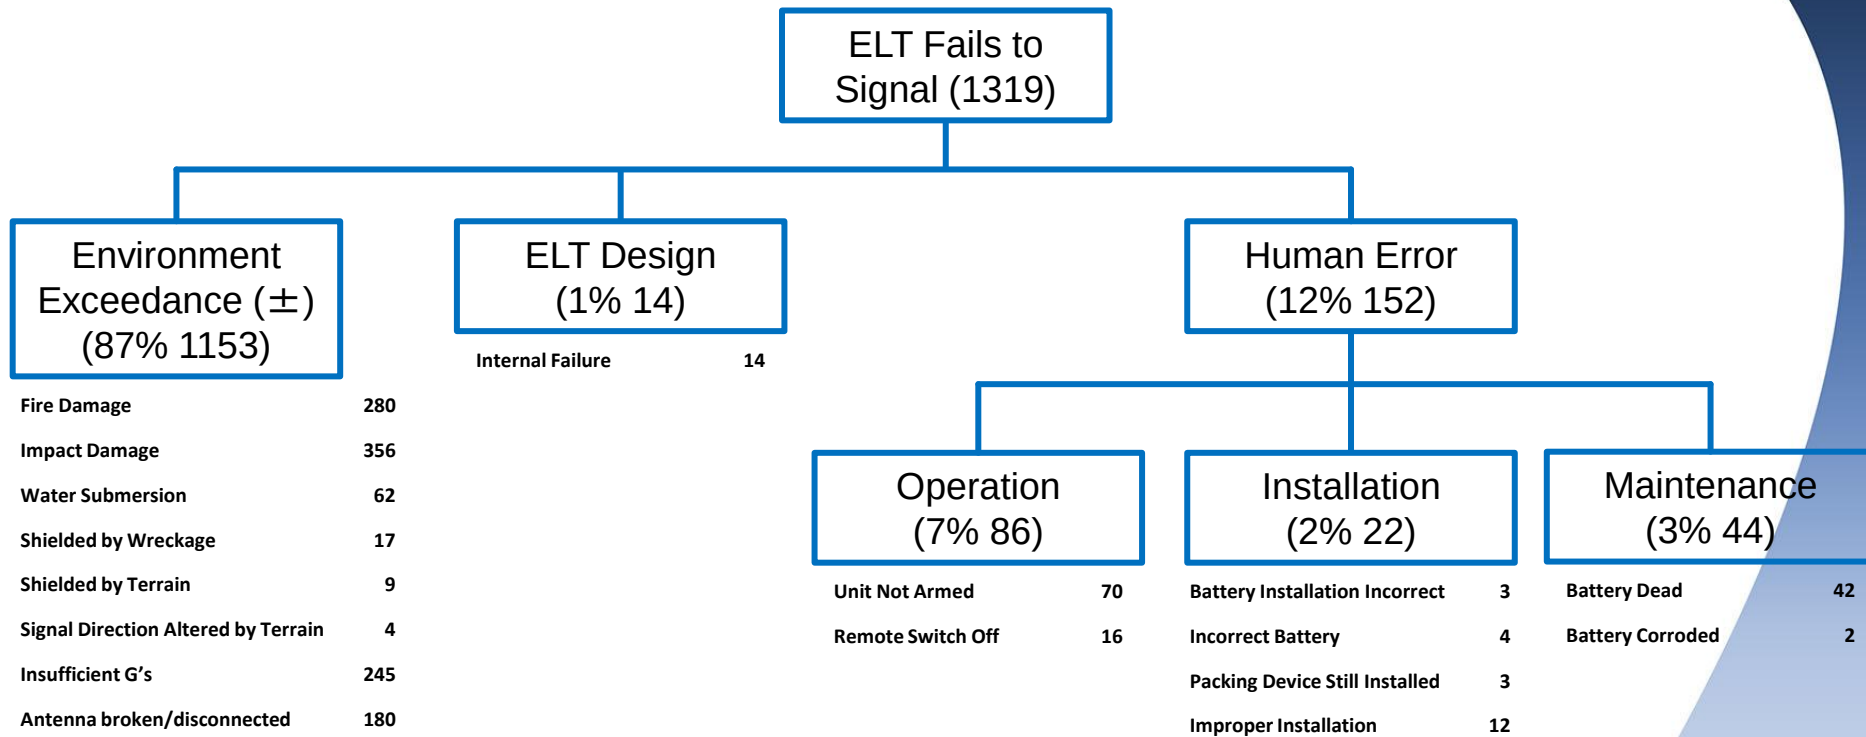
## ➤ Environment is the dominating factor (87%)

- Possible overlap between Environment & Design factors
- Detailed FMEA on a particular ELT design will not provide the greatest benefit
- Reference NASA CR 4330 dated 1990

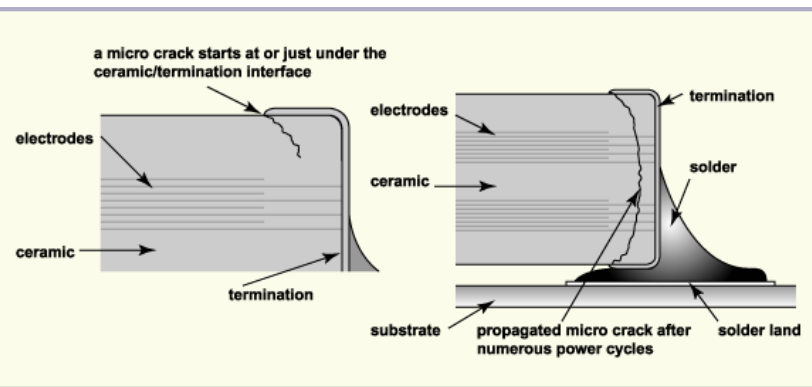
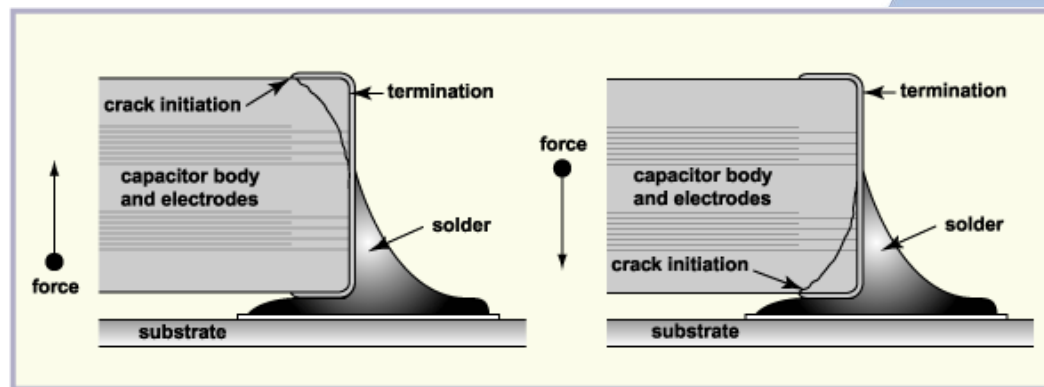
# MLC Failure Due to Crack Propagation (see previous reference)

- Component impact testing to 5 G's
- Ceramics are brittle and can fail unexpectedly due to micro-crack initiation and subsequent propagation, which is sometimes internal, thus invisible
- Thermal considerations: CTE mismatch between MLC and mounting board
- Mechanical considerations: Excessive flexure, MLC placement, handling
- Electrical considerations: Power cycling
- Responsible for “Internal”, “Impact” or “Unknown” failures?

Case study: Proximity of MLC to printed circuit board fasteners caused micro-crack initiation and subsequent burn-out (failure) in automotive application after moisture penetrated the crack over time

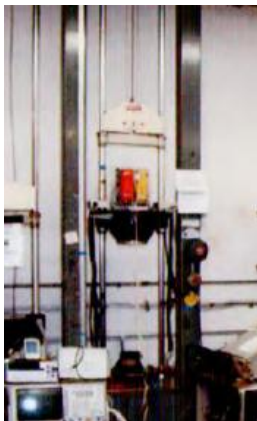
Crashworthiness test from a leading vendor report

- Current **crash safety testing** failed to identify failure mode of ELTs ejecting from their mounting trays in survivable crashes
- NASA will demonstrate an improved test with more realistic loading conditions that will form the basis for recommendations to RTCA SC-229
