STS-1 FORWARD RCS OXIDIZER TANK SUBSYSTEM FAILURE ASSESSMENT

K. Chauncey Wu NASA Langley Research Center Hampton, Virginia

John J. Zipay NASA Johnson Space Center Houston, Texas

2021 AIAA SciTech Forum and Expo 11-15 January 2021

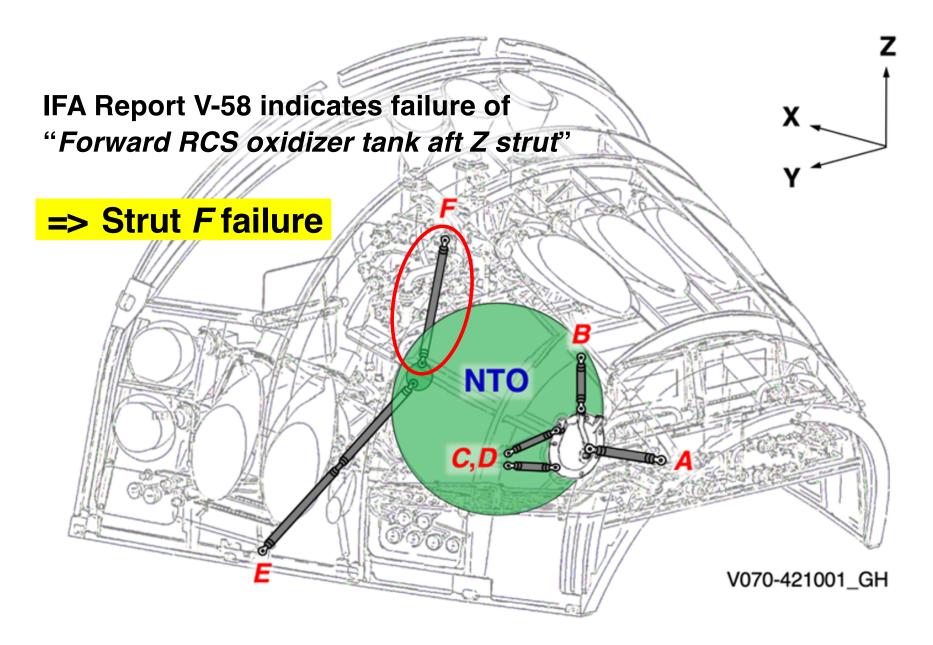
FRCS Oxidizer Tank Subsystem (2)

FLIGHT TEST PROBLEM REPORT NO. 58	
Statement of problem: Forward RCS oxidizer tank aft Z strut found deformed.	
Discussion: The forward RCS oxidizer aft Z strut failed in Euler buckling due to the lift-off dynamic response from the SRB overpressure. The forward and aft Z axis tank struts on both the fuel and the oxidizer tanks were replaced with struts reinforced by plies of boron/epoxy. The rod end diameter of the fuel tank struts was increased by 1/16 in. to be the same as the diameter of the ozidizer struts. The base heat shield left and right struts were reinforced and replaced. All other large mass support systems were reassessed for positive margins.	STS-1 Orbiter Final Mission Report, JSC-17378, Aug. 1981 In-Flight Anomaly STS-1-V-58 (IFA Report V-58)
Required date for resolution: CLOSED 7/22/81 Crown Lohan Personnel assigned: E. W. Sandars/ES2 X-6156, R. J. Ward/WA3 X-4323 Action progress: (blank)	"Forward RCS oxidizer tank aft Z strut found deformed."

Effect on subsequent missions: None	"The strut failed in Euler
Conclusions: Z axis accelerations exceeded design limits due to SRB overpressure which resulted in deformation of the forward RCS oxidizer tank aft Z strut.	buckling due the lift-off dynamic response from the SRB overpressure."
Corrective action: Forward RCS struts were modified and replaced. Base heat shield left and right struts were reinforced and replaced. All large mass structures were analyzed and found to have positive margins of safety.

- Forward RCS NTO tank Strut F material failure noted in STS-1 post-flight inspection
- Analyses of Strut *F* failure performed for Euler buckling, followed by elastic bending, then material yielding
- Further analyses suggest possible elastic failures of NTO Strut *B* and MMH tank Strut *F*
- Mitigations on STS-2 and subsequent flights
 - Boron-epoxy strips bonded to all Struts *B* and *F* for added strength and stiffness
 - Root-cause IOP reduced with increased pad water suppression/injection
