Spacesuit flash-fire provokes minor alterations

Lessons Learned From the EMU Fire

INVESTIGATORS FILE REPORT ON CAUSE OF SPACESUIT BACKPACK FIRE

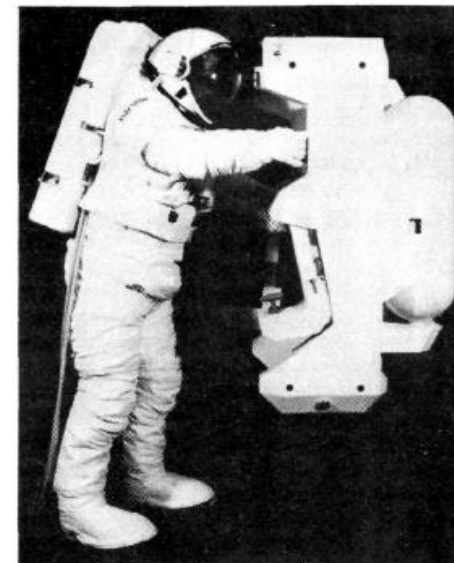
A spacesuited astronaut reaches for a manned manoeuvring unit. The back-pack on the spacesuit contains oxygen, cooling and other life-support systems

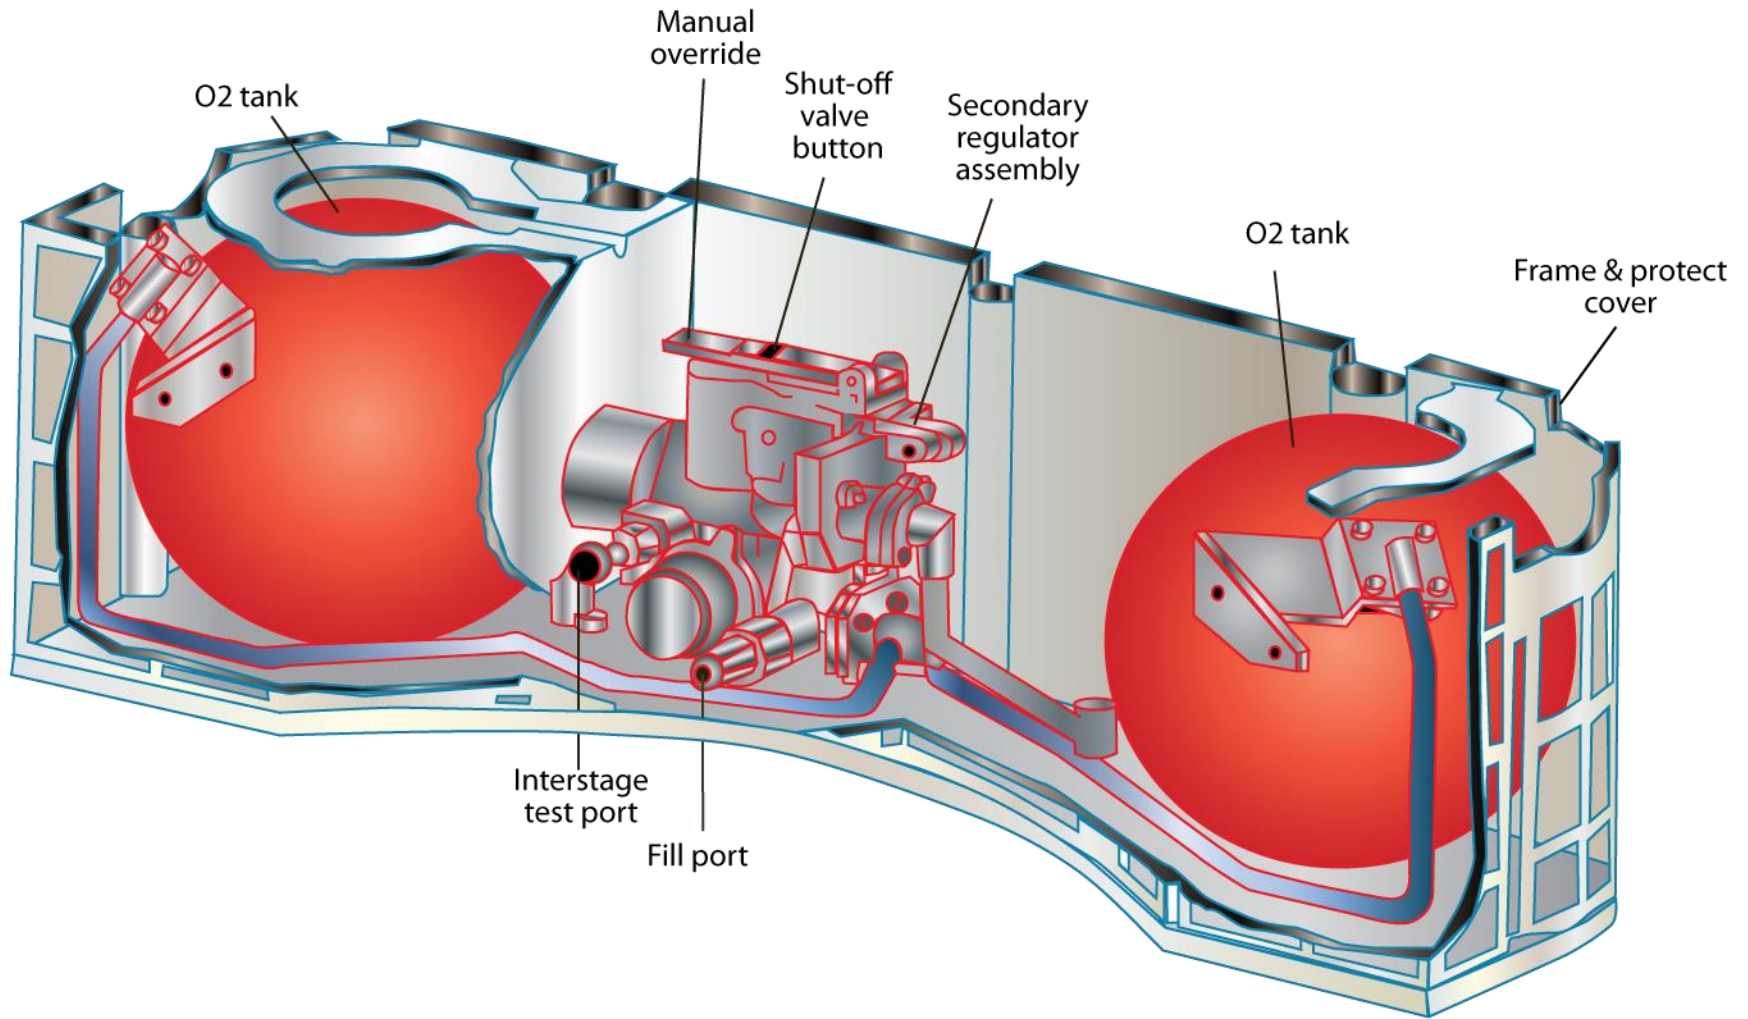
- Regulator vaporized in less than 1 second
- O₂ availability allowed for metal to burn
- O₂ depress less than 2 seconds
- Softgoods burned until extinguished - ~1-2 minutes

~2 million dollars worth of damage

Not Much Left!

As a result of the post-fire investigation, the regulator and valve assembly was redesigned, and the aluminum in this assembly was replaced with Monel®.
