STUDY OF SPACECRAFT DEPLOYABLES FAILURES

Alejandro Rivera ⁽¹⁾, Alphonso Stewart ⁽²⁾

ABSTRACT

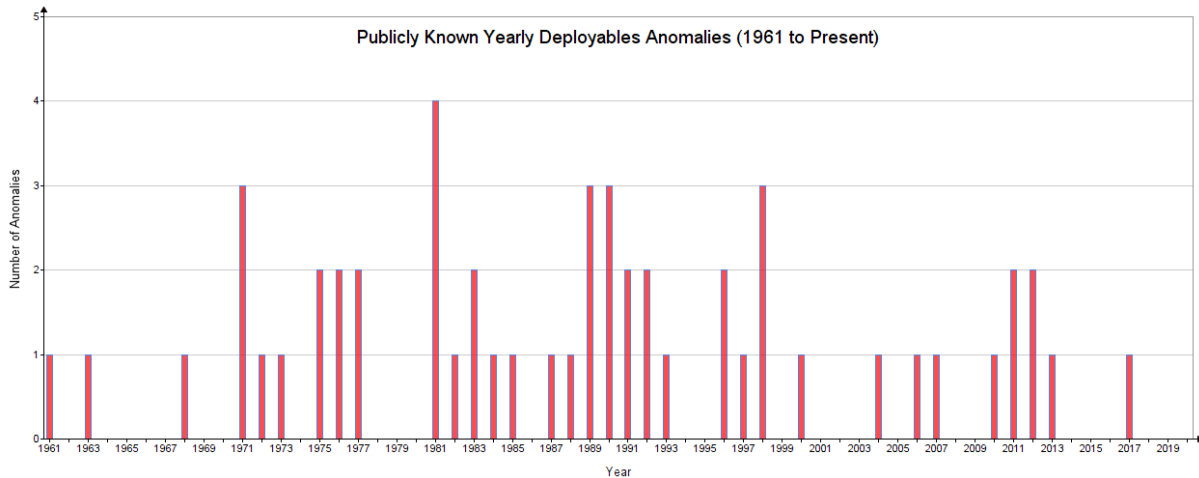
Figure 3. Anomalies by Year

Spacecraft having deployable related issues as early as 1961 (MIDAS 3), and as recently as 2017 (ViaSat-2), were found. The distribution of anomalies per year is shown in the Figure 3 histogram.

Before seeing this data, one might have expected to see many failures in the sixties followed by a reduction in the number of yearly failures through the seventies and subsequent decades. However, consider that initial number of SC placed in orbit annually has increased significantly through the years. From a few dozen per year in the sixties to now an average of 122 per year [8]. Second, as deployment technologies have been mastered, companies have pushed the envelope by designing larger and larger solar arrays and antennas that provide mobile communications to small devices such as car radios and smartphones. Increasing the satellite antenna size and power means user handsets do not need to generate as much power on their own to capture and maintain a communications link. As an example, the Harris Corporation has gone from building 5-meter (m) diameter L-band antenna reflectors to building 22-m ones, like that used in Skyterra-1 (largest commercial antenna ever built), in the span of just 10 years [9]. This aggressive scaling up has caused problems with the deployment of antennas in the Garuda-1 spacecraft (launched in 2000 / 12-m L-band antenna failed to fully deploy) and on Skyterra-1 (launched in 2010 / 22-m L-band antenna did not initially deploy).

From 2000 to 2013, there were a total of 10 deployables related anomalies and failures reported. For six of these SC, troubleshooting was not successful, and the deployment problem could not be fixed. The average insurance claim was \$131M. These 6 spacecraft could certainly have benefited from a robotic servicing mission.

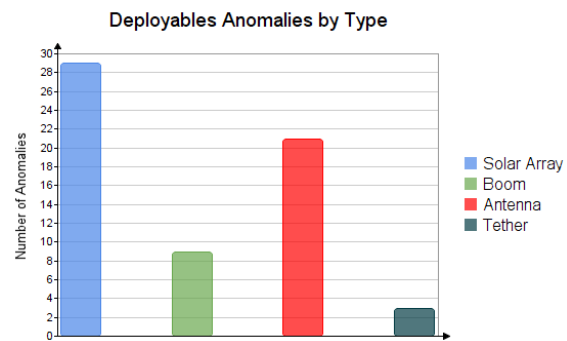
Figure 4. Anomalies by Type

Out of the 53 spacecraft surveyed that suffered deployables anomalies, 29 (55%) of them suffered solar array related anomalies, 20 (40%) of them had antenna related deployment problems, and 9 (17%) of them had boom deployment issues. Note that some spacecraft had issues on more than one type of deployable. As we will see later, minimizing the anomalies on SAs and HGAs would save millions of dollars in insurance costs.

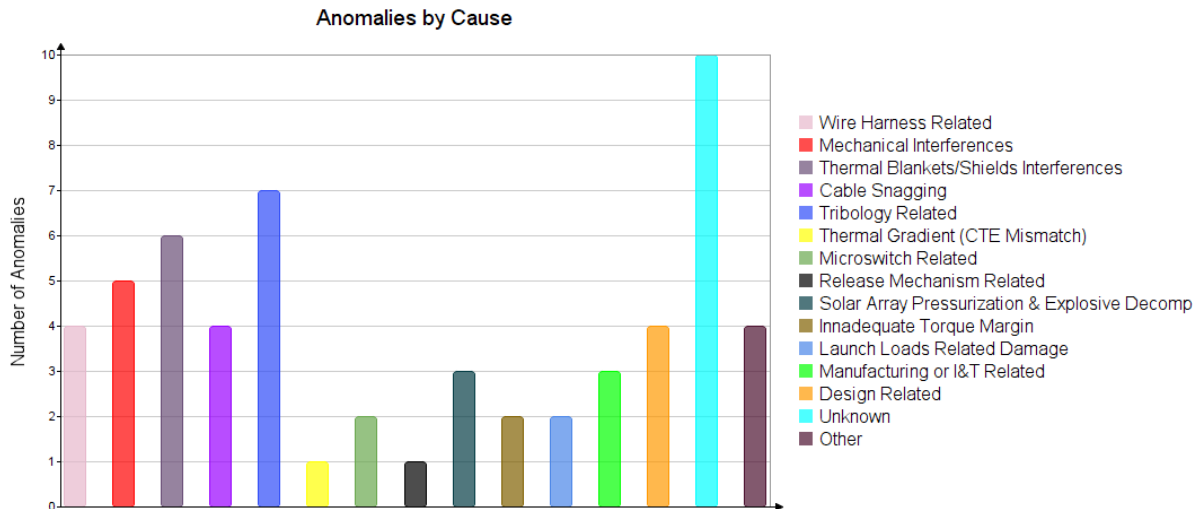
Figure 5. Anomalies by Cause

Analysis of all the failures yielded the breakdown shown in Figure 5. By far the most common causes of problems are tribology related issues and *thermal blankets/shields interferences*. Oftentimes, blankets are incorporated late into the Integration and Test (I&T) process and sometimes deployment testing is performed without them. This may result in deployment mechanisms getting caught in the shields and blankets that restrain and prevent their motion. Different variations of this problem happened to the Skylab, Voyager II, CRRES P86-1, Anik E-2, Gamma Ray Observatory, and New Dawn (both on the Ku-band and C-band antennas) spacecraft.

Tribology related problems seem to be the most common. Under this category anomalies were found due to friction welding (DMSP 5D1 F2), MoS2 solid lubricant problems (ERBS), cold welding (Galileo, JERS-1), increase in friction due to low temperatures and vacuum (Intelsat V, Voyager II), and thermal binding due to lubricant failure (Insat 1B).

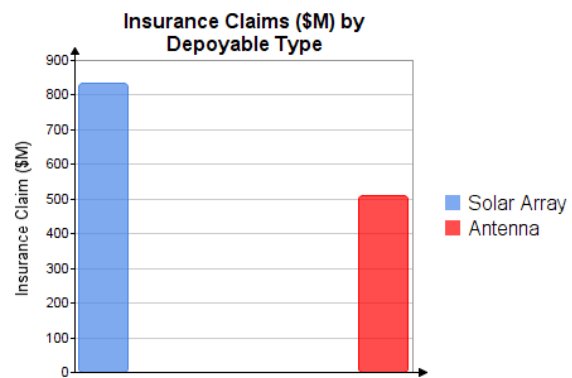
Figure 6. Insurance Claims by Deployable Type

Looking at the insurance claims data in terms of the type of deployable involved we can see that from 1998 to 2012 close to \$800M in insurance claims resulted from solar array failed deployments.

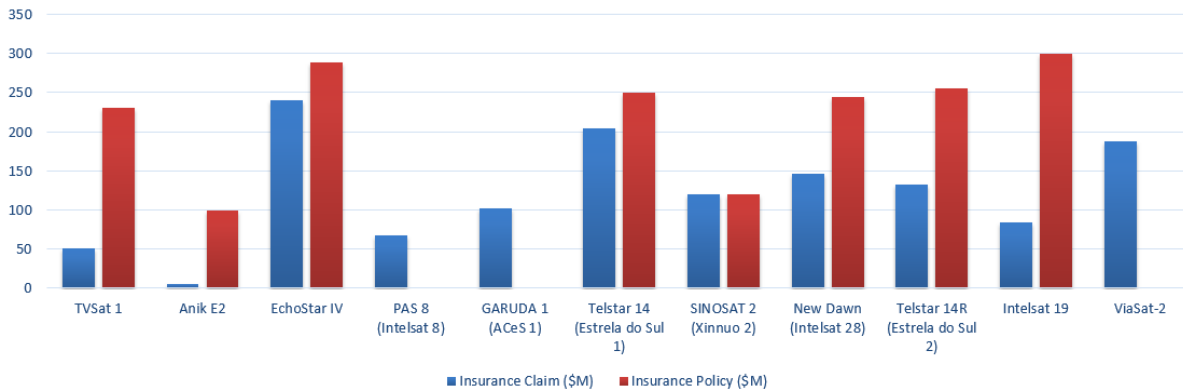
Figure 7. Insurance Claims

PAS 8 (Intelsat 8), Garuda 1, New Dawn (Intelsat 28), and ViaSat-2’s antenna issues resulted in insurance claims of \$508M. Figure 7 clearly shows that even though these types of failures happen only sporadically, they result in extremely large insurance claims. Being able to prevent them would save millions of dollars.

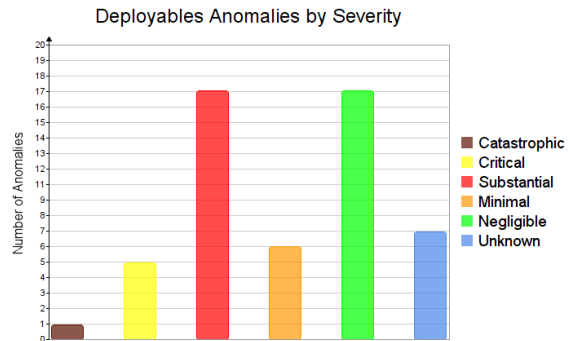
Figure 8. Failures & Anomalies by Severity Level

Chart shown in Figure 8 looks at the distribution of failures according to their severity level. While 32% of the SC are able to overcome the anomaly without loss of mission goals or SC performance, the vast majority (68%) suffer some degree of mission or performance degradation. Moreover, 32% of the deployment anomalies resulted in the substantial reduction of the spacecraft performance capabilities and/or partial loss of the mission, and in six instances, the spacecraft and/or the mission were completely lost. The main conclusion is that in most occurrences, the deployable failure is serious enough to reduce the capabilities of the spacecraft and affect the mission scope, duration and objectives, and the
