Study of Spacecraft Deployables Failures

Alejandro Rivera
Deployables Analysis Engineer
NASA Goddard Space Flight Center

Space Systems Anomalies and Failures (SCAF) Workshop 2022

January 11th, 2022

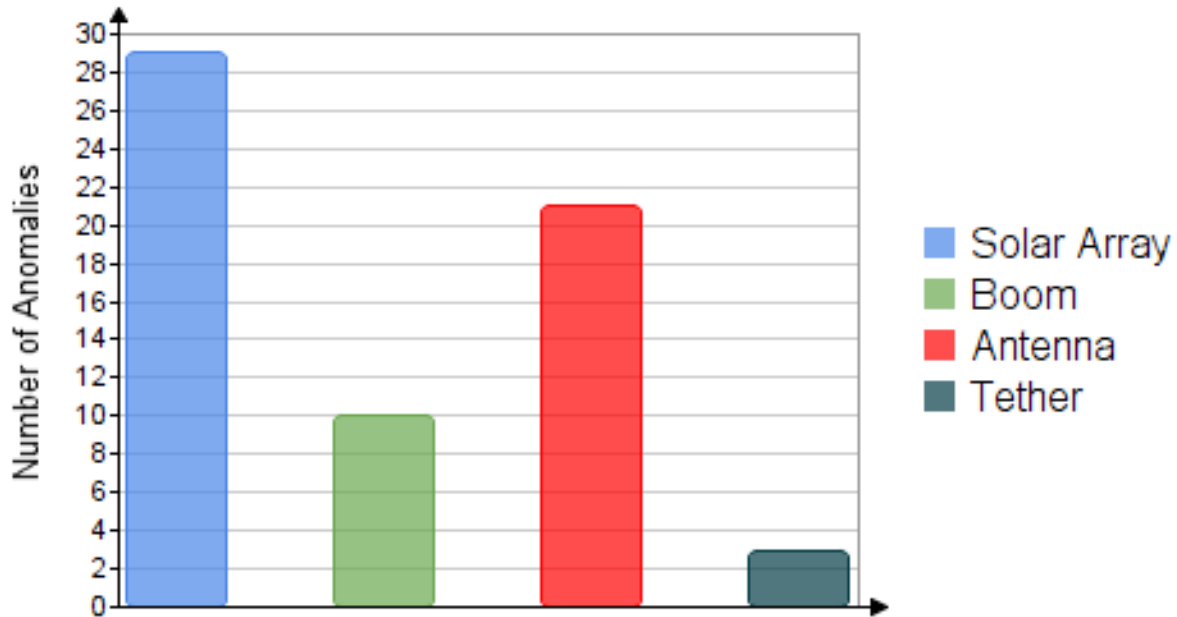
Deployables Anomalies by Type

- Solar Array anomalies most common (54%)
- Antennas (37%)
- Booms (18%)

Note: Some SC had issues on more than one type of deployable.

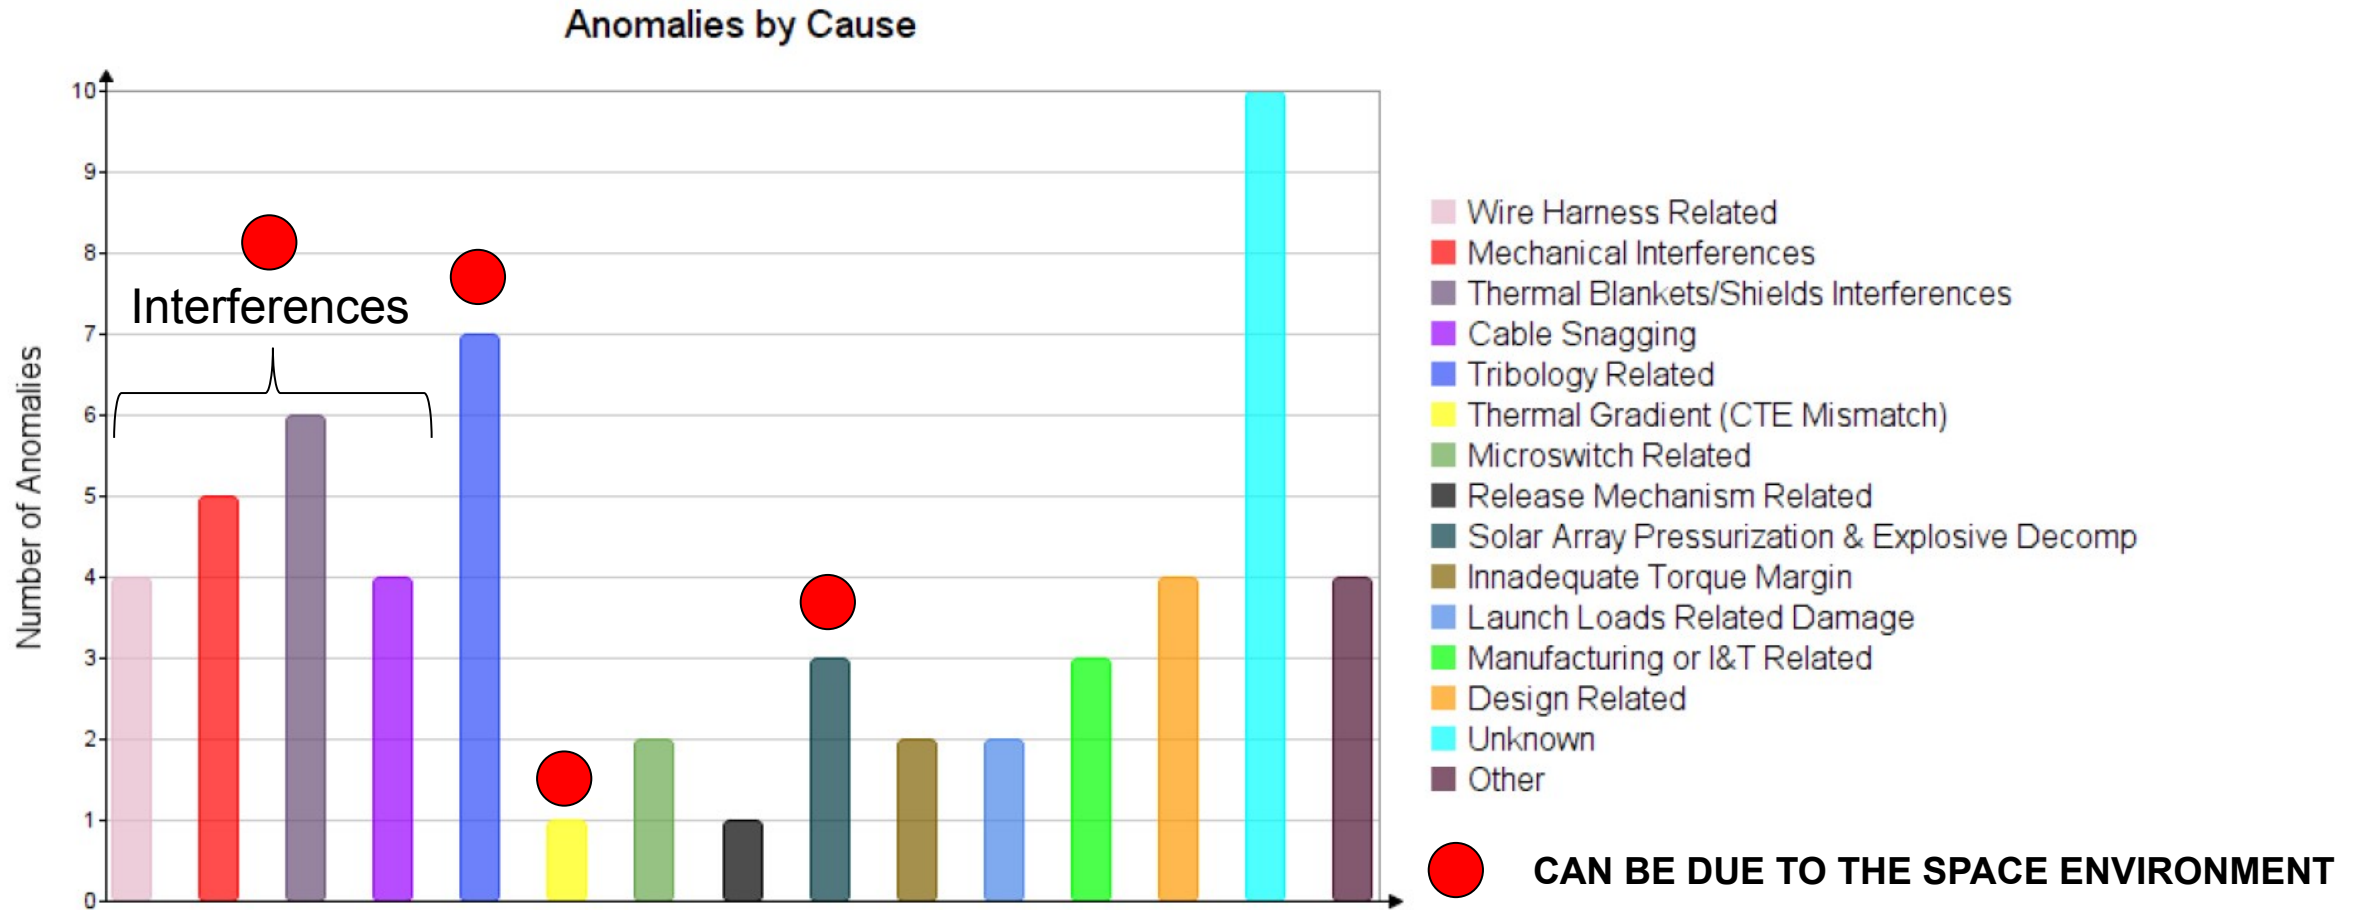
MAIN ANOMALIES AND FAILURES CAUSES

* Based on published information. Actual root causes may differ.

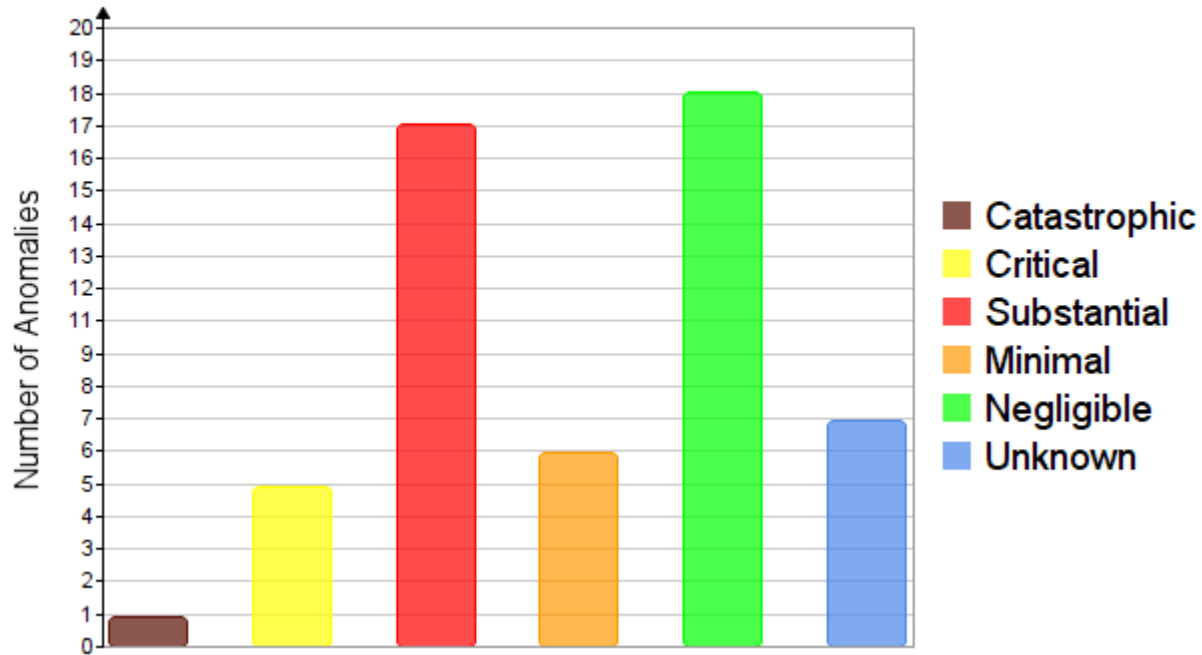
Deployables Anomalies by Severity

- 54% of anomalies result in some degree of mission and/or SC performance degradation (minimal, substantial, critical or catastrophic)
- 31% of anomalies results in substantial reduction of spacecraft performance and or loss of mission goals
