# Arecibo Observatory Auxiliary M4N Socket Termination Failure Analysis

NASA Engineering & Safety Center  
February 16th, 2022

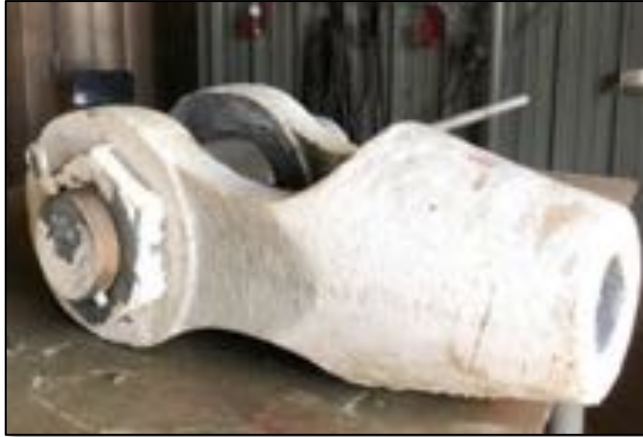
Aux M4N Failed Socket

- **August 10, 2020:** Aux M4N cable on the north side of Tower 4 failed. Cable was a primary component of the system used to suspend the large, steel-framed platform (feed platform) above the telescope reflector dish.
- **November 6, 2020:** One of four original main cables of Tower 4 failed. Second cable failure was one of the original main cables, which had a different structural strand construction and cable termination.
- **December 1, 2020:** Second original main cable at Tower 4 failed, causing a chain reaction of failures and load imbalances in the suspension cable system that led to total collapse of the observatory.

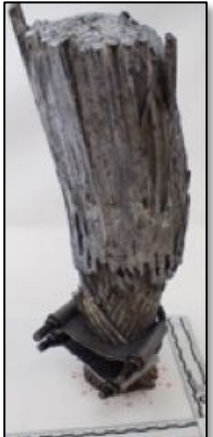
Pulled-out wires/core

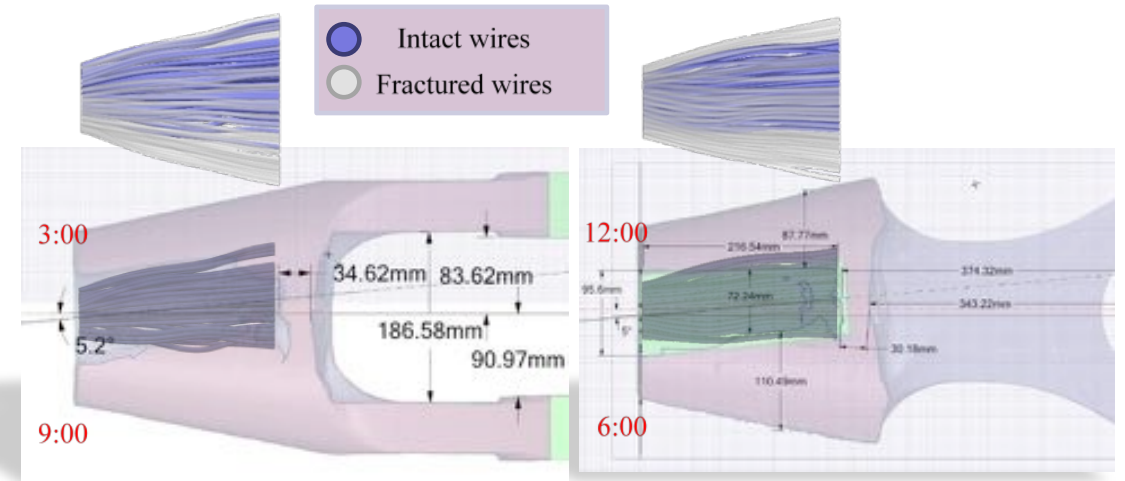
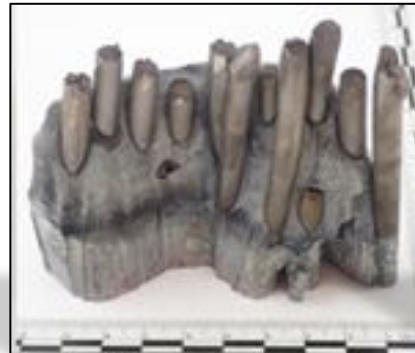
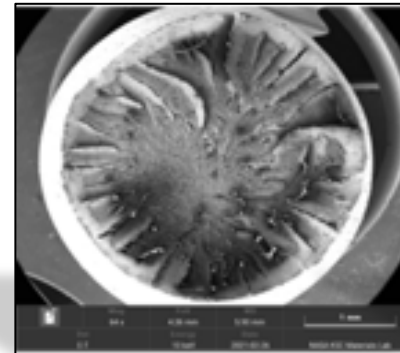
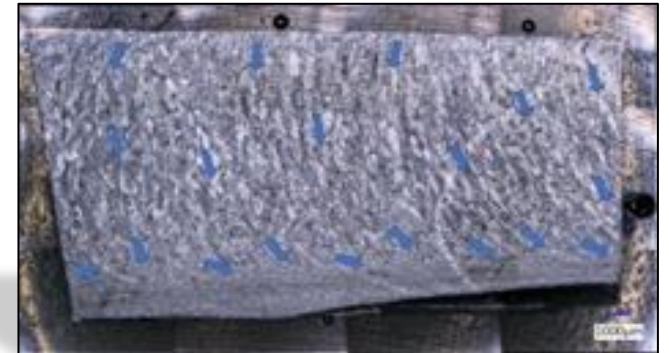
- **As-received socket housing and cable met spec/reqt's, but contained some defects analyzed for potential contribution:**
  - Zinc porosity
  - Solidification gas bubbles near the casting cap surface
  - Poor wire/zinc bonding at the wire ends
  - Brittle fracture region
  - Cracks throughout the bulk zinc
  - Five of 126 wires had surface defects in vicinity of fracture:
    - At least two were influential in their fracture; one of two probably HAC.
  - Three of 126 wires found to be mixed-mode fractures, in part HAC.
  - FEM evaluated the effects of voids/defects (discussed later)

- Most features inconsequential to failure progression (more discussion to follow)
- Surface defects on a few outer wires may have contributed to wire failure initiation and progression

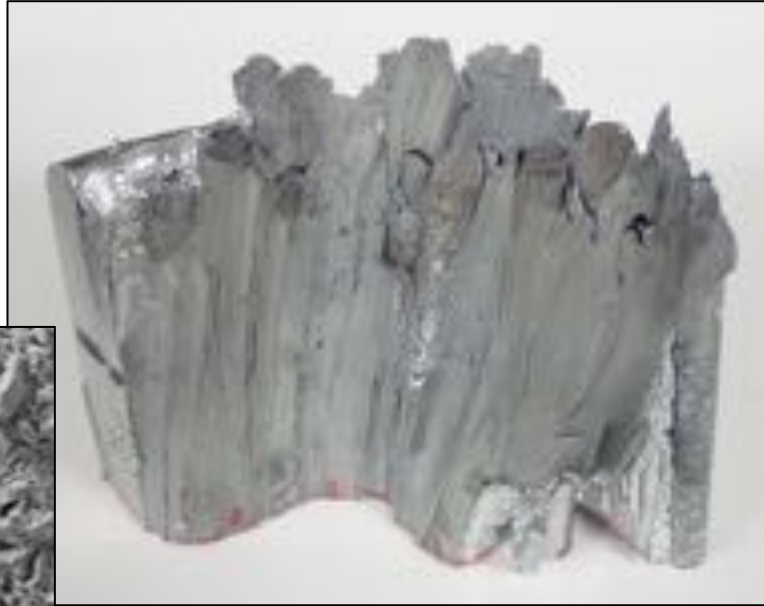
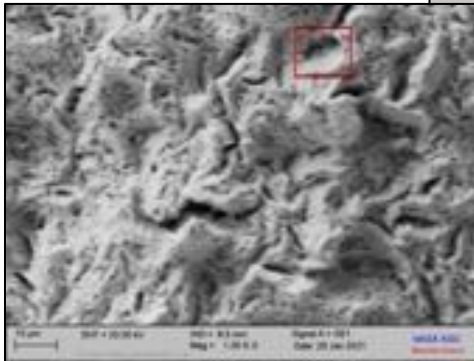
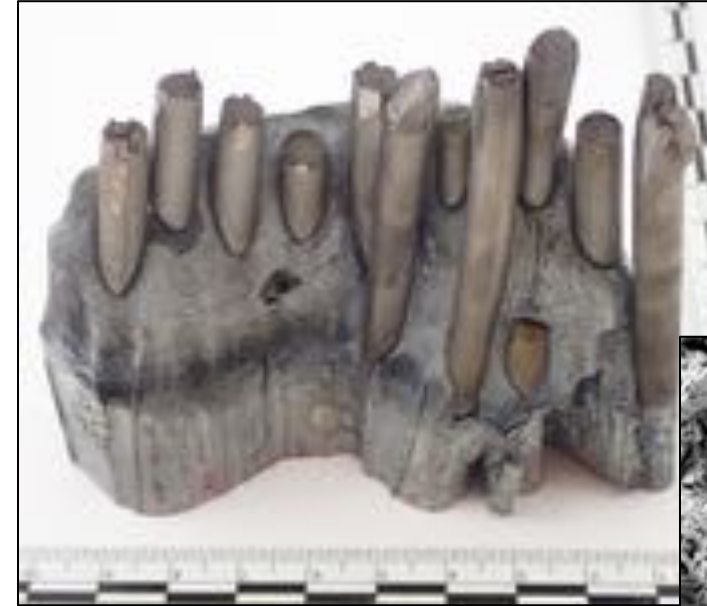
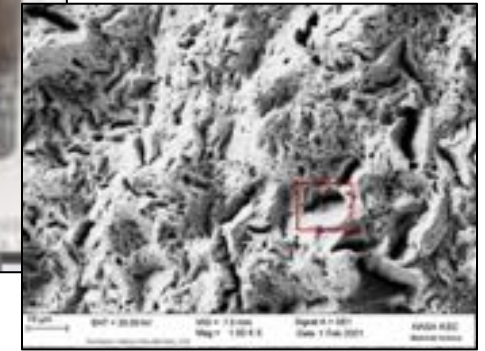
# Galvanically Revealed Fracture Surface

- **Fracture surfaces were revealed by immersing sections of the socket base slice into hydrochloric acid**
  - Galvanic reaction corroded the zinc metal, while protecting the steel wires; no effects observed to 1000x
  - Enabled wire fractures to be visualized together, in their socket positions.
  - Process did not retain corrosion evidence on wire fracture surfaces.

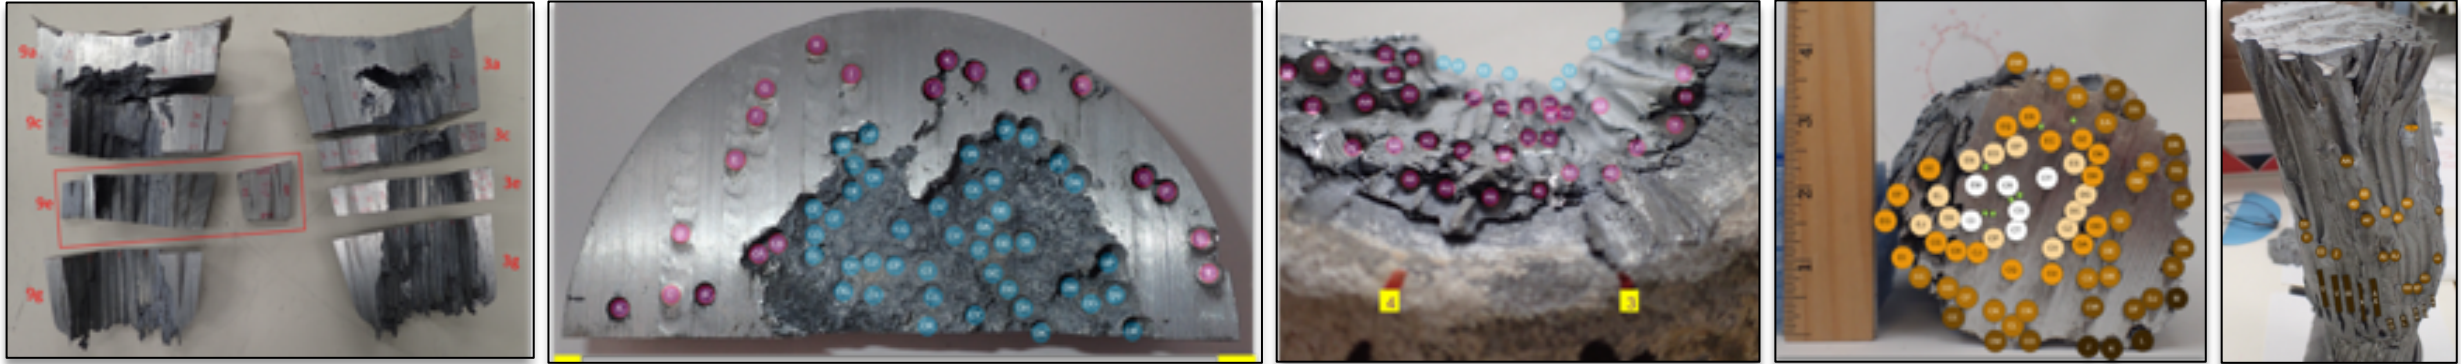
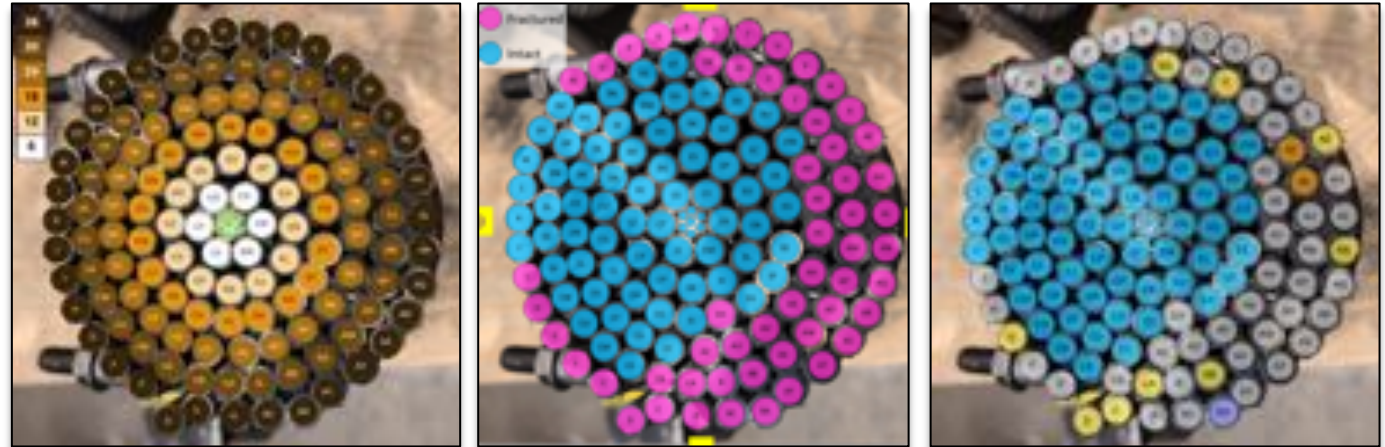
# Wire Mapping

- Zinc casting was sectioned from the casting cap to the socket base opening
- Wires labeled/tracked through the process
- Wires matched with their mating halves from the cable/zinc slug
- Final mapping aided in creating an as-built analytical model and understanding of the failure from a “system of wires” point of view

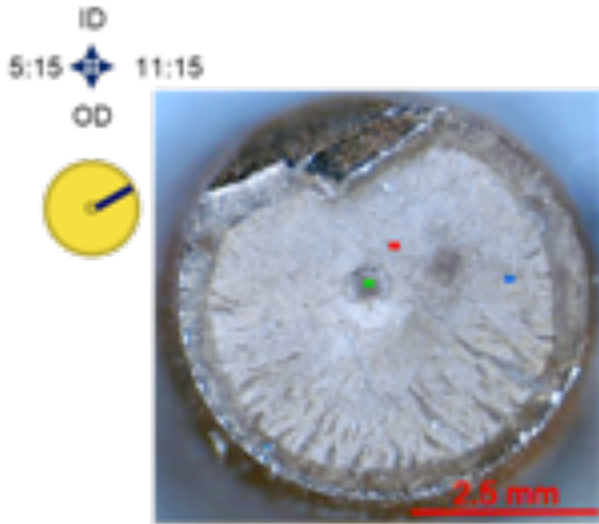
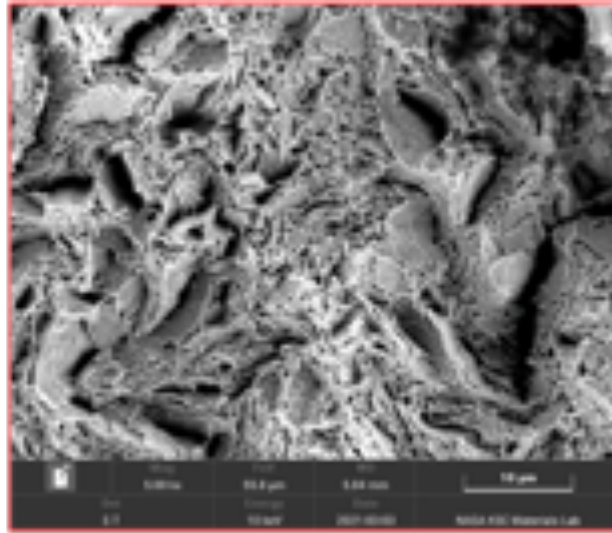
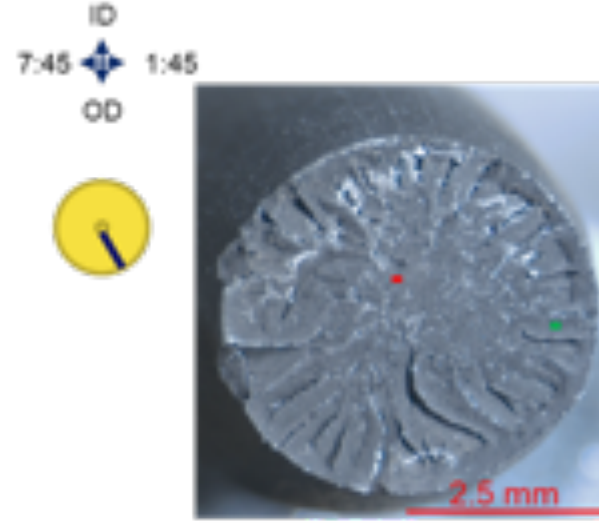
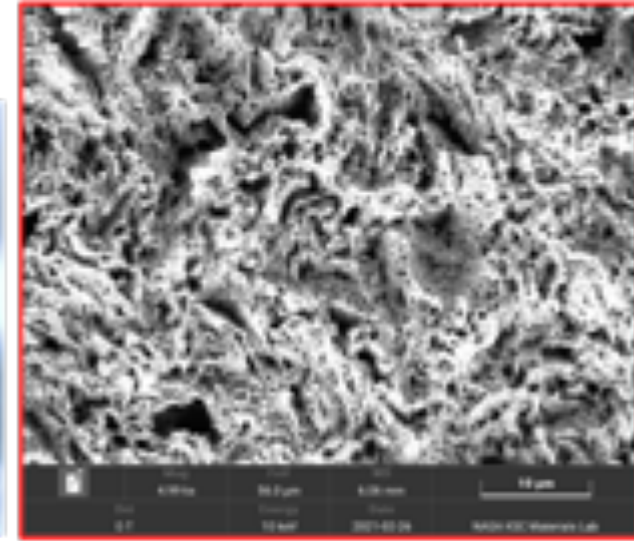
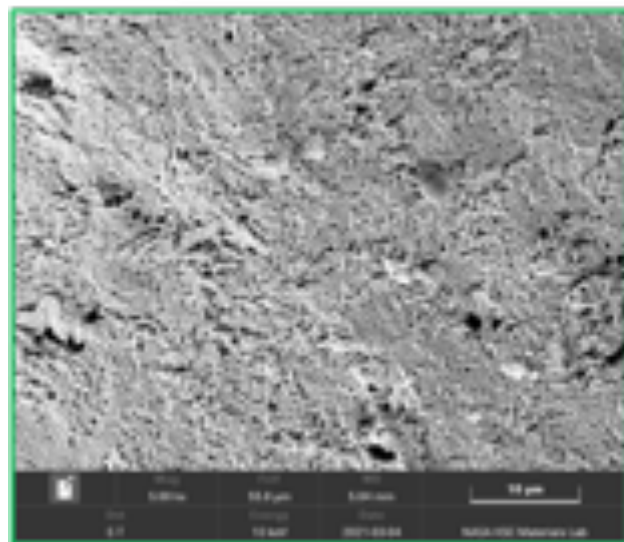
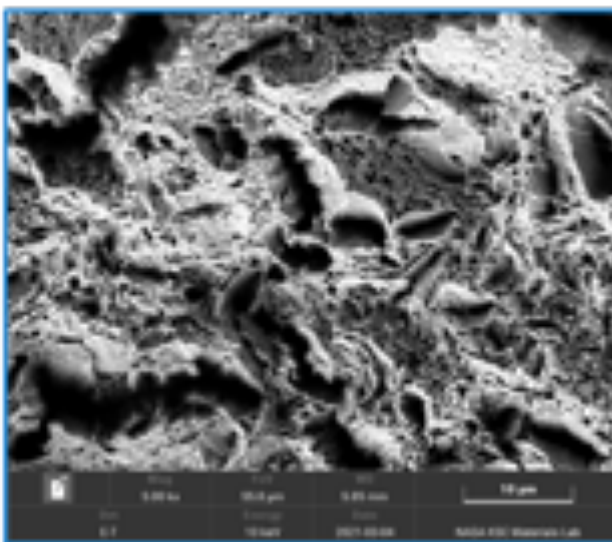
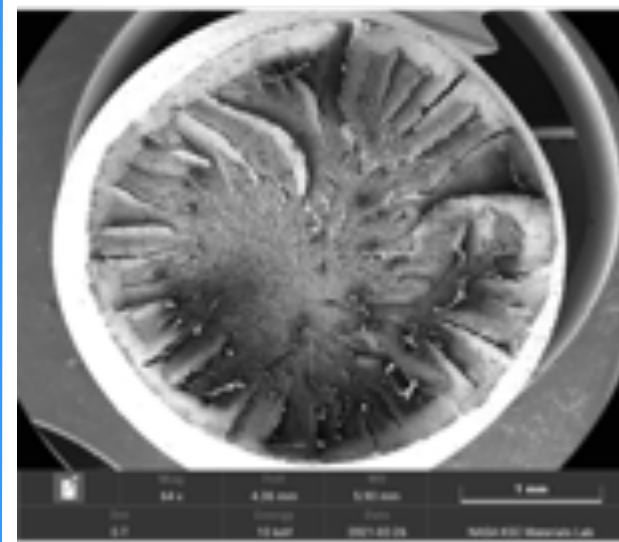
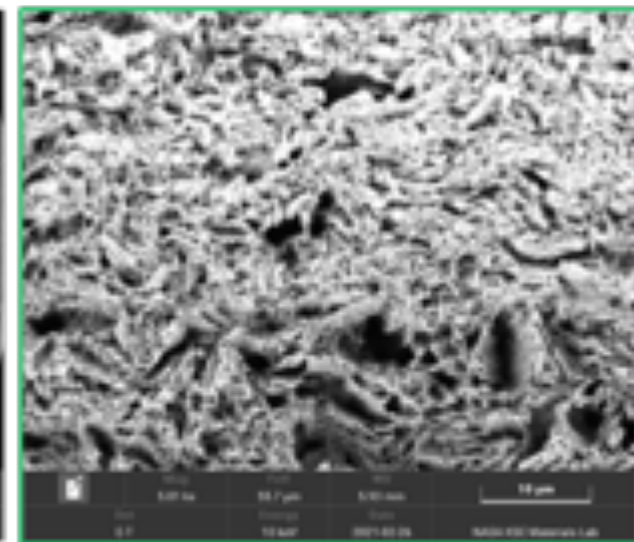
Surface Initiated Fatigue Crack    Inclusion Initiated Fatigue Crack

Gradually more progressively cold-drawn pearlitic steel wire specimens failed by tensile overload

Wire Z

Wire EH

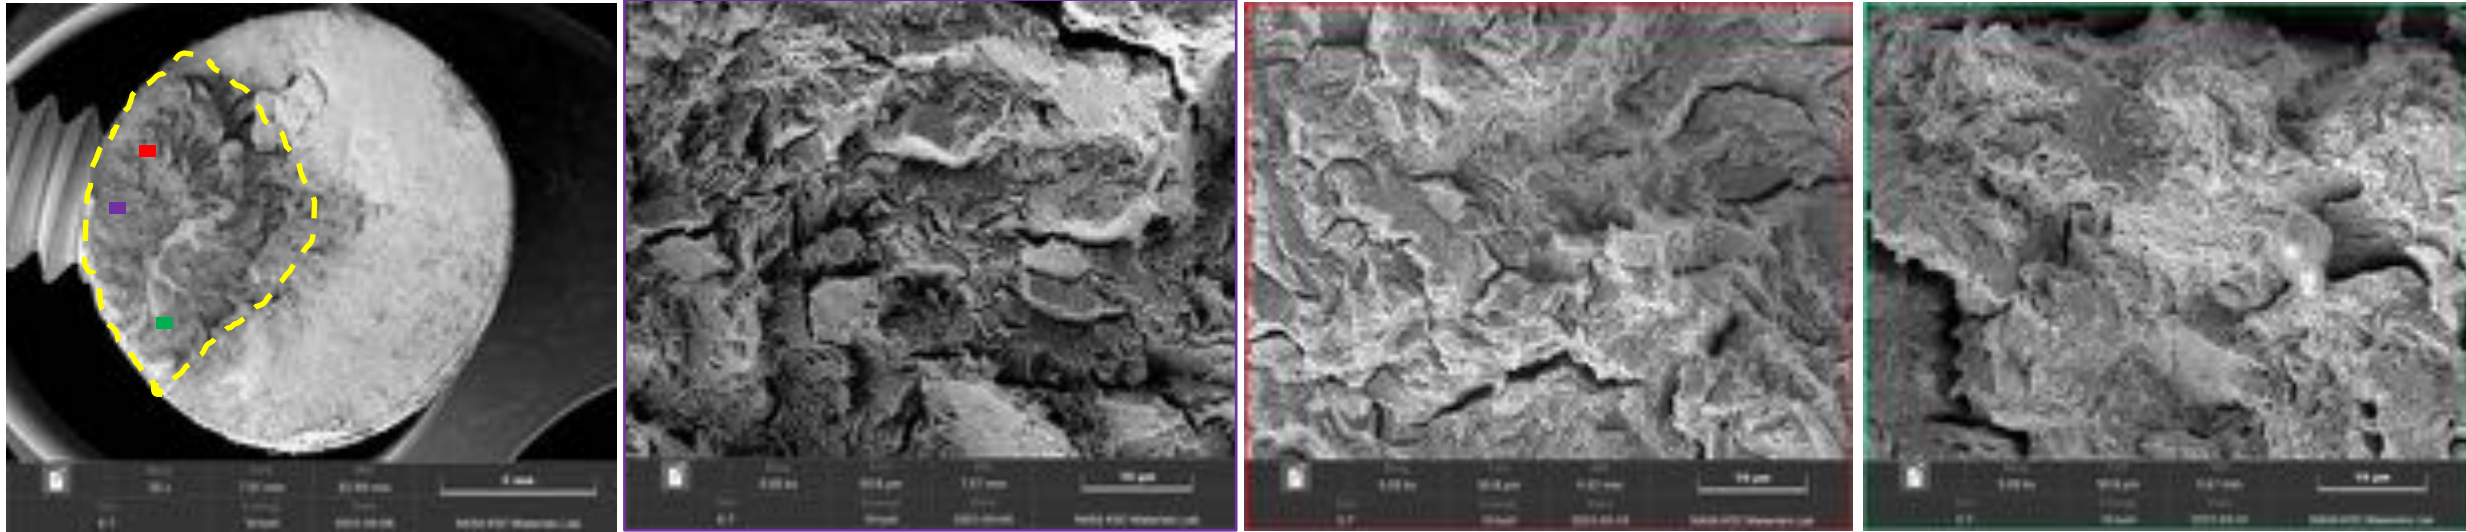
- HAC can accelerate failure, especially when subject to sustained loading, and has negative structural margins over the entire service life.
- Three wires exhibited mixed-mode fractures, with one mode being progressive failure, probably HAC.

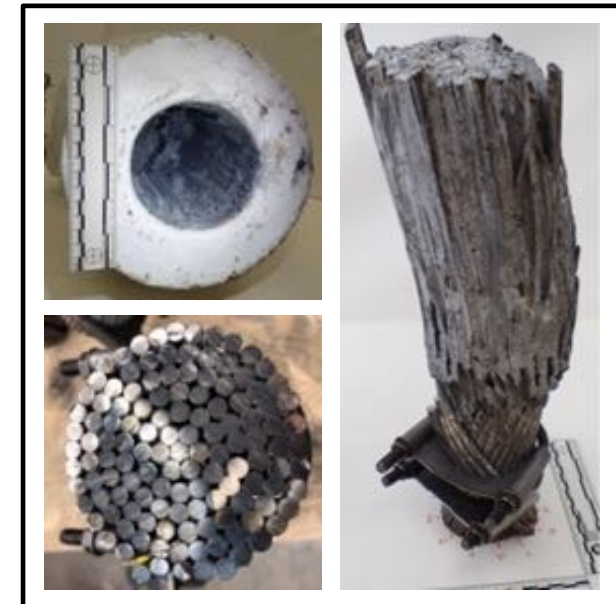
Comparison of forensics (left) with modeling  
predictions just prior to failure (center/right)

- Analysis examined loads/stresses, and pattern of progressively failing wires adjacent to the socket termination. (LEFT)
- Varied number of failed wires to represent post-fracture configuration. (CENTER)
- Analytical progression of failure qualitatively matches forensics analysis including final zinc overload/cable core pullout. (TOP/BOTTOM RIGHT)

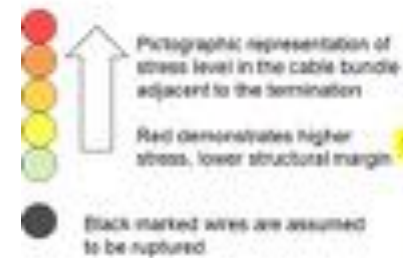
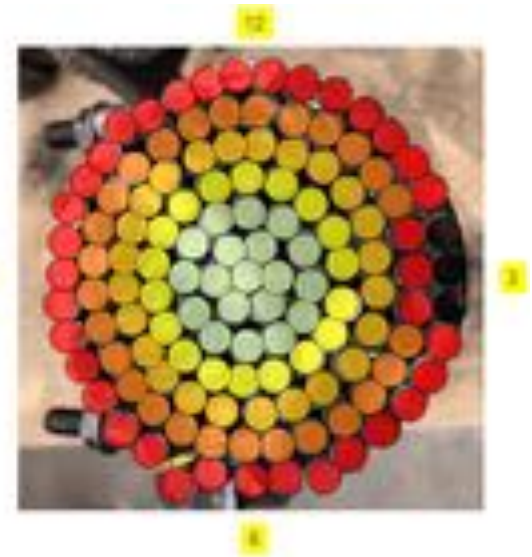
Fully circumferential 3D FEM showing three “failed” disconnected wires corresponding to same three wires indicated at 3 o’clock side in below image

- Qualitatively, the analytical progression of failure matches well with forensics analysis of wire mapping.
- Plastic strain of zinc shows a significant increase after wires fracture, indicating transfer of failure mode to zinc overload/cable core pullout.
