## **ANALYSIS OF HYPERVELOCITY-IMPACTED THIN FILMS FOR SPACE APPLICATIONS**

**Melissa A. Ward<sup>1</sup>, Phillip D. Anz - Meador<sup>1</sup>, Heather M. Cowardin<sup>2</sup>**

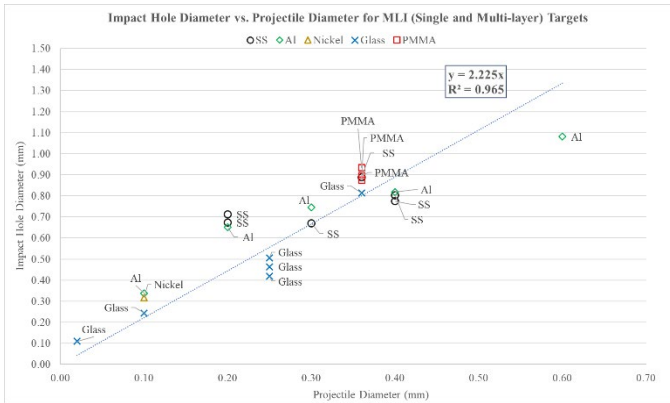
**FIGURE 2:** REPRESENTATION OF THE IMPACT HOLE DIAMETER AS A FUNCTION OF PROJECTILE DIAMETER FOR HST AND HST EQUIVALENT MLI TARGETS.

There is a relationship between the projectile diameter size (and accompanying parameters) and the hole it creates. The association between projectile size and resulting hole diameter is 2.225 (*i.e.*, a projectile will create a hole of approximately 2.2 times the size of the projectile in HST MLI-type film). Some of the spread along the trendline can be attributed to parameters being varied. For example, the material/density varied with the 0.36 mm and the 0.10 mm projectile shots. Another example is the 0.2 mm-sized projectiles, where the velocity was changed. In the 0.25 mm projectile size grouping, the angle parameter was varied. The target configuration (a single-layer versus multi-layered sample) also can be a factor in the spread of data. Further research is in work to answer target configuration questions specifically, in addition to what parameter or subset of parameters is connected to resultant impact hole diameter.

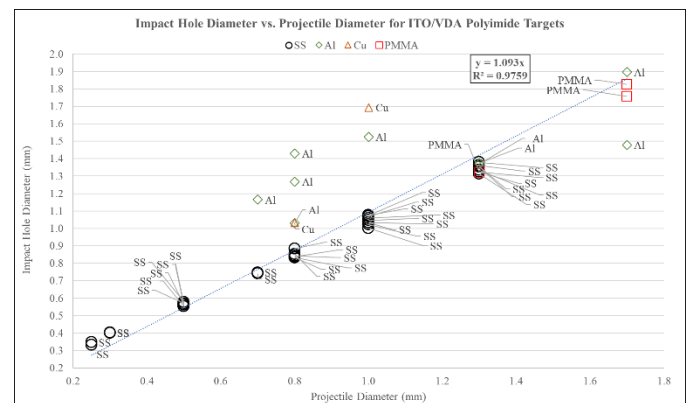
**FIGURE 4:** REPRESENTATION OF THE IMPACT HOLE DIAMETER AS A FUNCTION OF PROJECTILE DIAMETER FOR ITO/VDA-COATED-POLYIMIDE TARGETS.

Principal outliers on the plot are Al and Cu projectiles, which may be due to the breakup of the projectile material on the film. The ratio of impact hole diameter to projectile diameter (1.093) is about half of the ratio found in the MLI samples, which may indicate a dependence on the thickness of the film or the material type (polyimide versus PTFE). More investigation is in progress to quantitatively determine the dependence of impact hole to the film thickness and film material type.

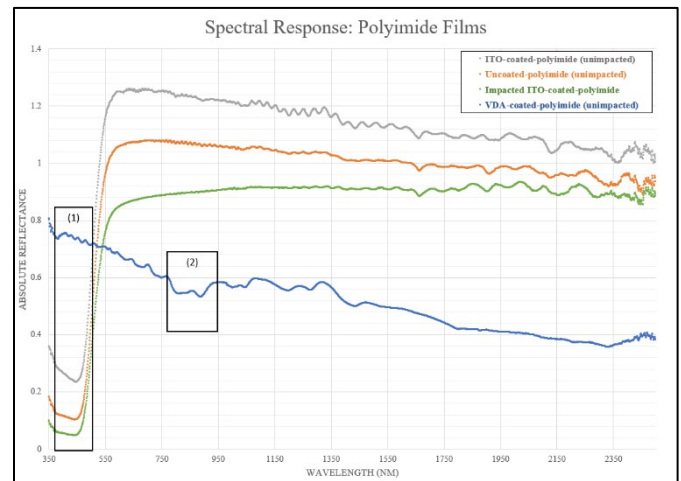
**FIGURE 8:** SPECTRAL RESPONSE OF POLYIMIDE MATERIALS INVESTIGATED. NOTE, THE UNCOATED POLYIMIDE AND ITO-COATED-POLYIMIDE SAMPLES SATURATED THE DETECTOR (ABSOLUTE REFLECTANCE  $> 1$ ).

region of interest is indicated in Fig. 8 (1) that clearly distinguishes the uncoated- and ITO-coated-polyimide films from the VDA between 400 nm and 500 nm. Due to the thicker VDA coating, the typical absorption feature in polyimide is not present. The second feature (2) noted is a doublet between 800 nm and 900 nm, an absorption feature common with Al materials, but not typically presented as a doublet. Several organic features (dips in the curves) are present near 1650 nm and 2300 nm in all three non-VDA-coated-polyimide samples, and a weak H<sub>2</sub>O feature near 1400 nm and 1900 nm is present in all four samples, but the organic features are more difficult to isolate in all of the materials. Additionally, in all measurements of the thin films, there appear to be significant oscillations due to the incident light interacting with the films. It is also possible that the measured samples were not in a perfectly pristine state and minor biases could have been introduced by accidental contamination.

In summary, the impacted ITO-coated-polyimide film appeared to have an overall decreased reflectance attributed to the gunpowder soot but was optically flat, which is consistent with the uncoated and unimpacted ITO-coated samples. The VDA-coated sample appears to have the lowest reflectance, decreasing slowly into the infrared regime. Without further inspection, it is not evident that the ITO coating fractured or cracked, as the reflectance did not return to baseline (ITO-coated-polyimide) and consequently, reflectance spectroscopy is limited when additional materials/contamination are present on thin films.
