# ISS EVA 23 Lessons Learned

Date of Mishap: July 16, 2013

**Chris Hansen**, Chairman – Mishap Investigation Board  
Manager, EVA Office, Johnson Space Center

NASA Johnson Space Center, September 26th, 2019

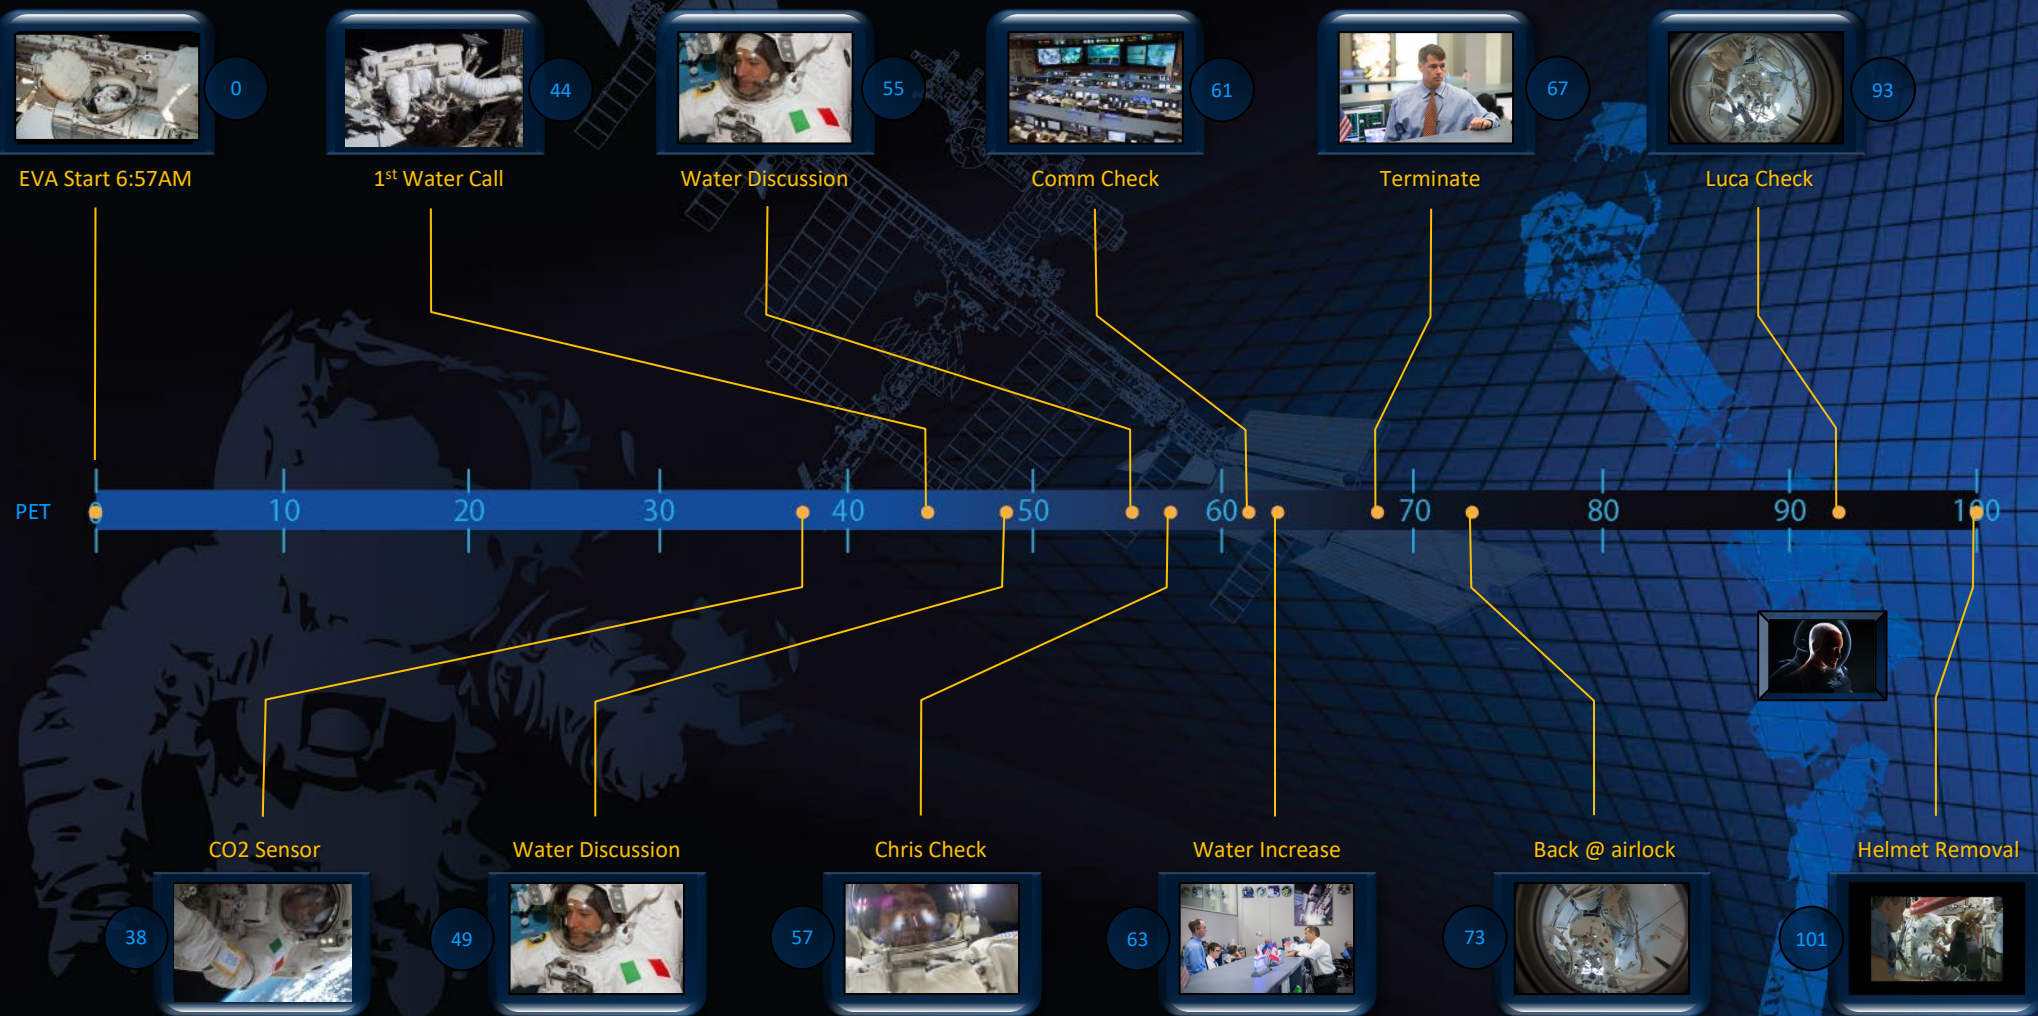
# Timeline

- DATE: July 16, 2013
- TIME: 1241 GMT (0741 CDT)
- LOCATION: Outside ISS, on orbit during US EVA 23
- BRIEF DESCRIPTION:
  - Roughly 44 minutes into EVA 23, ESA Astronaut Luca Parmitano reported water inside his helmet on the back of his head. The EVA ground team, Luca and his spacewalking partner Chris Cassidy were unable to identify the water's source. As they continued to work, the amount of water in Luca's helmet increased and eventually migrated from the back of his head onto his face. EVA 23 was terminated early and the crew safely returned to the Space Station. What started as a normal EVA day on ISS became one of the most serious mishaps in the history of Spacewalking.

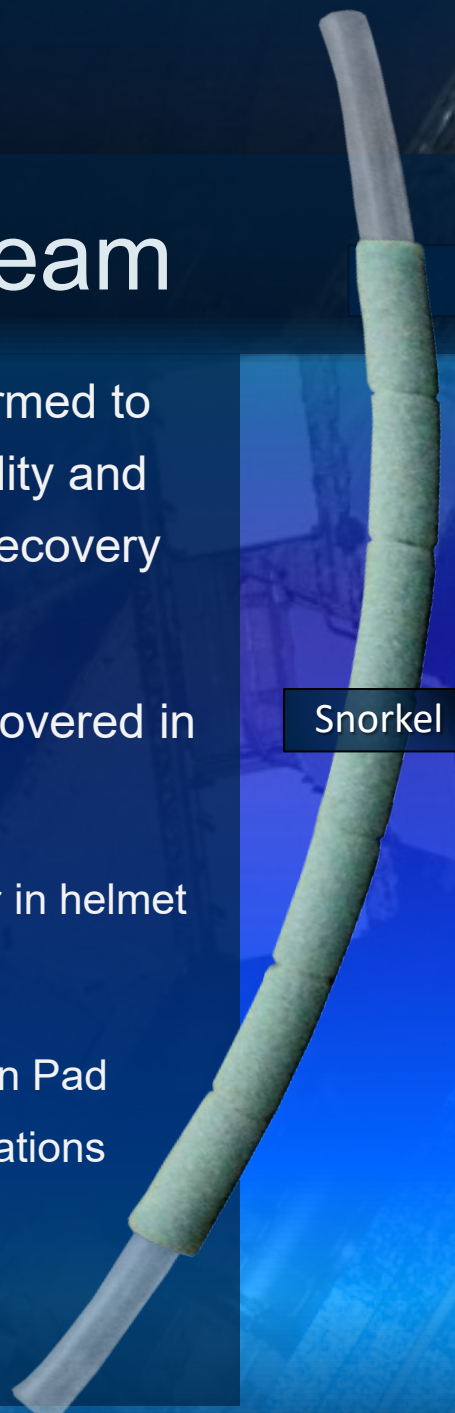
- EVA Recovery Team initially formed to regain contingency EVA capability and later focused on planned EVA recovery and root cause determination
- Contingency EVA capability recovered in September 2014
  - Operational response to water in helmet developed
  - Snorkel and Helmet Absorption Pad (HAP) developed as risk mitigations

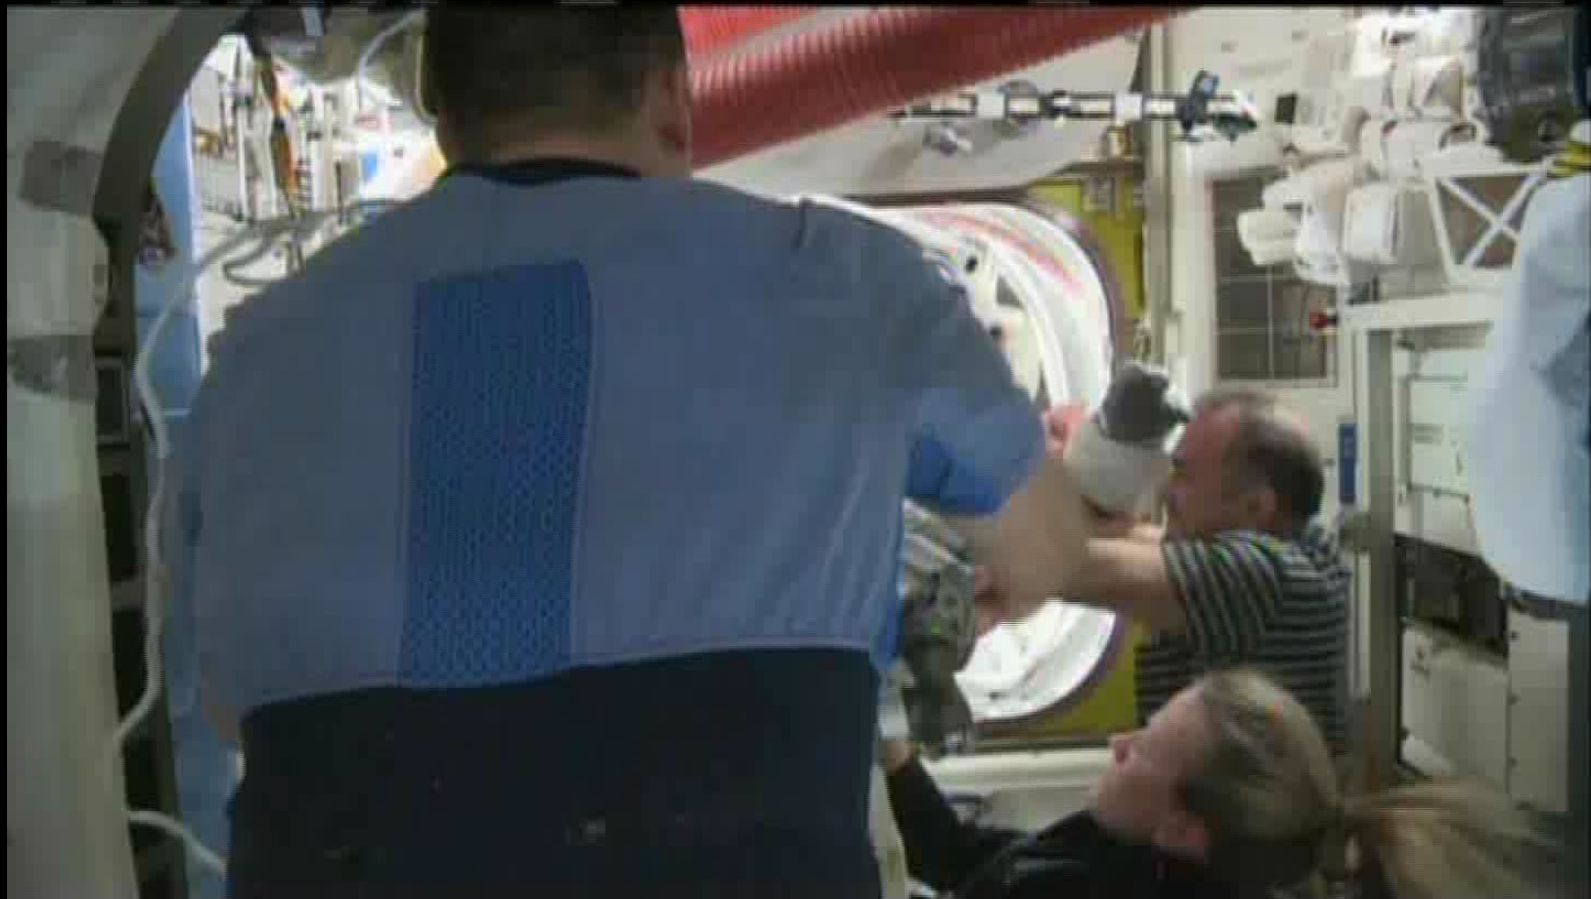
# Helmet Removal

- EVA 22, Luca's first EVA, began with Chris and Luca one week earlier on July 9th, 2014
- The EVA was completed with no issues, however, during repress Luca noticed water in his helmet
- When his helmet was removed, almost ½ liter of water was discovered
- Subsequent conversations led to an assumption that water had leaked from Luca's drink bag during his time in the airlock, so the drink bag was replaced prior to EVA 23
- Later investigation determined that the drink bag was not the source of the water in Luca's helmet, but other possible failures were not investigated, and EVA 23 proceeded on time one week later
