Metal Additive Manufacturing for Rocket Engines: Successes and Failures

Paul Gradl

National Aeronautics and Space Administration (NASA)

21 March 2023

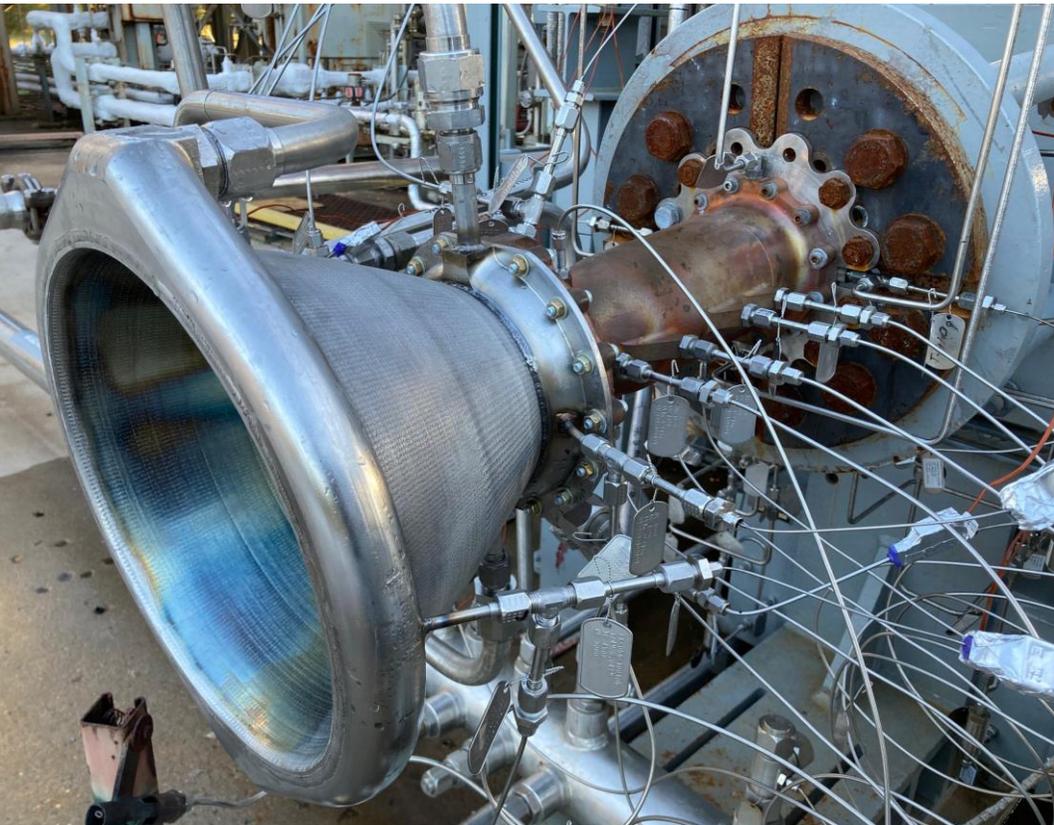
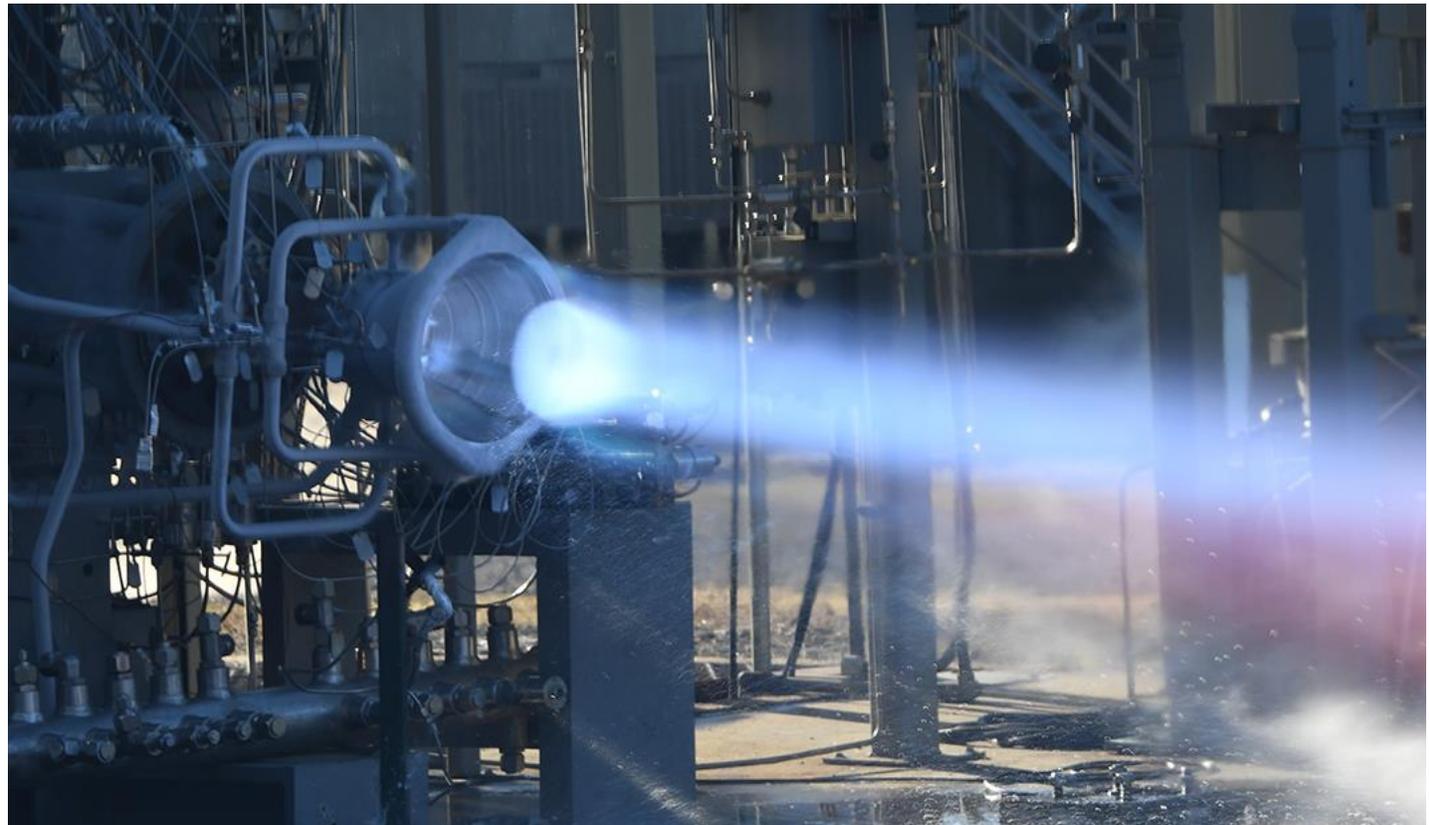
Successful Test of “Sister” Chamber – 51 starts

L-PBF GRCop-42 chamber from same build plate and identical processing successfully tested 51 starts and 1,000 seconds

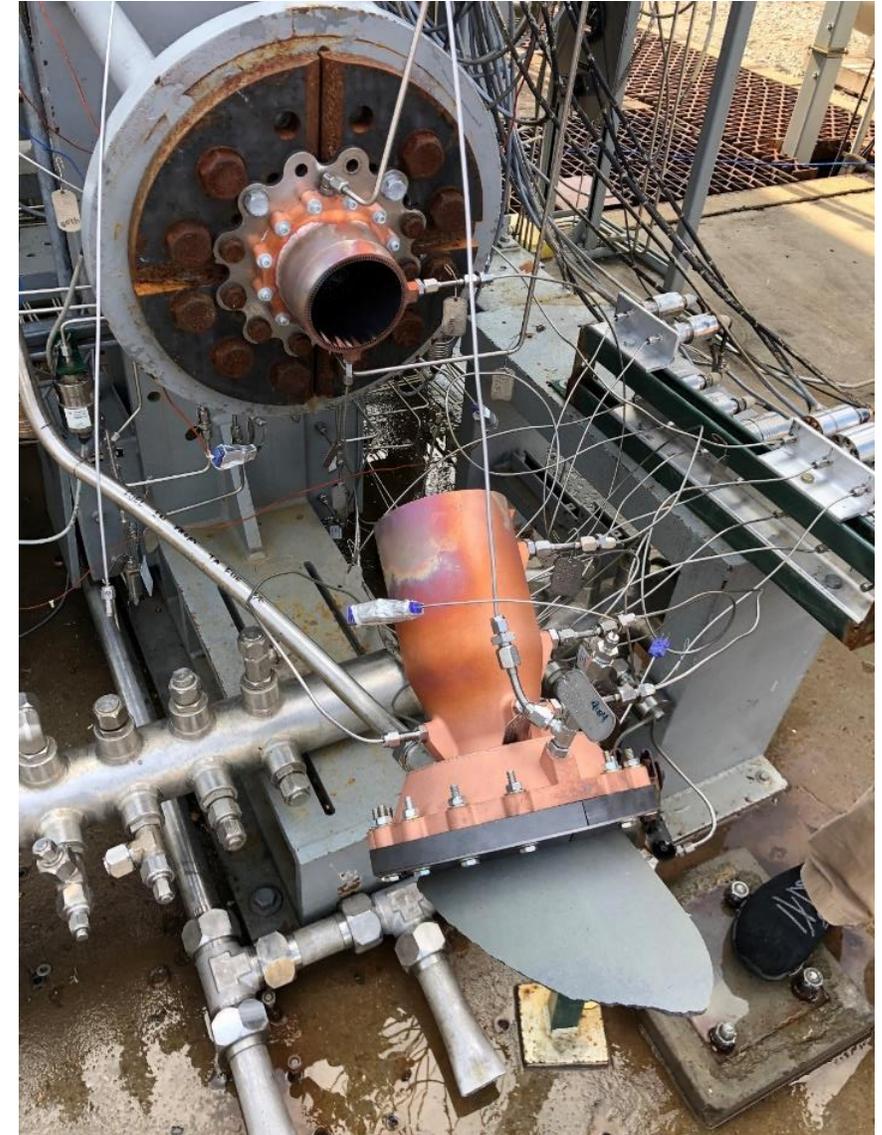
- Tested in early 2021
- Location: MSFC Test Stand 115
- L-PBF GRCop-42 chamber
 - 8 starts and 83.3 seconds total before separation.
 - No issues observed in prior chamber test data.
- Carbon-Composite experimental nozzle
 - Untested and possessed a noticeable crack.
 - Deemed an acceptable risk for test.

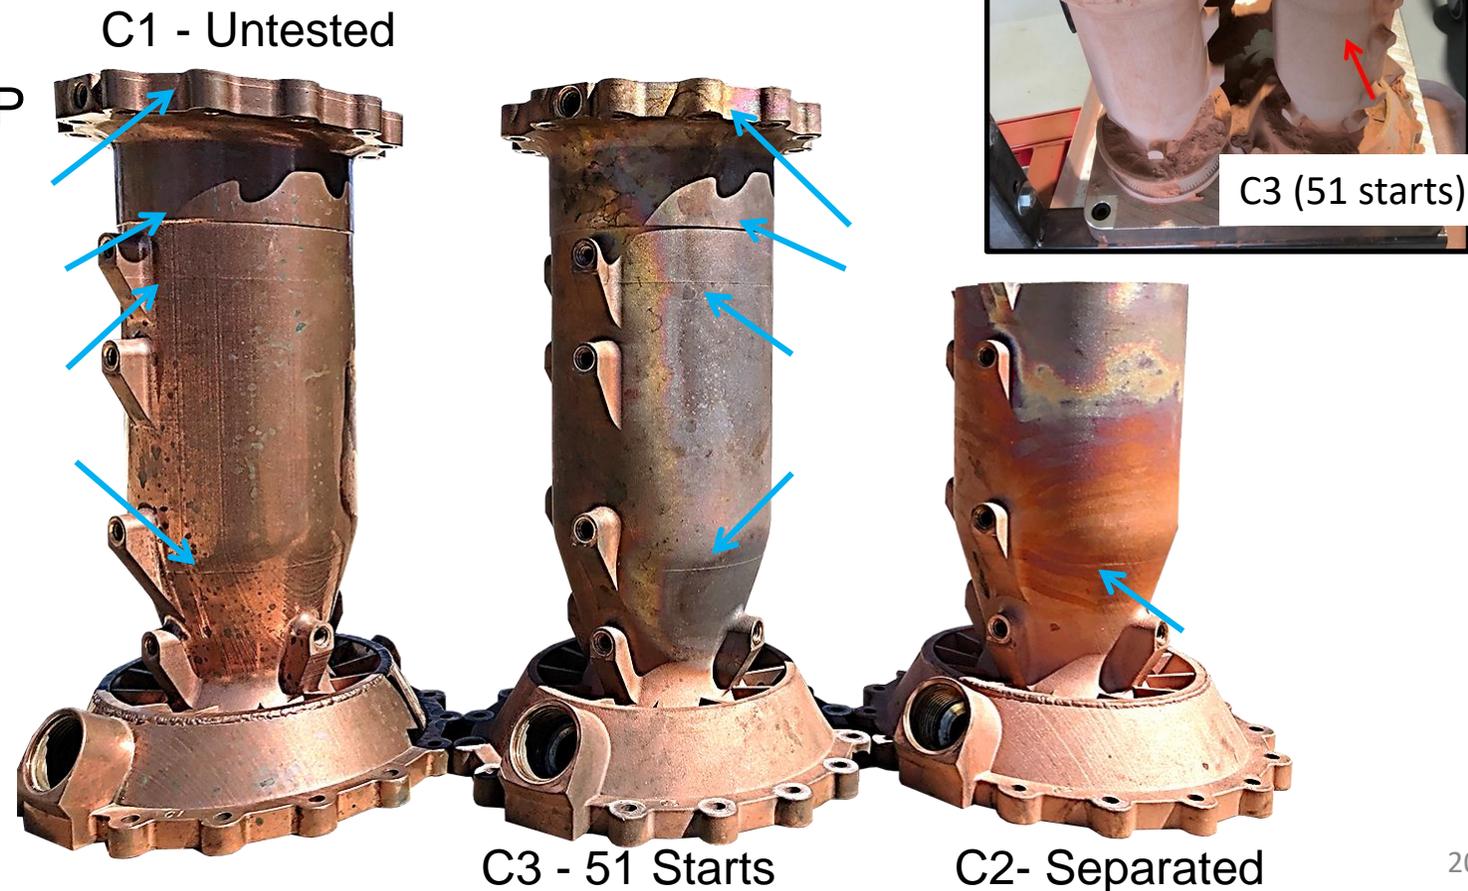
Multiple L-PBF Chambers Built and Tested

- EOS M400 L-PBF printer
 - Certified GRCop-42 powder lot
 - 4 chambers on the build
 - 3 w/ identical designs for LLAMA
- Computed Tomography Scans
 - No observations from data prior to HIP
 - Did not specifically look for witness lines – focused on powder removal verification
- Post-processing
 - C1 – HIP, EB weld manifold, exterior polishing
 - C2 – HIP, EB weld manifold
 - C3 – HIP, EB weld manifold, chemically milled

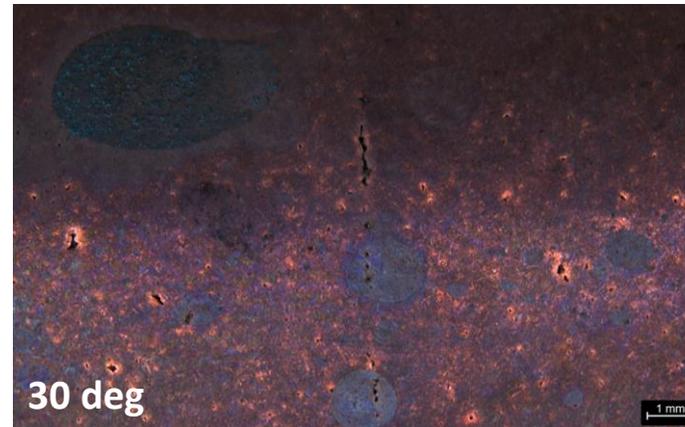
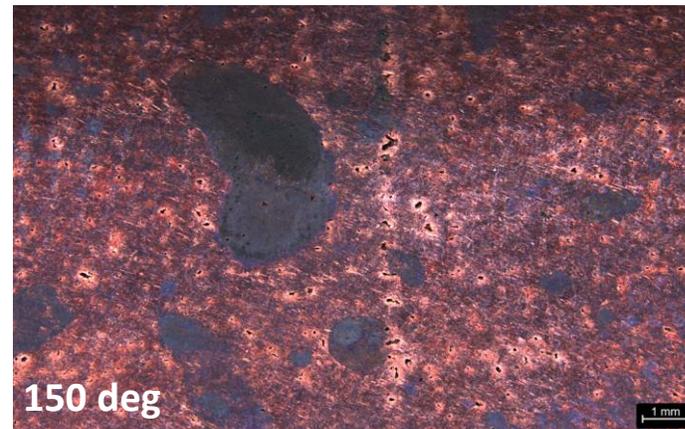
Middle witness line: C1 (untested)
Surface was polished using CMP

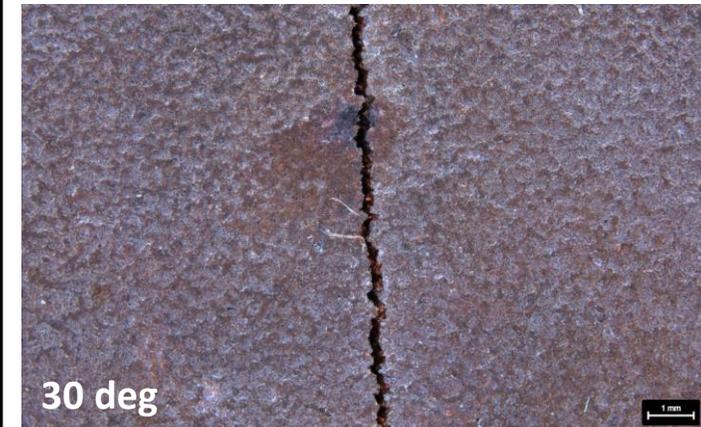
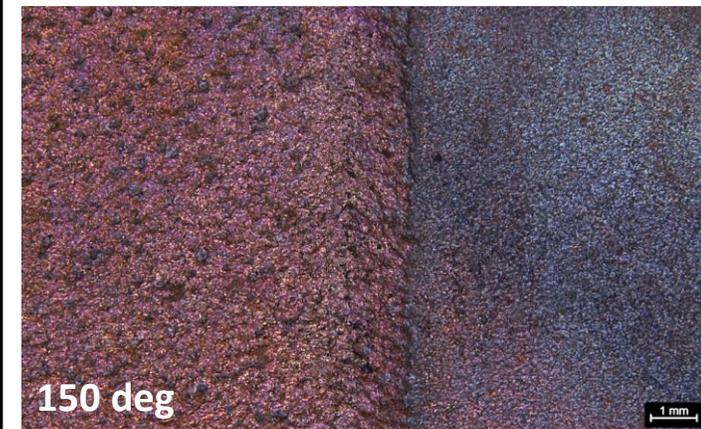
- Unpolished external surfaces.
- Top (power outage) and bottom (powder overflow) witness lines did not appear to have many detrimental defects.
- Middle witness line on chamber 1, there were some large lack of fusion defects that appeared to line up with the restart line.
- Chamber 3 – no defects visible at the surface beyond the crack that had already developed after test.

Middle witness line: C3 (51 starts)

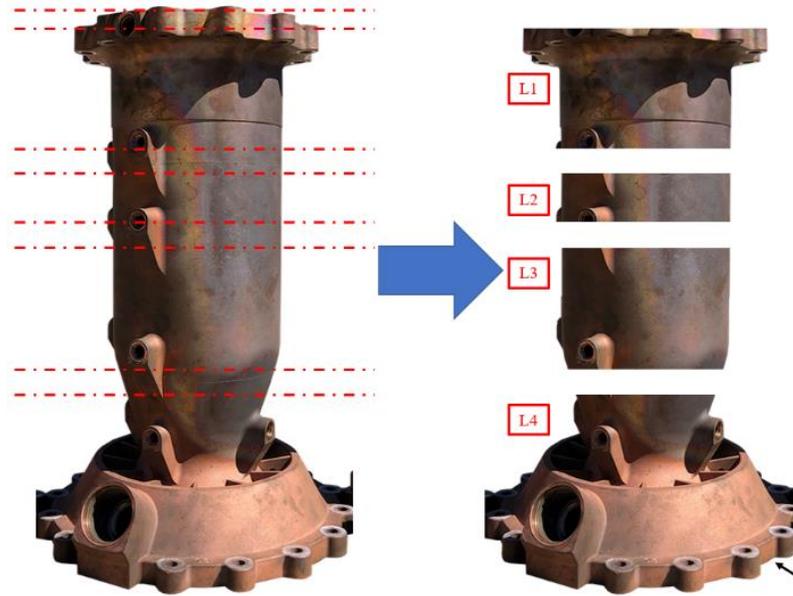
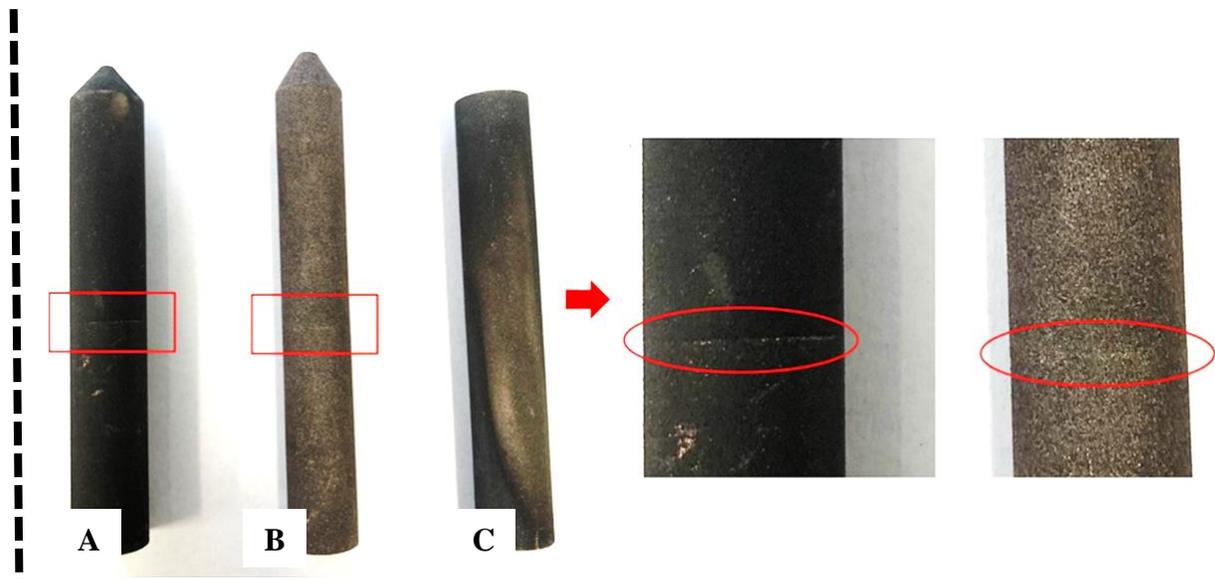
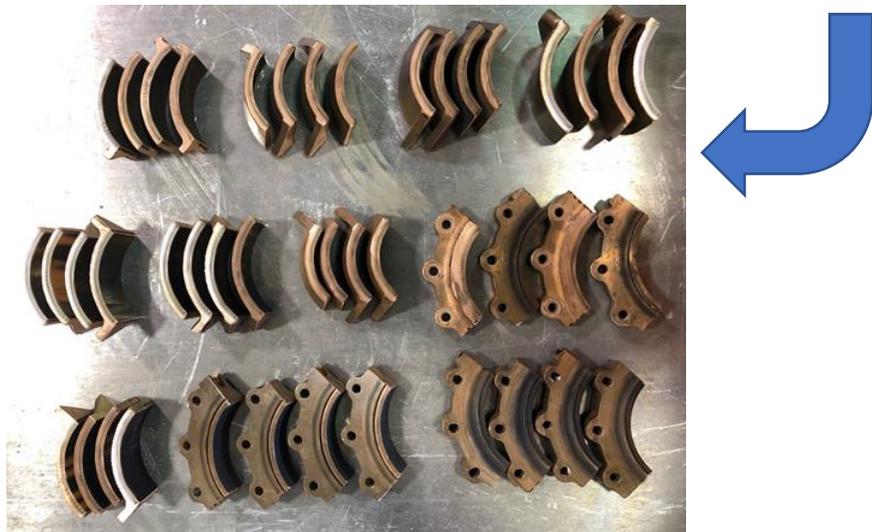
Test Specimens: Chamber Sectioning, Test Bars

Bar	Chamber Restart Replicated	Witness Line Replicated	Restart
A	None	Control Section	None
B	Empty Overflow	Middle and Lower	Chamber Open
C	Power Outage	Upper	Chamber Closed

Label	Section	Porosity
A	Upper Witness Line	0.748%
B	Middle Witness Line	1.906%
C	Control Section	0.511%
D	Lower Witness Line	1.743%
E	Tensile Bar	0.006%

- Samples taken from un-tested chamber (C1).
- Tensile bar built separately as part of investigation.
- Proper HIP of chambers was confirmed.
- Porosity is evident throughout samples.
- Clear congregation of porosity around witness lines.
- Porosity reduces load bearing capacity (reduced area) and can act as stress concentrators/crack initiators.

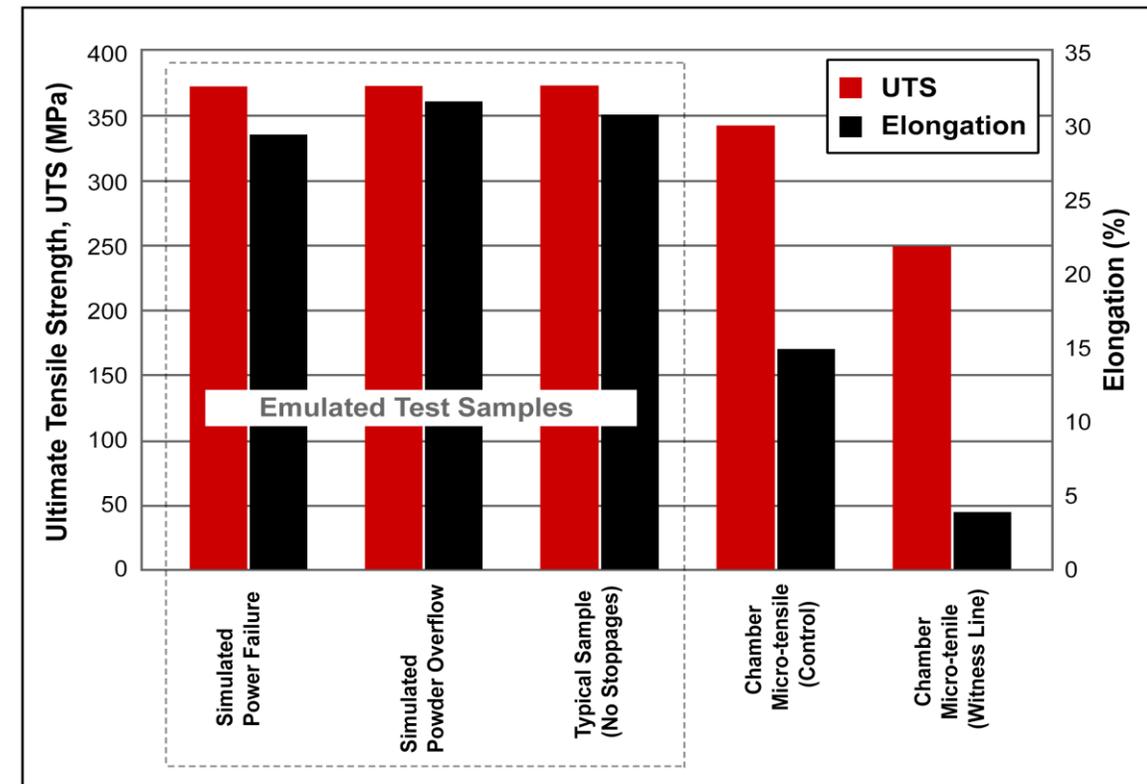
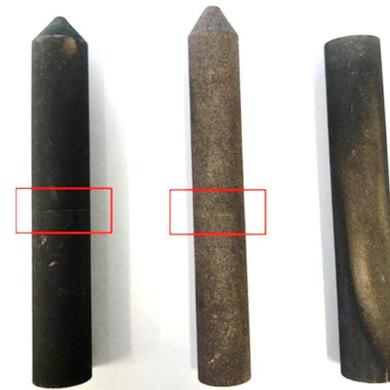
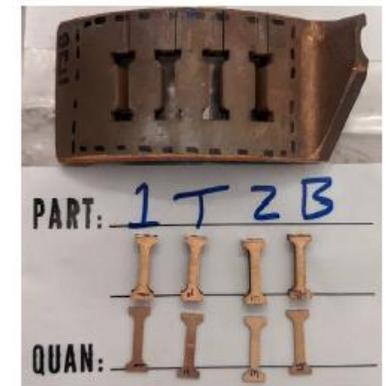
Combined Microtensile & Tensile Results

- Room temp tensile testing conducted on ASTM E8 specimens (0.25" dia gage) from witness bars with various restarts
 - Testing at 1200F for ASTM E8 round bars showed similar trends
 - Fracture surfaces appeared similar
- Microtensile testing conducted at room temp on section from chamber (C1 and C3) at witness line and non-witness

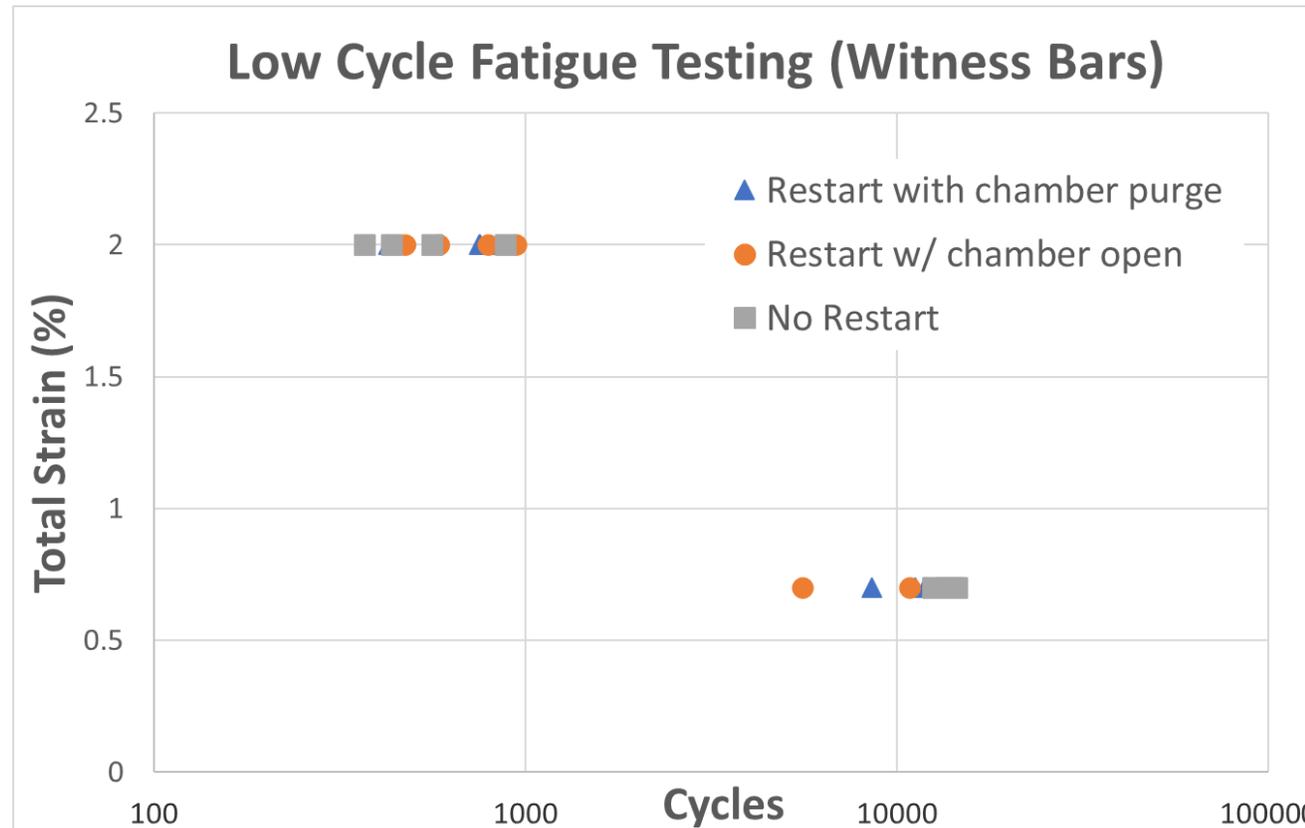
Low Cycle Fatigue of Post-build Witness Specimens

- LCF conducted at room temperature, total strain of 0.7% and 2%
- R = -1, triangular

Restart w/purge	Restart, open	No restart
2%, Avg	785	781	562
St Dev	175	182	228
0.7%, Avg	12171	10677	13669
St Dev	1657	3582	849

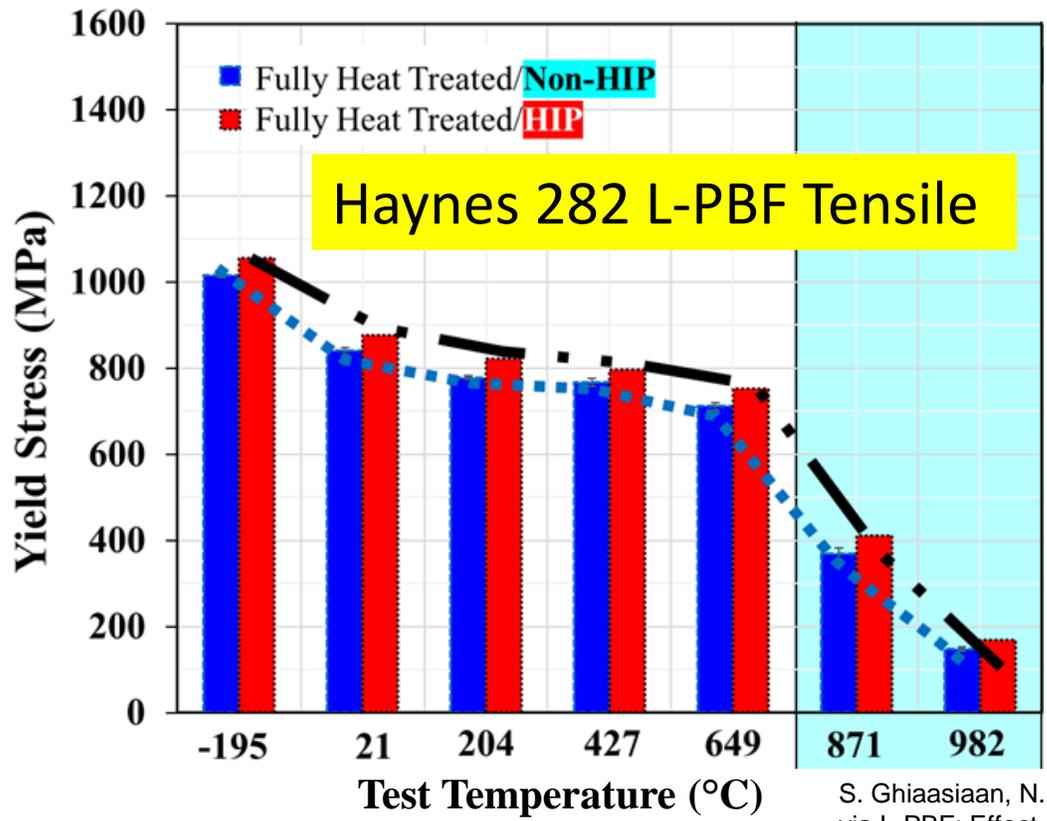
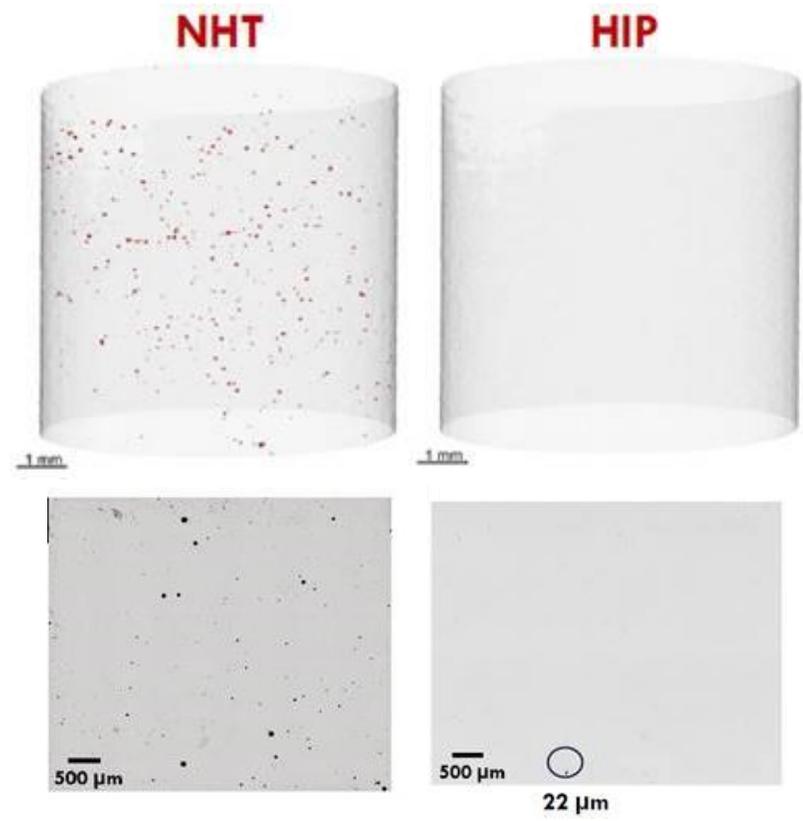
- NASA has baselined HIP for data generation (per NASA 6030).
- HIP does add process time and cost but can improve performance of alloys for tensile and fatigue based on comparison studies.

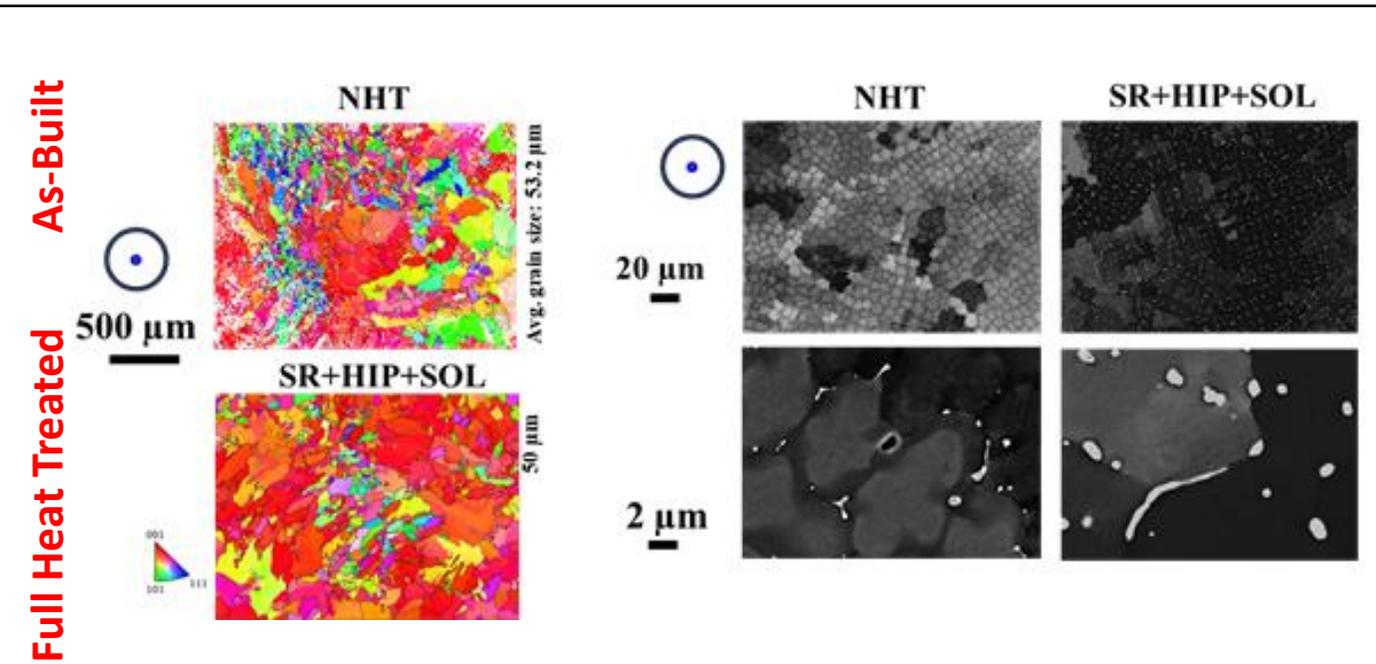
Procedure (Designation)	Temperature (°C)	Time (hrs)	Cooling
Stress Relief (SR)	1066	1.5	Furnace cool
HIP [2]	1163/103 MPa	3	Furnace cool
Solution Annealing (SOL)	1177	3	Argon quench

[2] HIP per ASTM F3301
