# Space Environmental Damage Assessment on Sail/Deorbit Materials in Low Earth Orbit

The 6<sup>th</sup> International Symposium on Space Sailing, June 8, 2023, New York, NY

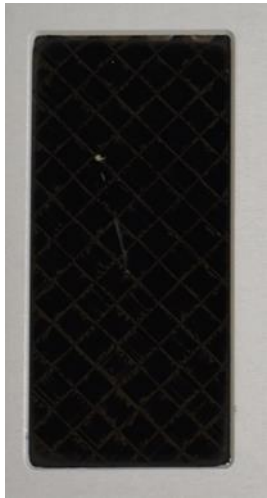
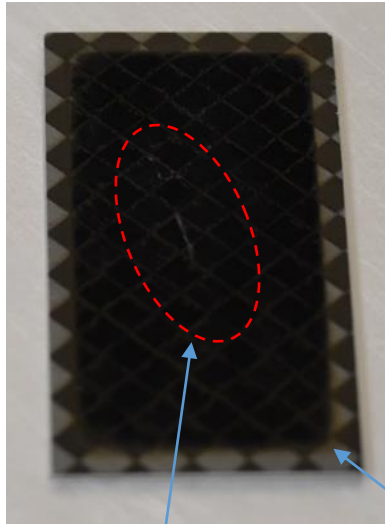
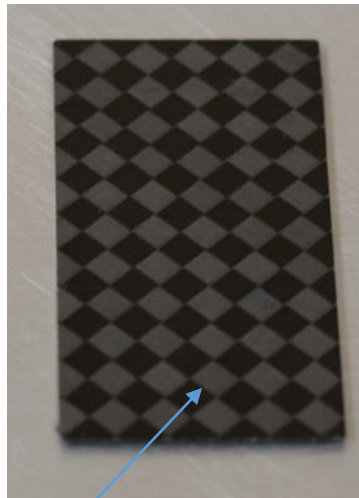
# Post-Flight Image [Epoxy PMT F7/M30S-1 (M14-BK-R10), Ram]

Exposed surface was  
eroded and became matte

Edge and 2<sup>nd</sup> layer  
kept shiny surface

*Significant erosion on the sample surface was found after total 133 days exposure in Ram direction. MMOD suspected impact damage was found.*

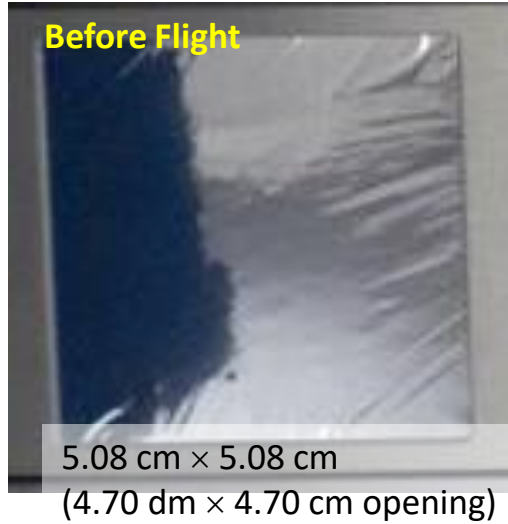
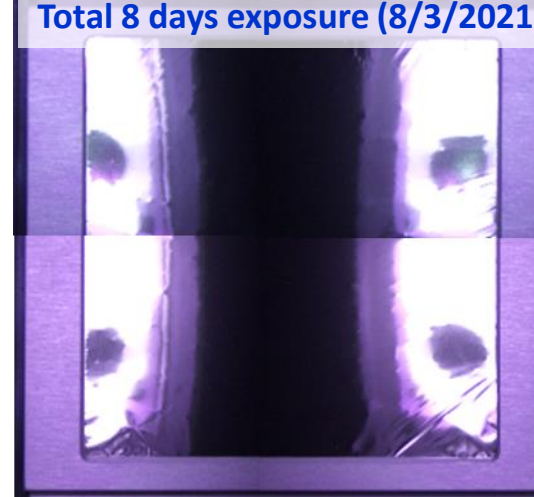
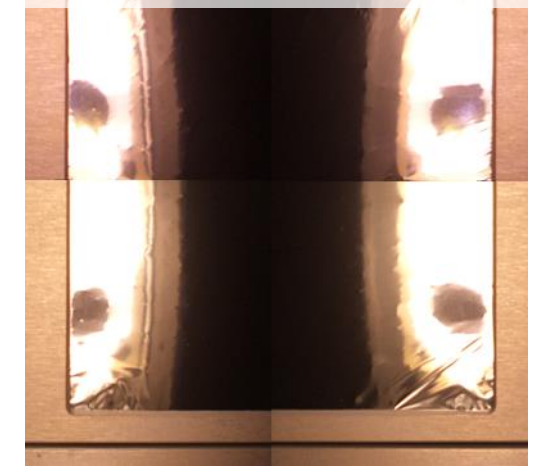
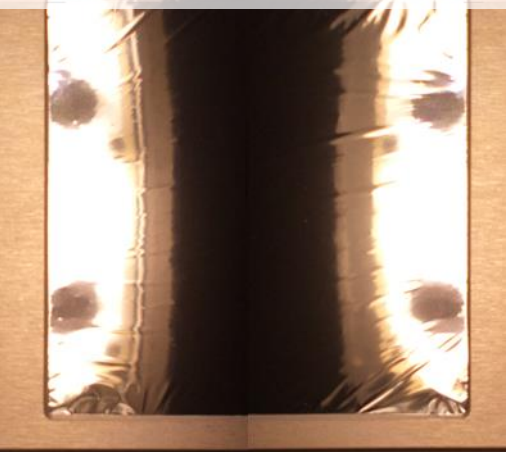
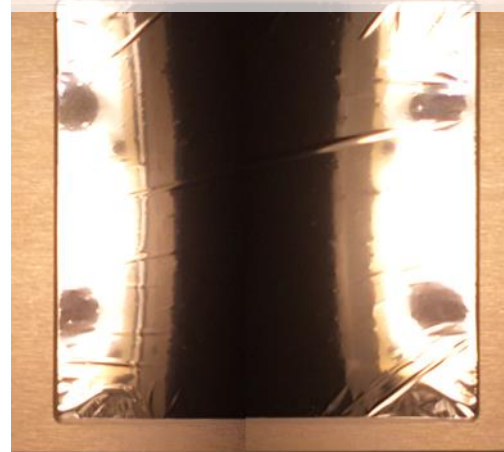
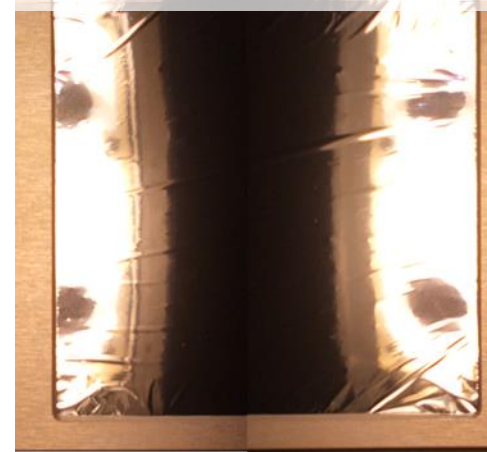
# In-Flight Image [Al-Met PEN (M14-BK-R7), Ram]

No significant change except some wrinkles was found after total 133 days exposure in Ram direction. Sample was shrunk and taut

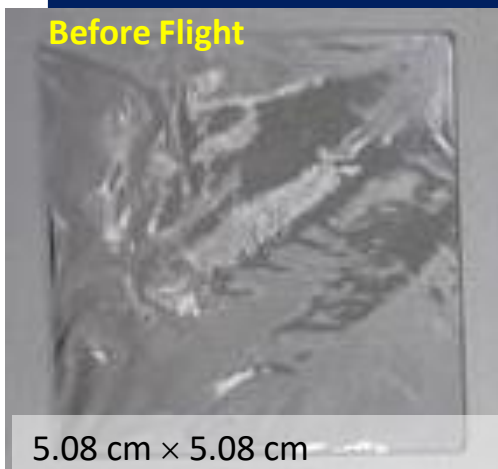
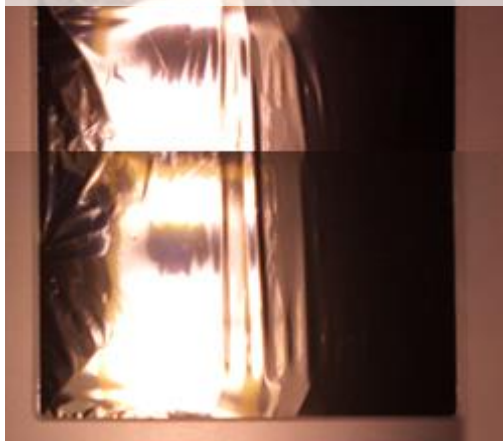
# In-Flight Image [Al-Met PEN (M14-BK-Z3), Zenith]

*Significant change in wrinkle was found after total 15 days exposure in Zenith direction. Sample was shrunk and taut.*

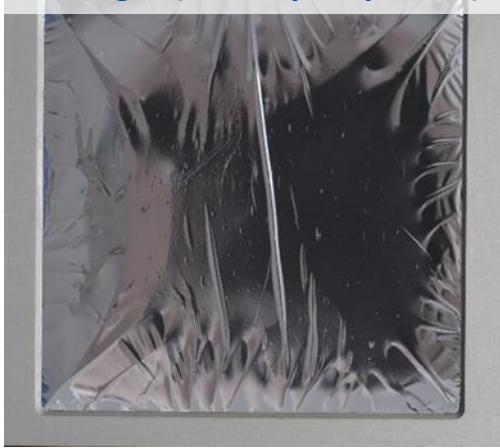
Post Flight (149 days exposure)

*No visible change on the first layer (direct exposure to space) but visible foggy (diffuse reflective) mark on the second layer and reduction in reflectance was found*

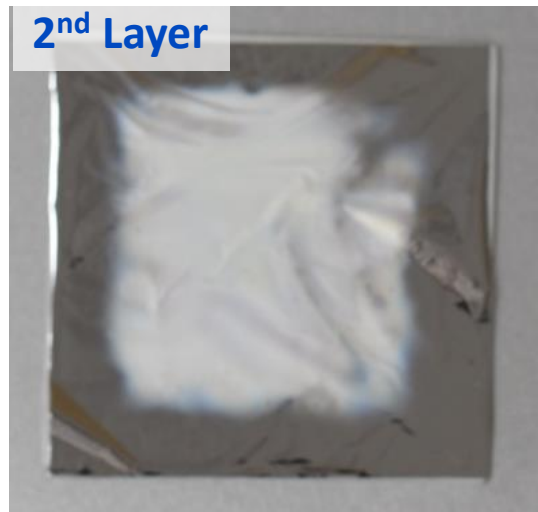
2<sup>nd</sup> Layer

*Hydrogen blistering  
by solar particles  
(proton radiation)?*

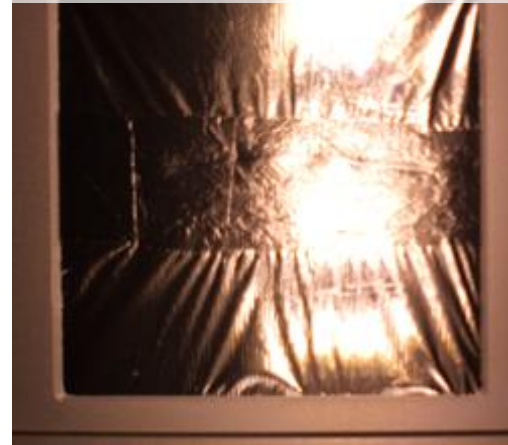
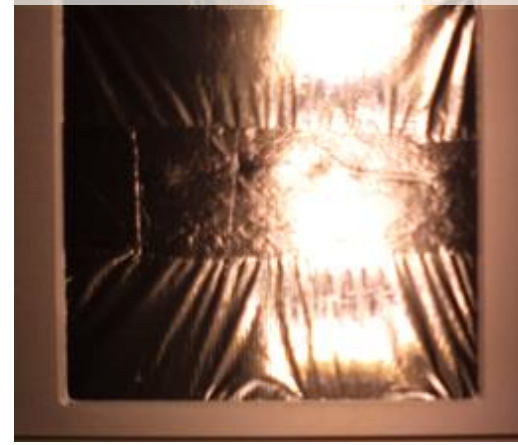
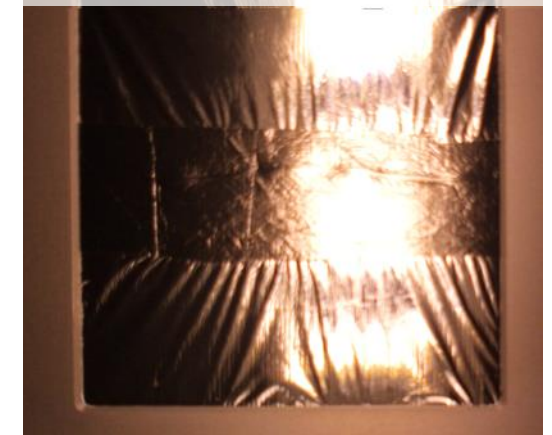
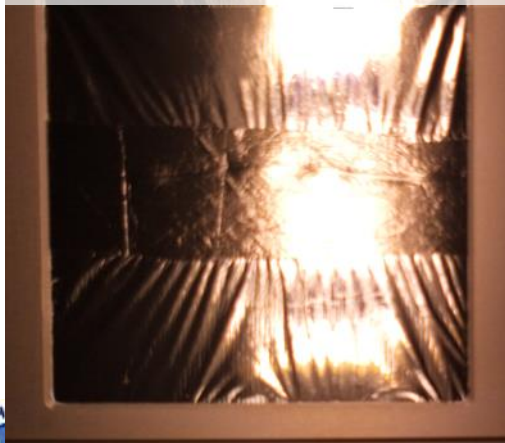
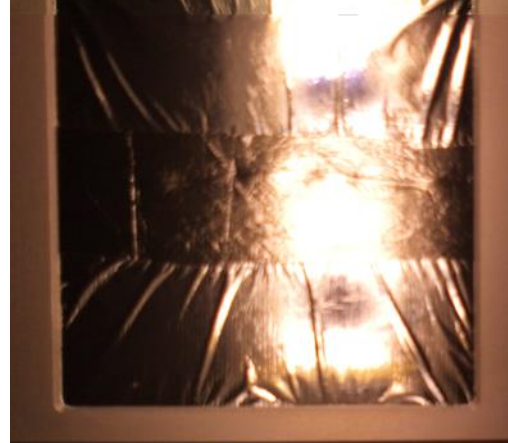
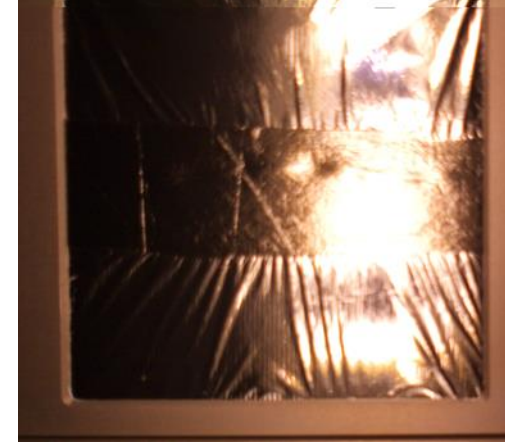
*Significant change in wrinkle was found after total 15 days exposure in Zenith direction. Sample was shrunk and taut, but no visible delamination/bubbles on the seamed joint was found.*

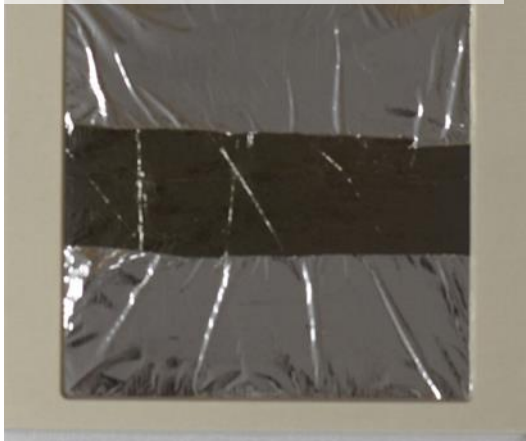
Post Flight (149 days exposure)

*No visible change in reflectiveness on the first layer (direct exposure to space) but some foggy (diffuse reflective) mark on the second layer was found.*

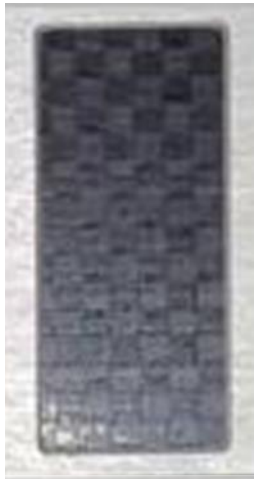
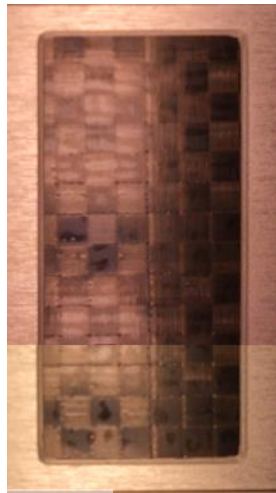
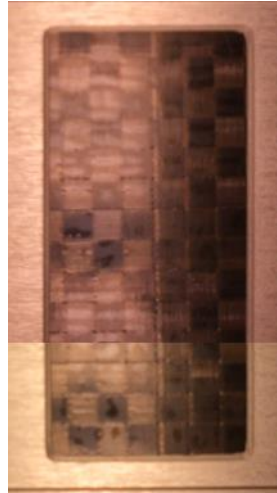
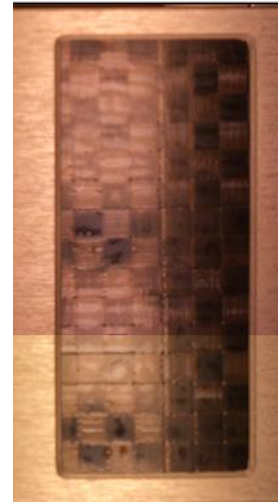
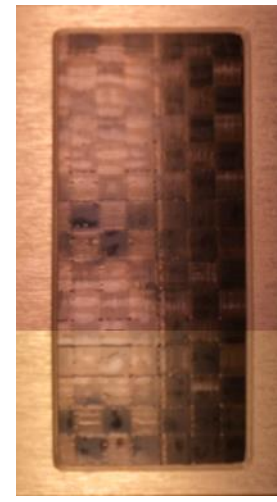
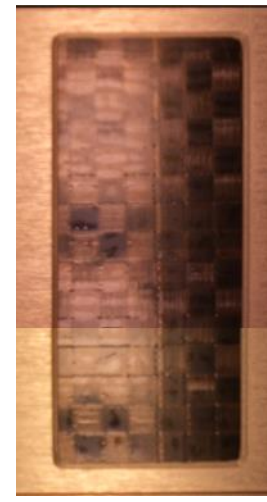
*No significant change was found after total 149 days exposure in Zenith direction.*

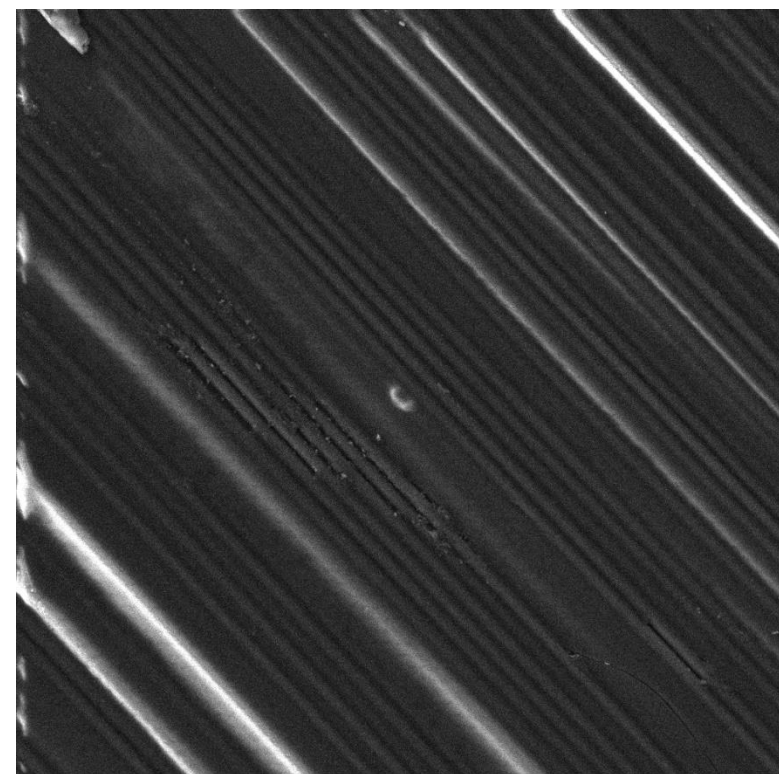
Post-Flight: Zenith

*Dried carbon fiber (CF) morphology was found with Ram sample*

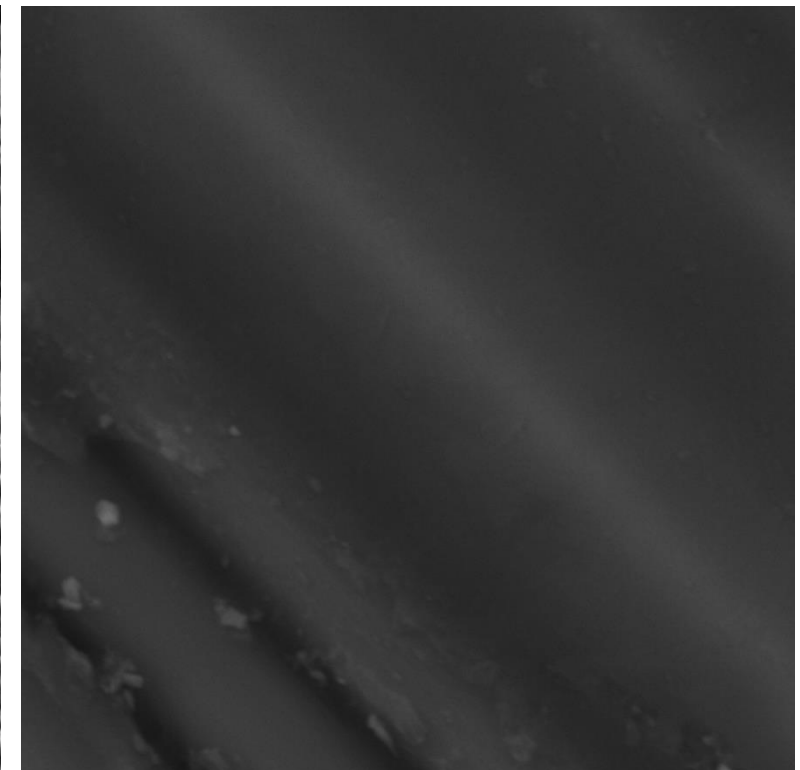
**Post-Flight: Zenith**

*Severe erosion on CF surface was found with Ram sample*

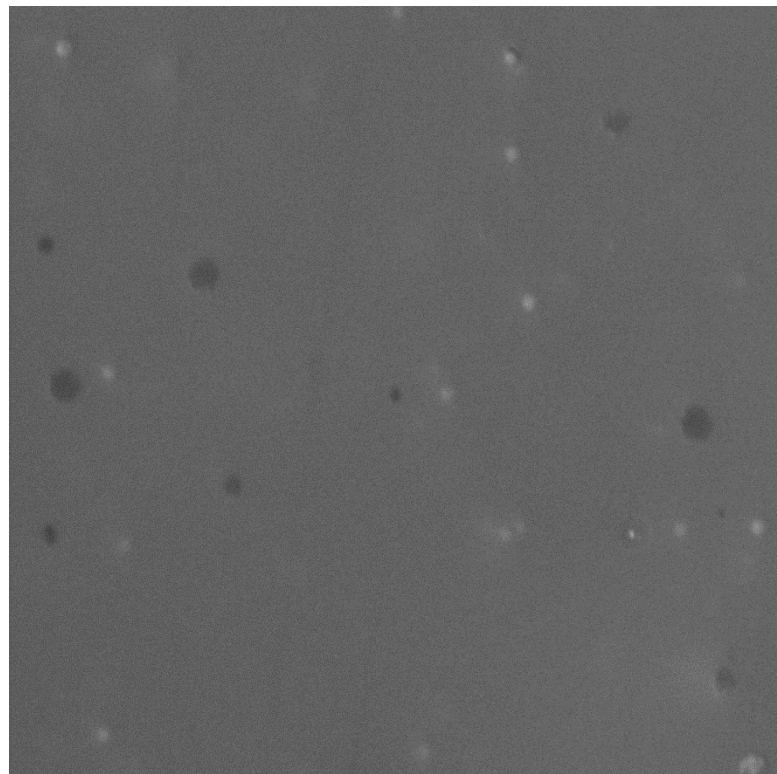
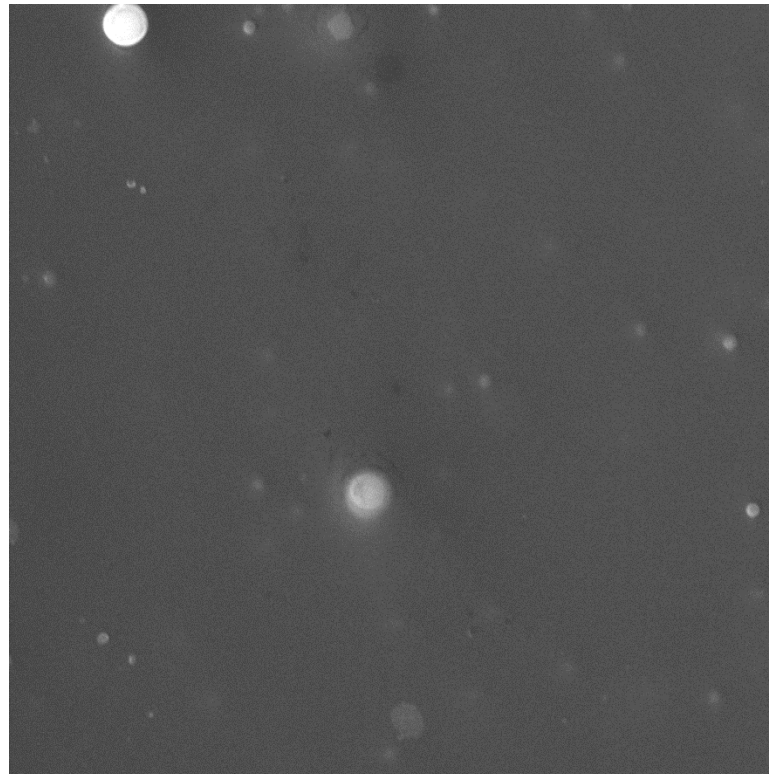
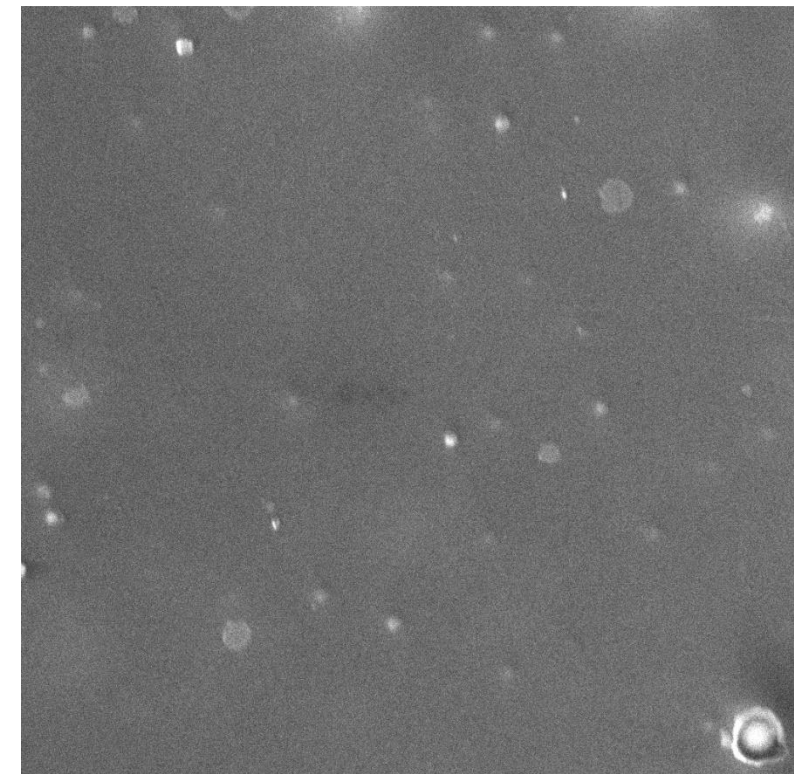
*No significant difference of 1<sup>st</sup> layer samples was found*

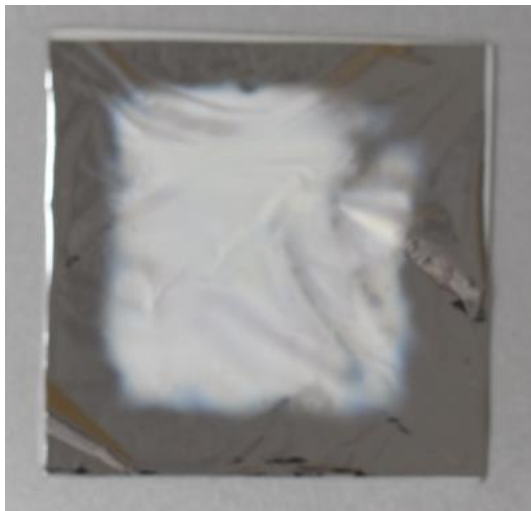
Post-Flight: Zenith

Hydrogen Blistering on Aluminum layer of Metallized PEN film by proton radiation

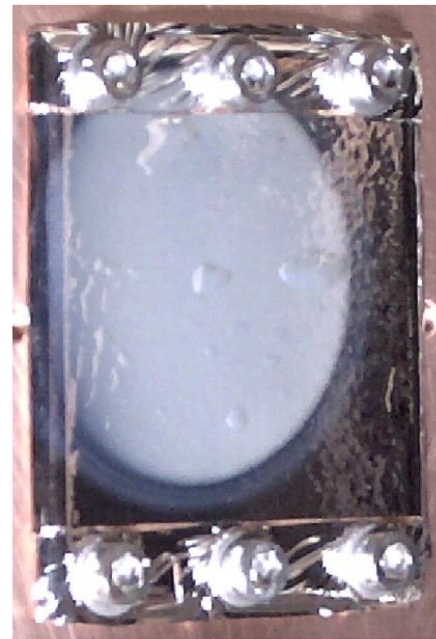
Foggy diffusive reflection of the 2<sup>nd</sup> layer of Met PEN on Zenith is similar to the hydrogen blistering by proton radiation (<2.5 keV)

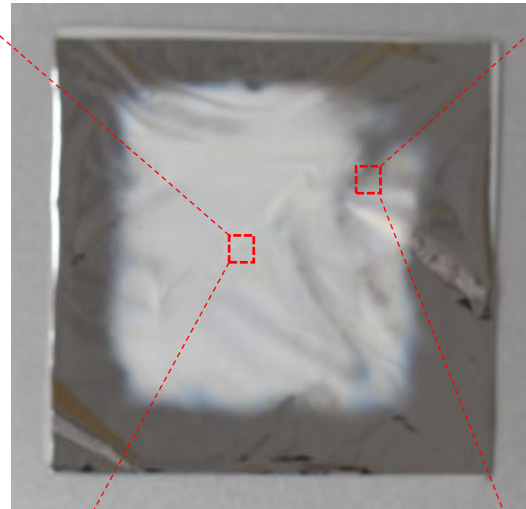
1<sup>st</sup> Layer (space exposed)  
PET (12.7μm) liner  
2<sup>nd</sup> Layer

Polyethyleneterephthalate (PET) liner might work as a proton moderator to create hydrogen blistering

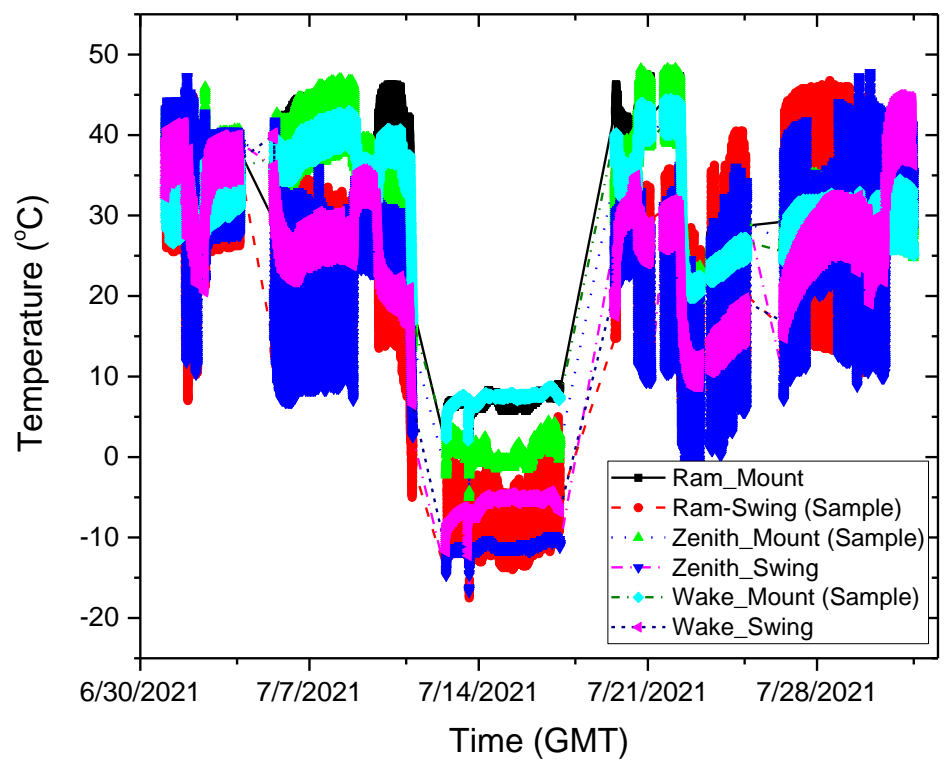
*The temperature of MSC varied from about -17°C to 47°C in July, and was greatly affected by the ISS attitude/orbit adjustment.*

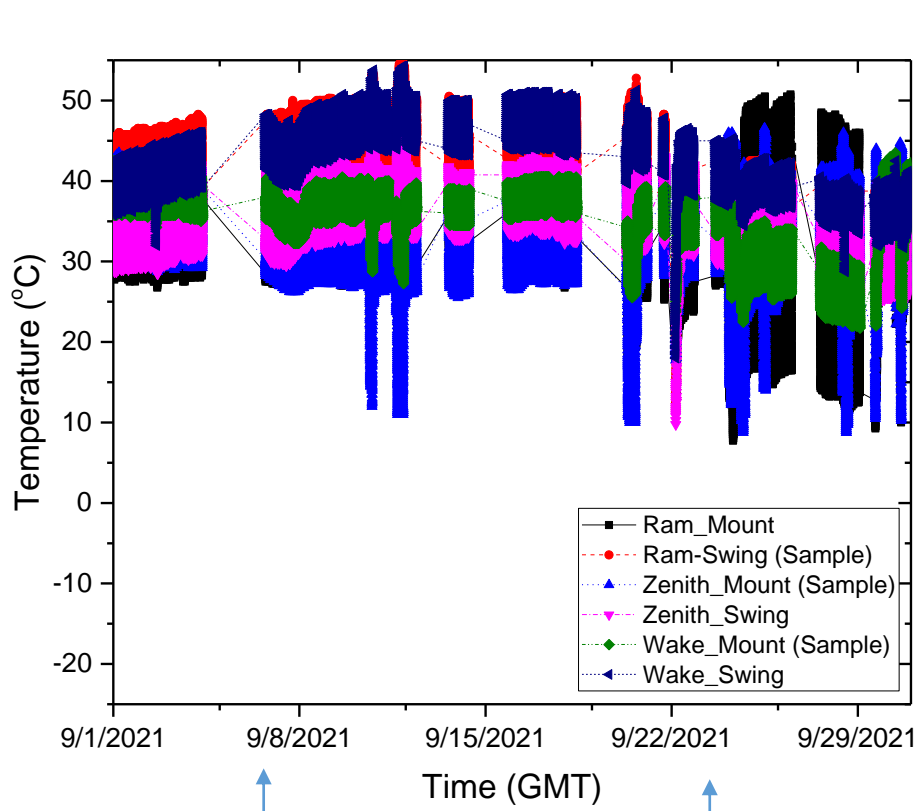
3<sup>rd</sup> Photo (Wake, 9/7)      3<sup>rd</sup> Photo (Zenith, 9/13)      3<sup>rd</sup> Photo (Ram, 9/23)

*The temperature of MSC varied from about 8°C to 54°C in September.*

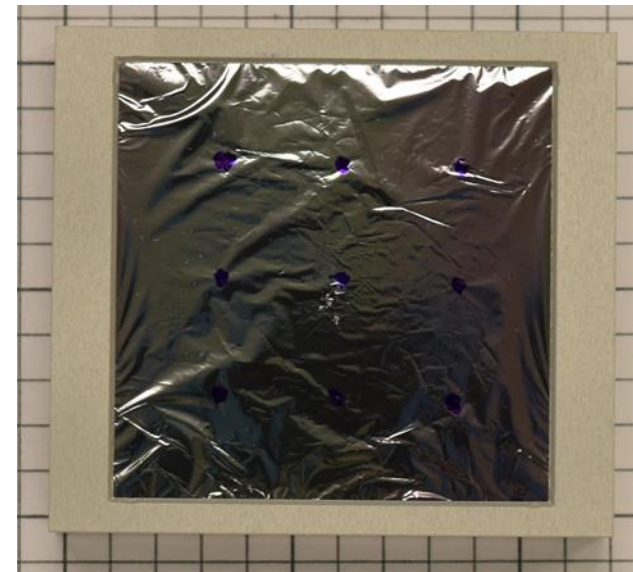
80°C, 5 days

*No significant change*

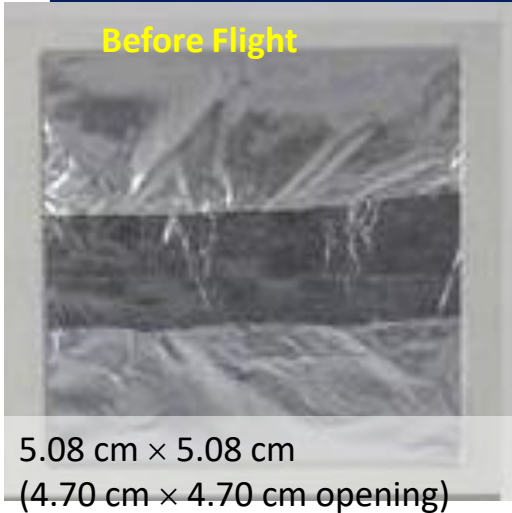
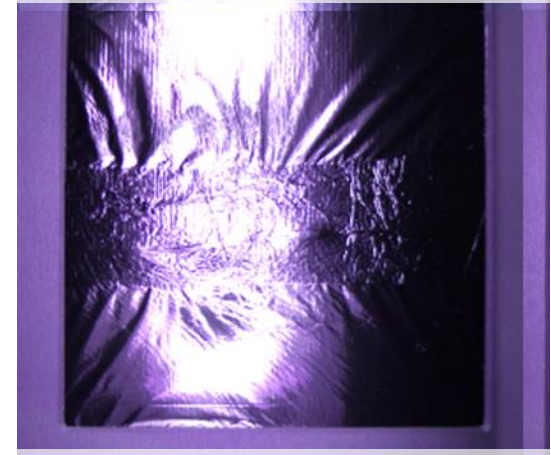
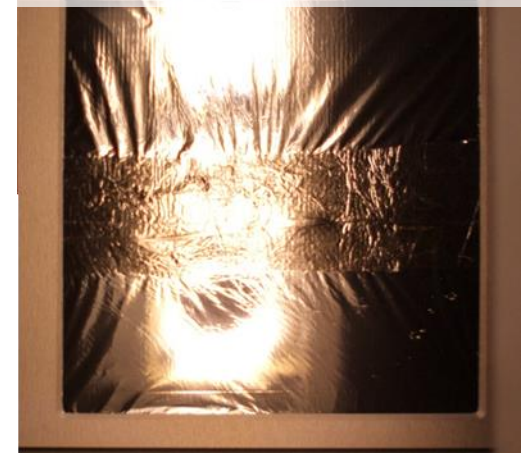
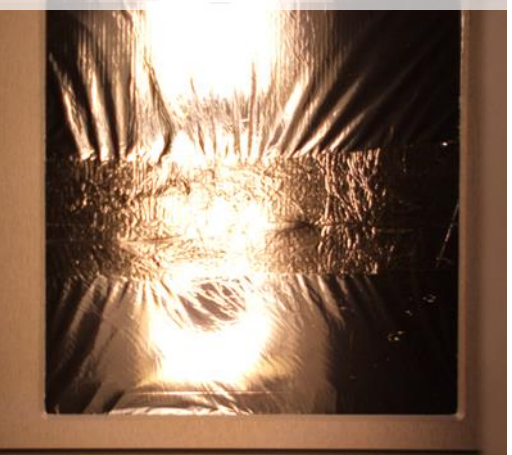
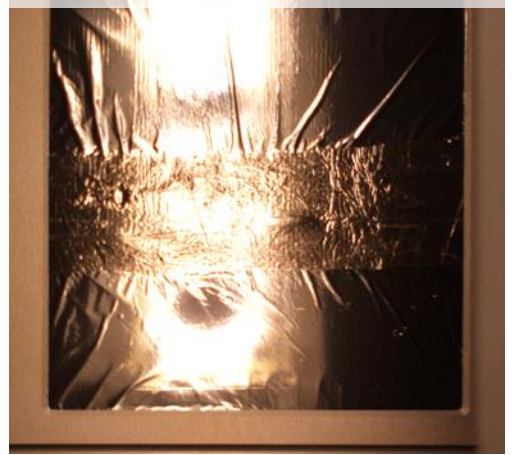
# In-Flight Image [Seamed Met PEN (M14-BK-R9), Ram]

*No significant change was found after total 133 days exposure in Ram direction. Sample was slightly shrunk and taut.*

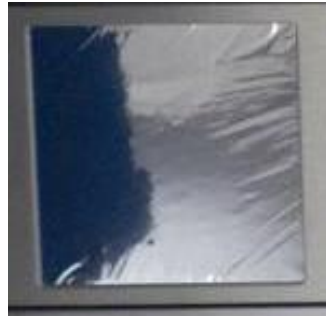
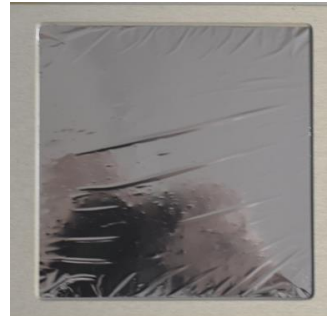
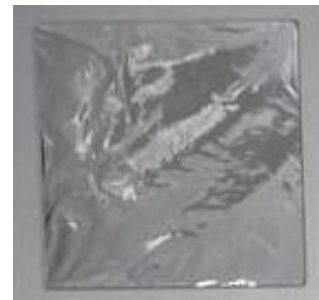
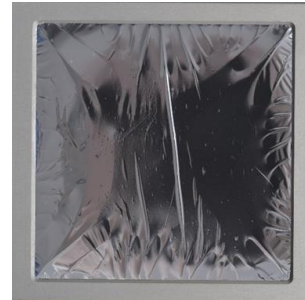
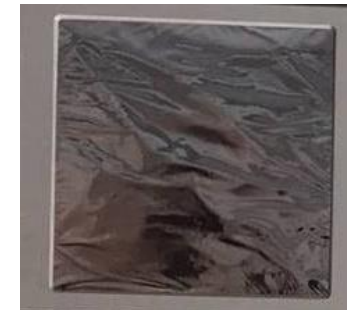
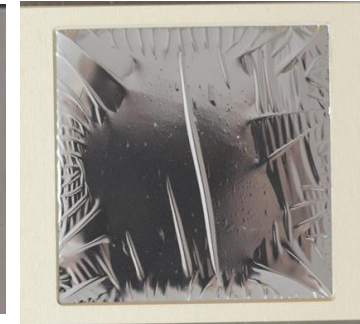
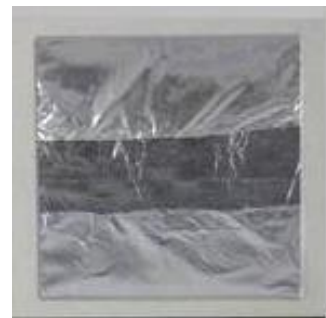
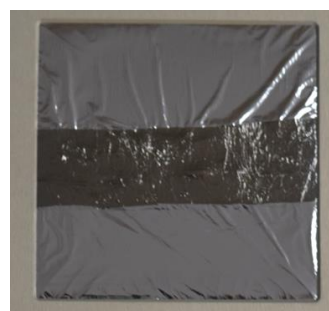
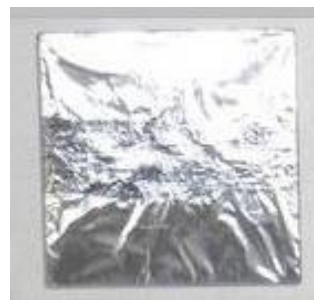
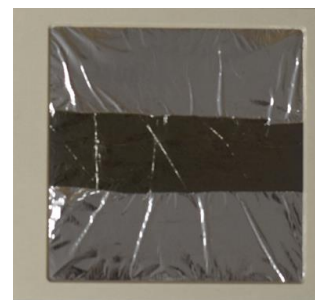
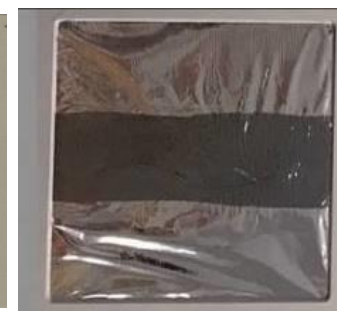
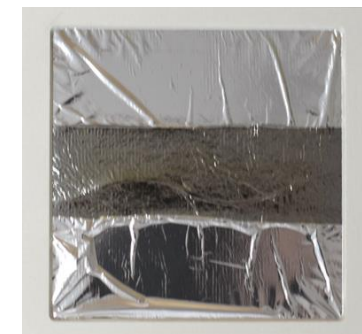
# Sail Membrane Image Highlights

*Samples look shrunk and taut. No delamination in the seamed joint was found*

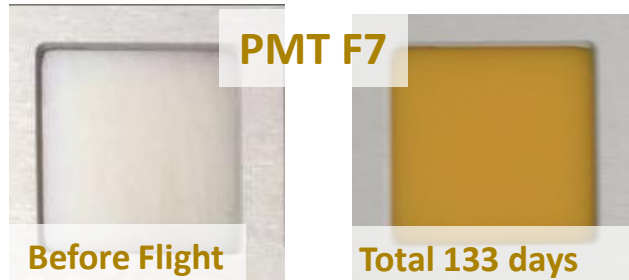
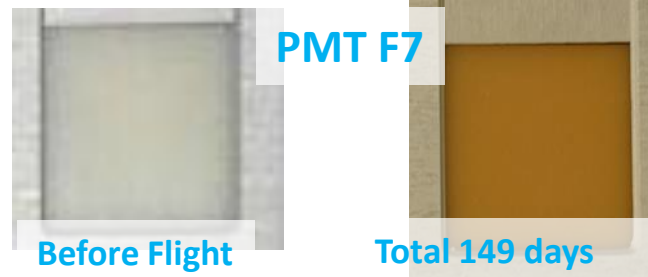
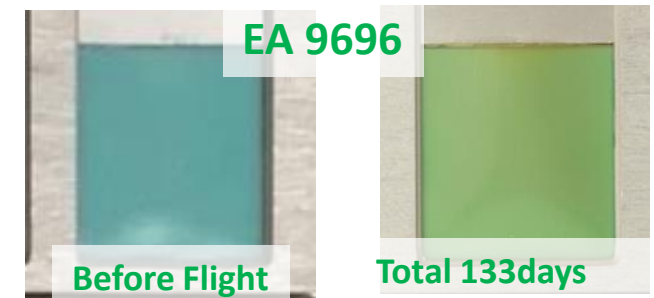
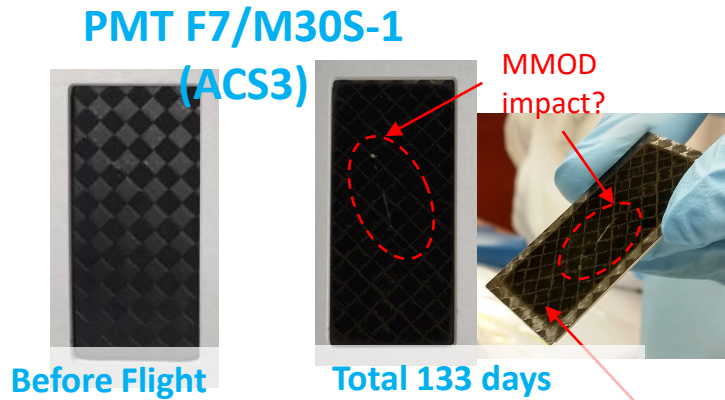
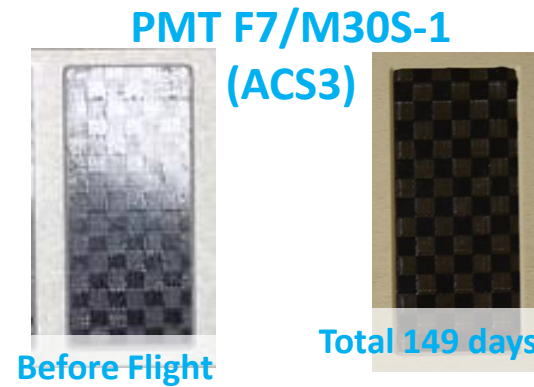
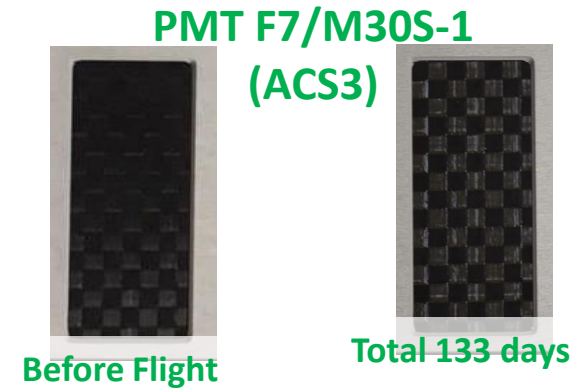
Ram samples were eroded significantly
