Thermochemical/Thermomechanical Synergies in High Temperature Particle Erosion of CMAS Exposed EBCs

Jamesa L. Stokes¹, Michael J. Presby¹, Rebekah I. Webster¹,
John A. Setlock², Bryan J. Harder¹

¹NASA Glenn Research Center

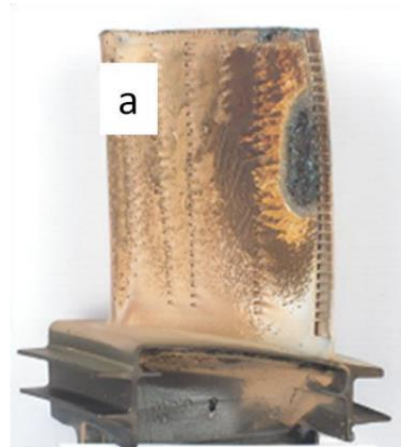
Damage on a turbine blade caused by CMAS >1200°C

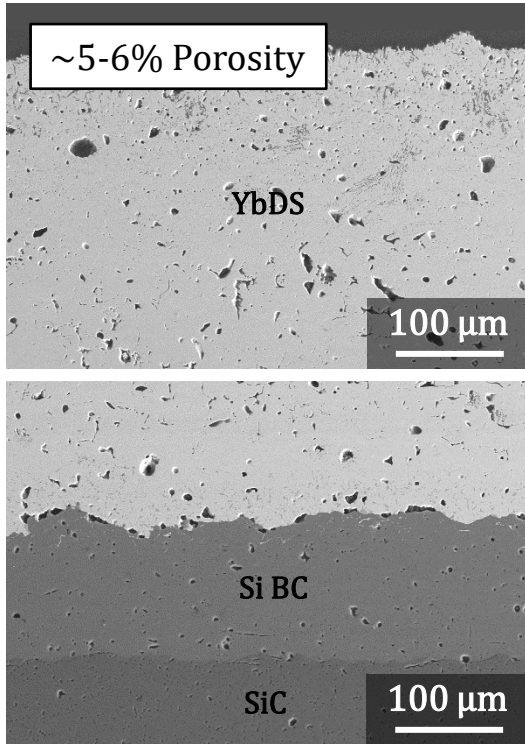
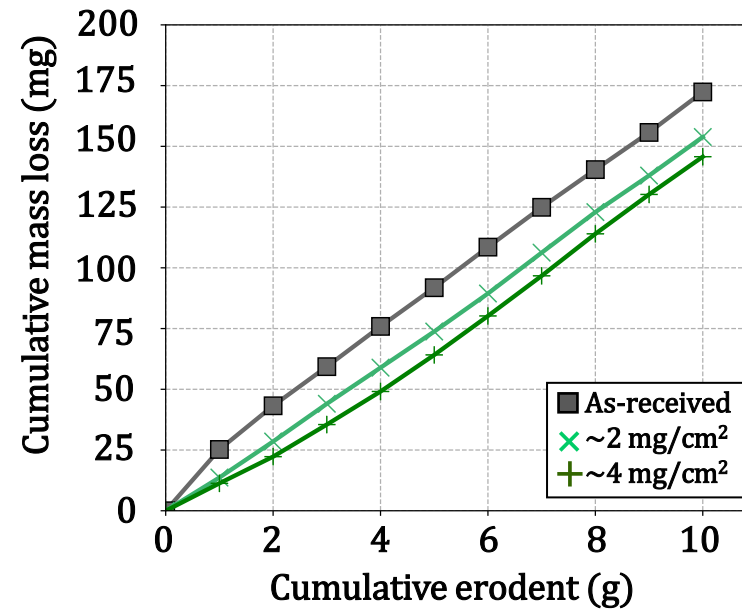
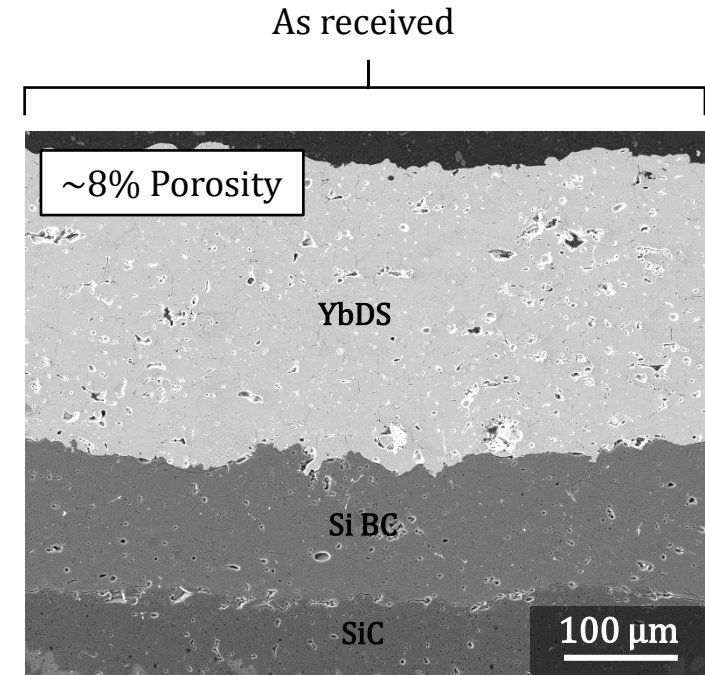
As received 16.34 mg/g
 $\sim 2 \text{ mg/cm}^2$ 16.08 mg/g
 $\sim 4 \text{ mg/cm}^2$ 16.43 mg/g

- Increased loading resulted in slight cumulative mass loss decrease across the entire erosion test.
- Fairly linear behavior throughout the entire test

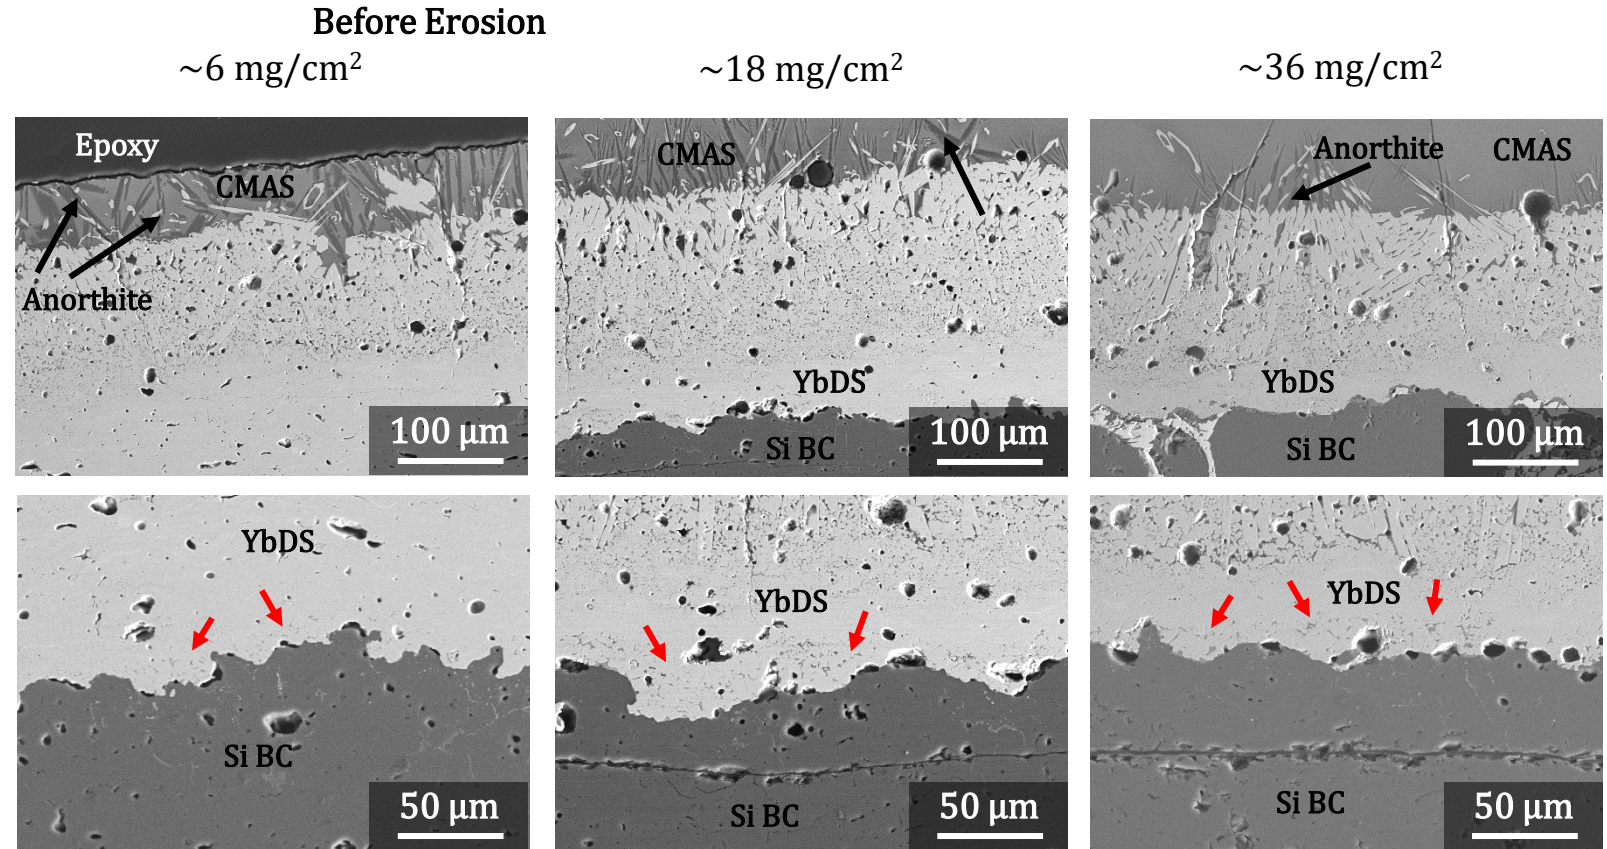
- Thicker layer of apatite formation with increased loading
- Crystallization of residual CMAS to anorthite ($\text{CaAl}_2\text{Si}_2\text{O}_8$)
- CMAS pooling between grains at bondcoat consistent with lower loading samples
- Large crack through the bondcoat in $\sim 18 \text{ mg/cm}^2$ and $\sim 36 \text{ mg/cm}^2$ samples, extending from the middle of the coating to the edges of CMAS bubble.

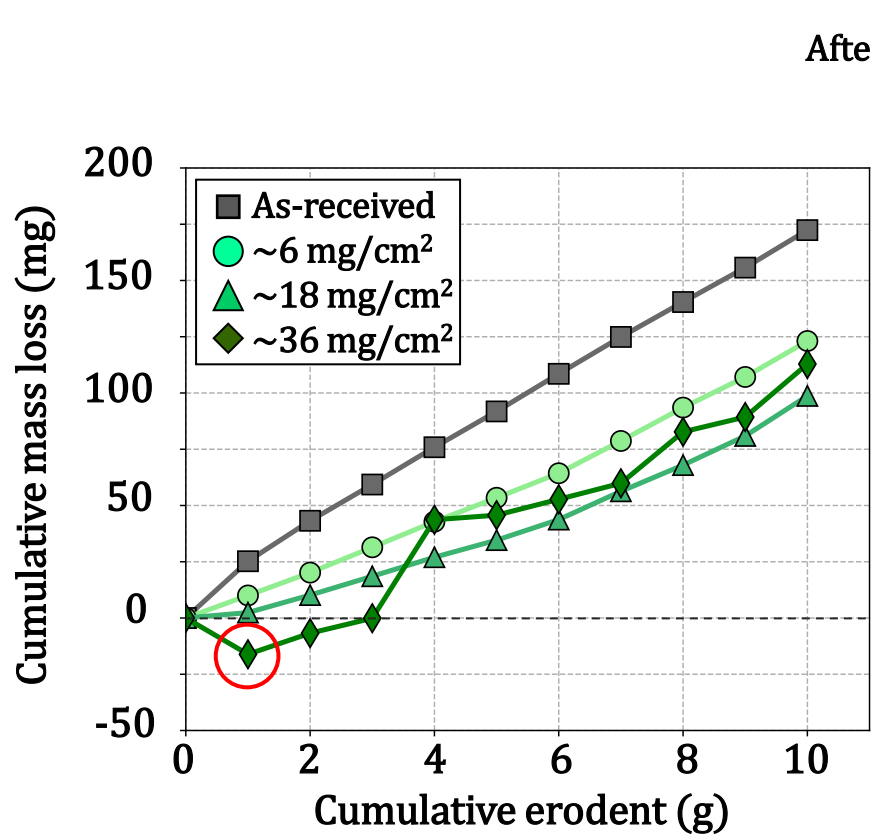
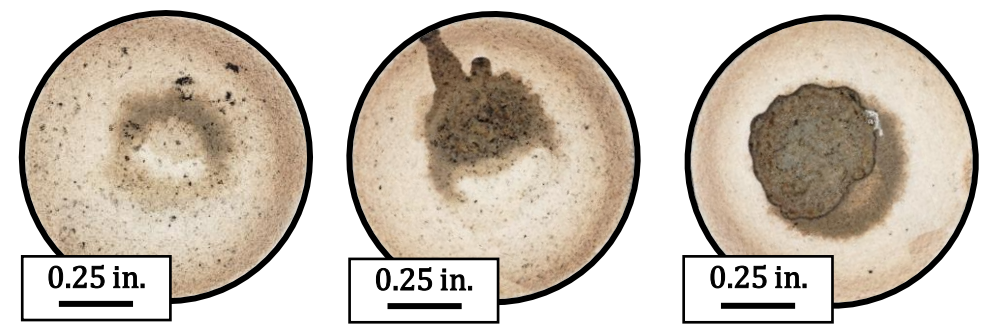
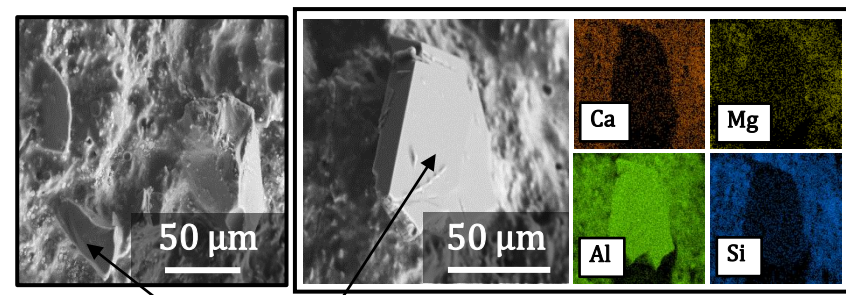
As received 16.34 mg/g
 $\sim 6 \text{ mg/cm}^2$ 14.05 mg/g
 $\sim 18 \text{ mg/cm}^2$ 12.68 mg/g
 $\sim 36 \text{ mg/cm}^2$ 13.38 mg/g

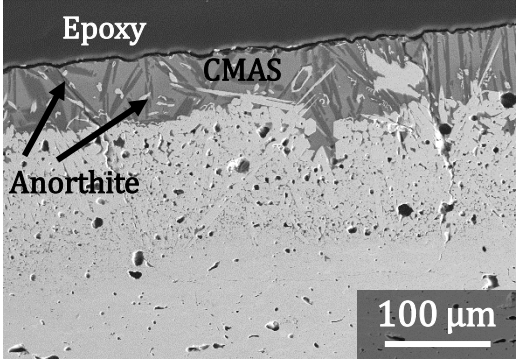
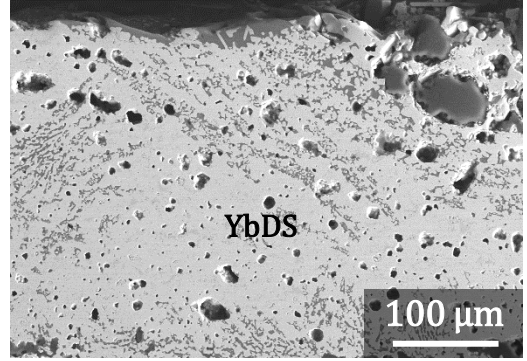
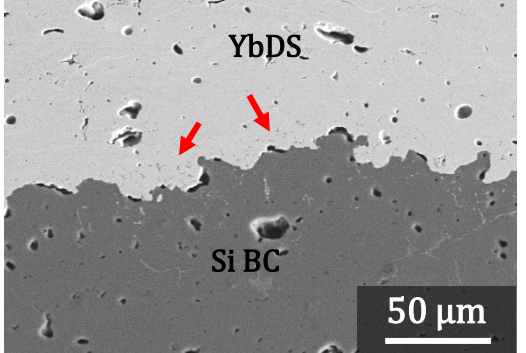
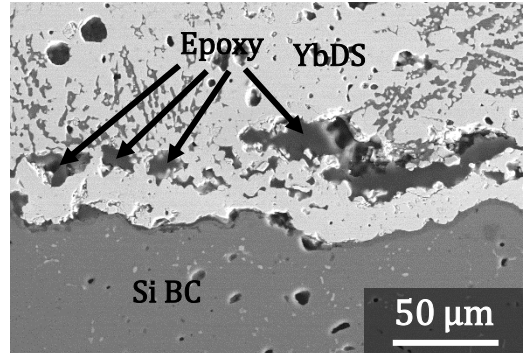
$\sim 6 \text{ mg/cm}^2$ After Erosion

- With increasing exposure time at $\sim 6 \text{ mg/cm}^2$, there was cumulative mass loss increase.

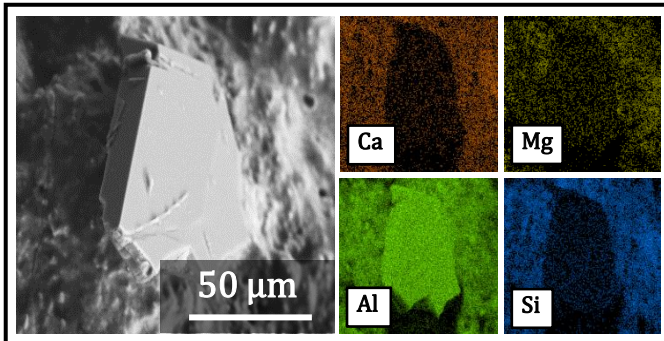
Erodent accumulation

Are CMAS particles more likely to “splat” and stick to coatings than to remove material due to lower melting temperatures? → greater mass accumulation over time

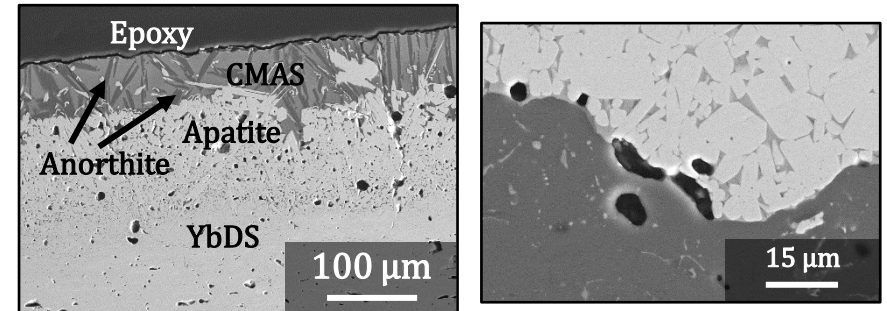
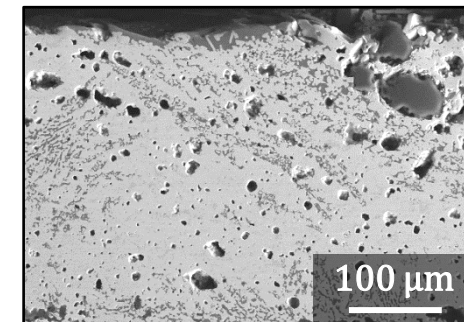
Morphological changes affecting mechanical durability

- Void and porosity formation from CMAS interactions
- Differences in the mechanical properties (fracture toughness, elastic modulus, hardness) of reaction products will affect durability
