NASA/TM–202300012644

A Summary of Structural Test and Simulation Results for Hawker 4000 Composite Fuselage Hardware

*Justin D. Littell, Jacob B. Putnam, and Nathaniel W. Gardner
Langley Research Center, Hampton, Virginia*

December 2023

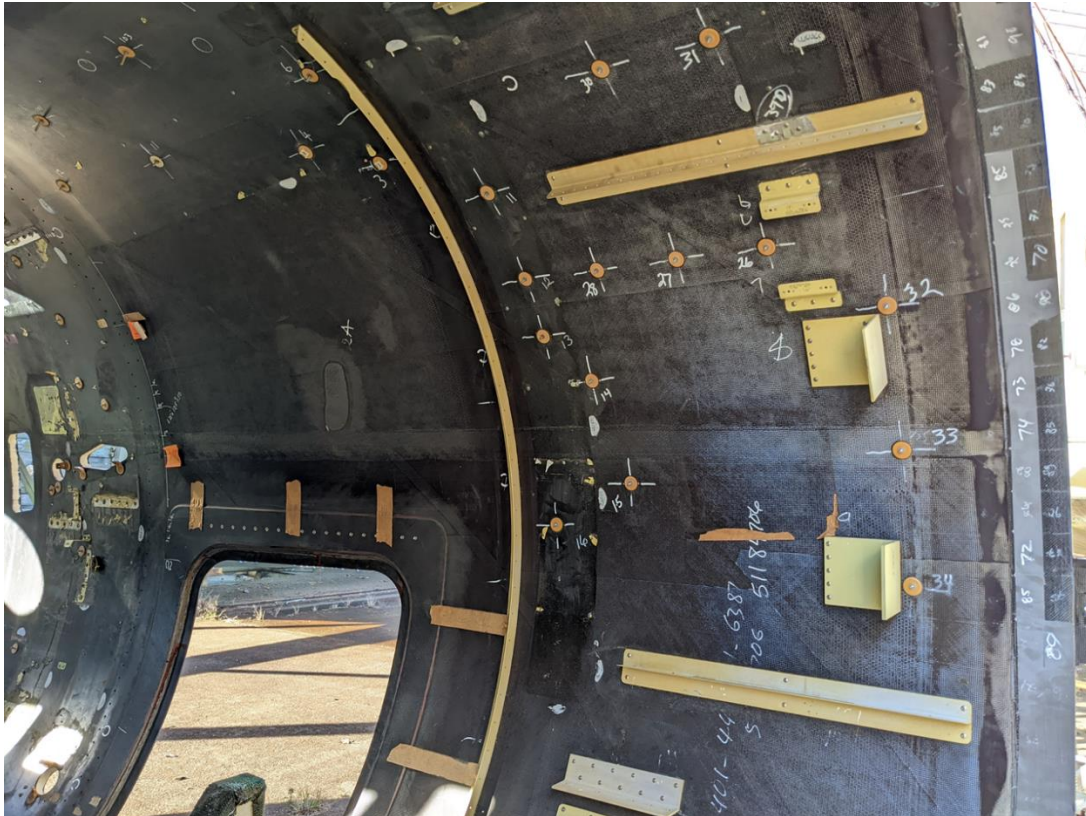
Figure 3 - Hawker 4000 interior close up.

Examining the interior in more detail, some of the metallic brackets that were installed via rivets at the time of manufacture can be seen. In addition, a series of small metallic studs were bonded onto the interior skin prior research programs, and not present at manufacture. However, these studs did not penetrate the interior skin and therefore were assumed to not affect the overall material response. The studs can be identified by the orange circular base, and a silver numbering scheme present next to the base. All brackets and studs remained in the articles when conducting the testing. A detailed interior view is shown in Figure 3.

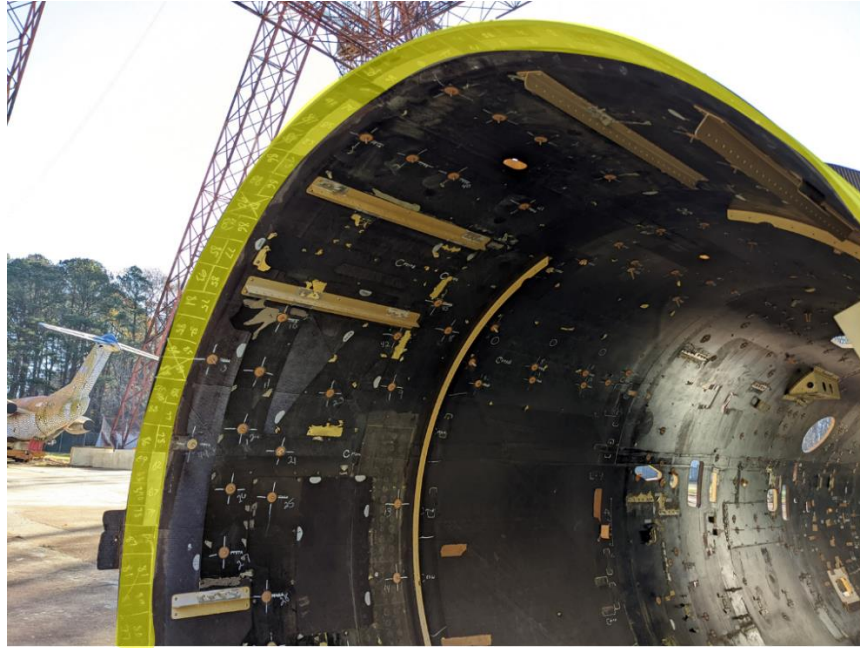
Figure 4 - Hawker 4000 forward composite flange highlighted.

There was a flange approximately 2 inches wide at the forward end of the section. The flange appeared to be entirely fabricated of carbon layers, though the exact number was not determined, and the thickness measurements varied around the perimeter. The flange can be seen in Figure 2 and Figure 3, however is also highlighted in Figure 4 for clarity.

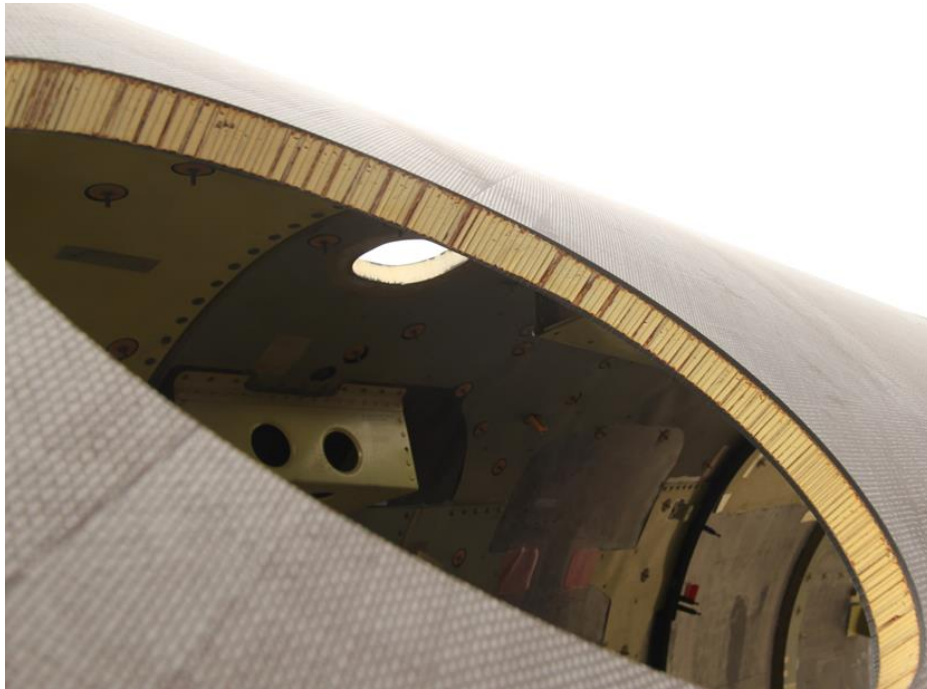
Figure 5 - Honeycomb sandwich core close up.

Finally, the visual inspections revealed that there was a filled honeycomb sandwich core around most of the manufactured openings, and it appeared the sandwich material was the same color and density throughout the section where it was visible. A close-up view of the interior filled honeycomb sandwich material is shown in Figure 5.

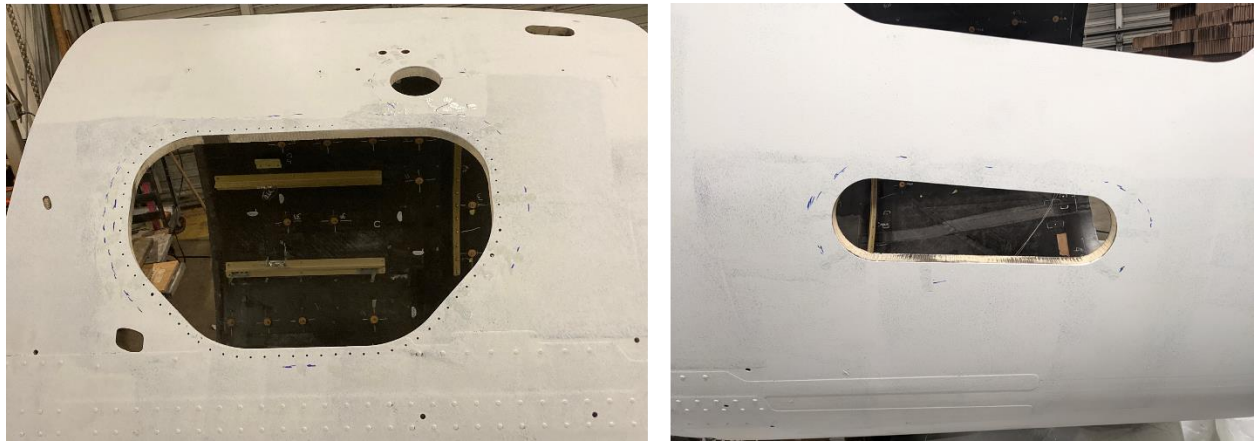
Figure 11 – Filled honeycomb around factory produced openings in the Forward Section (left) and Aft Section (right).

After point measurements were made, the general trend emerged showing that filled honeycomb was primarily around the factory created openings in the fuselage, presumably to add some structural reinforcement at these locations. The area of the honeycomb that was filled was typically on the order of 1 inch around the holes, though the measurement positions were not precise. Where a filled honeycomb measurement occurred, the skin was marked, and then the marks were interpolated to show the picture of

the fill. An example filled honeycomb measurement around a factory produced opening is shown in Figure 11. These locations were documented and used as references for building up the computational models.

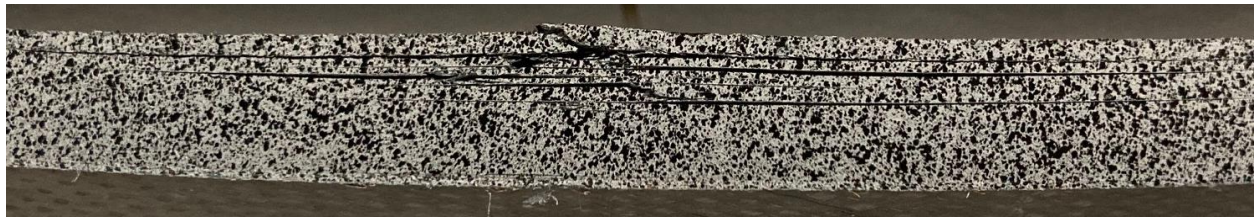
Figure 19 – Close-up view of failure location and interlaminar damage (Convex – 8278).

The delaminations in the specimen are shown in Figure 19. The upper portion of the specimen contains all of the visible damage from the test. The top layers show fiber failure due to the compressive loading. The bottom of the specimen appears to still be intact after the test.

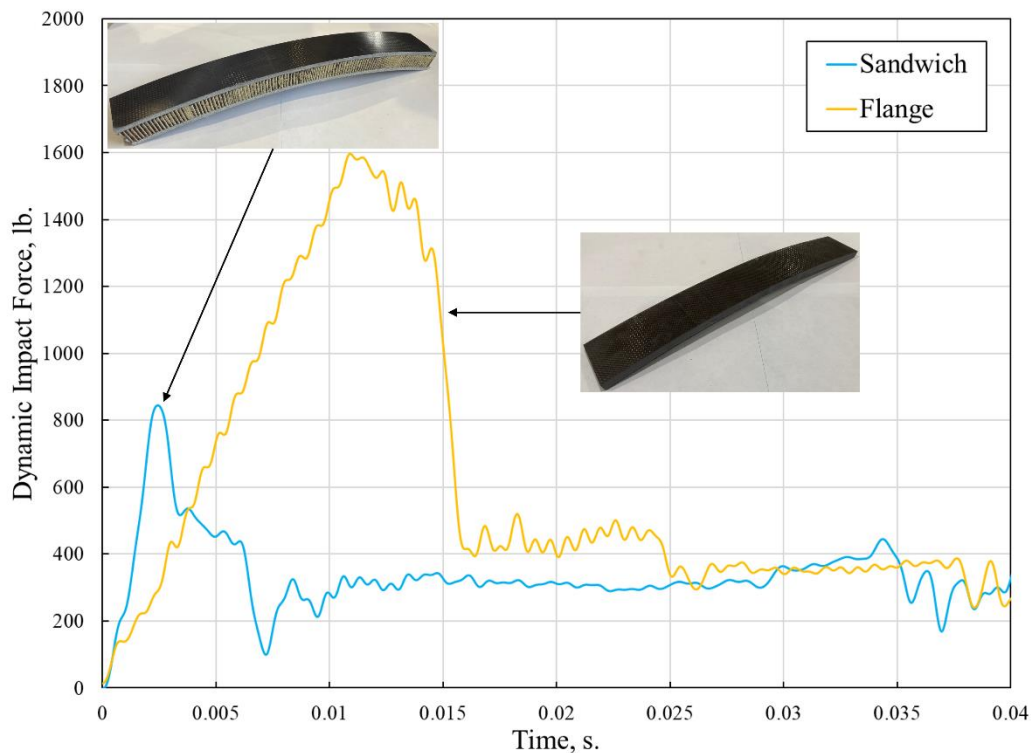
Figure 30 – Dynamic three-point bend results showing nominal response.

The data show the sandwich panel with unfilled honeycomb core was able to withstand a dynamic impact force of approximately 800 lb. prior to damage initiation (core crushing and/or core shear failure), while the composite flange panel was able to withstand approximately twice the impact load before damage initiation (cracking and fiber delamination) began. The damage initiation and failure observed for both types of specimens can be seen in Figure 31. For the sandwich specimen, post-peak damage continued which primarily consisted of crushing of the core at a sustained load of approximately 400 lb. The post-peak damage consisted primarily of tensile fiber failures on the bottom edge of the specimen.

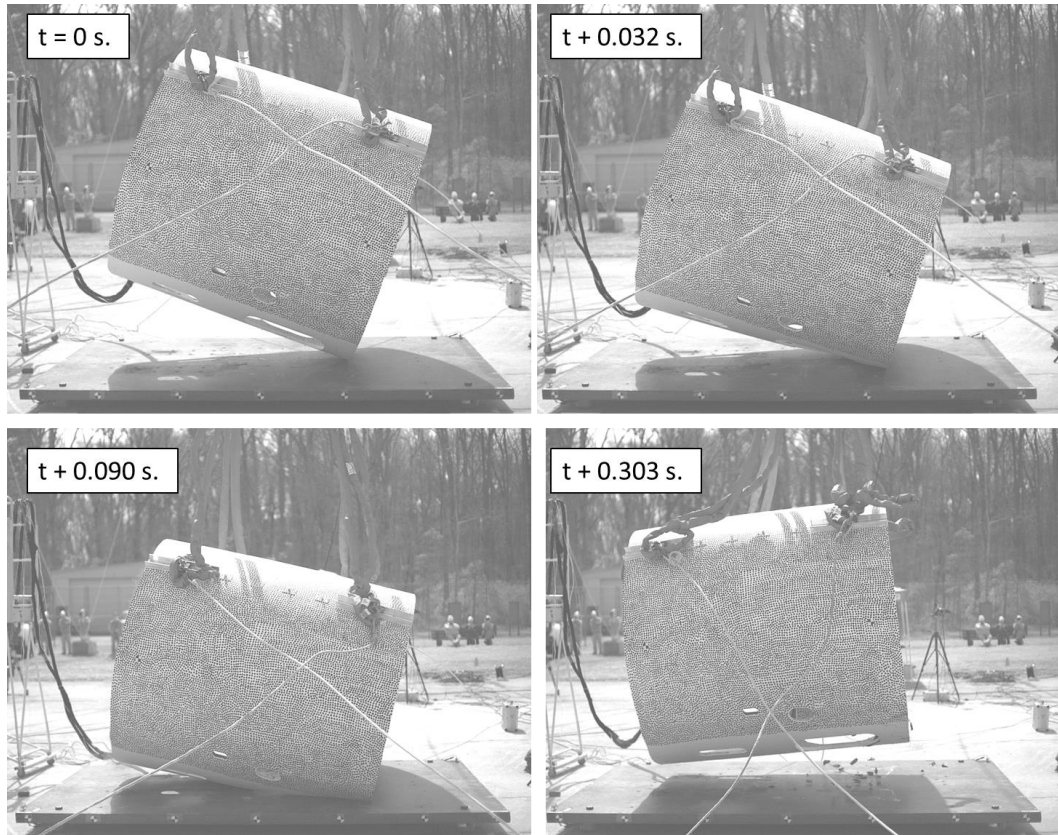
Figure 44 – Starboard side image sequence.

The images from this camera view provided relevant information to identify some of the notable events that occurred throughout the test sequence. The upper left image shows the test article at the time of impact, noting that the forward end, which is depicted on the right side of the image, has contacted the impact surface. The upper right image is taken at 0.032 s. after impact shows the test article at the time in which the composite sandwich structure in the forward end begins to delaminate. The lower left image shows the test article at the point of maximum vertical deflection, while the lower right picture shows the test article at the time of maximum rebound, 0.303 s. after initial impact.

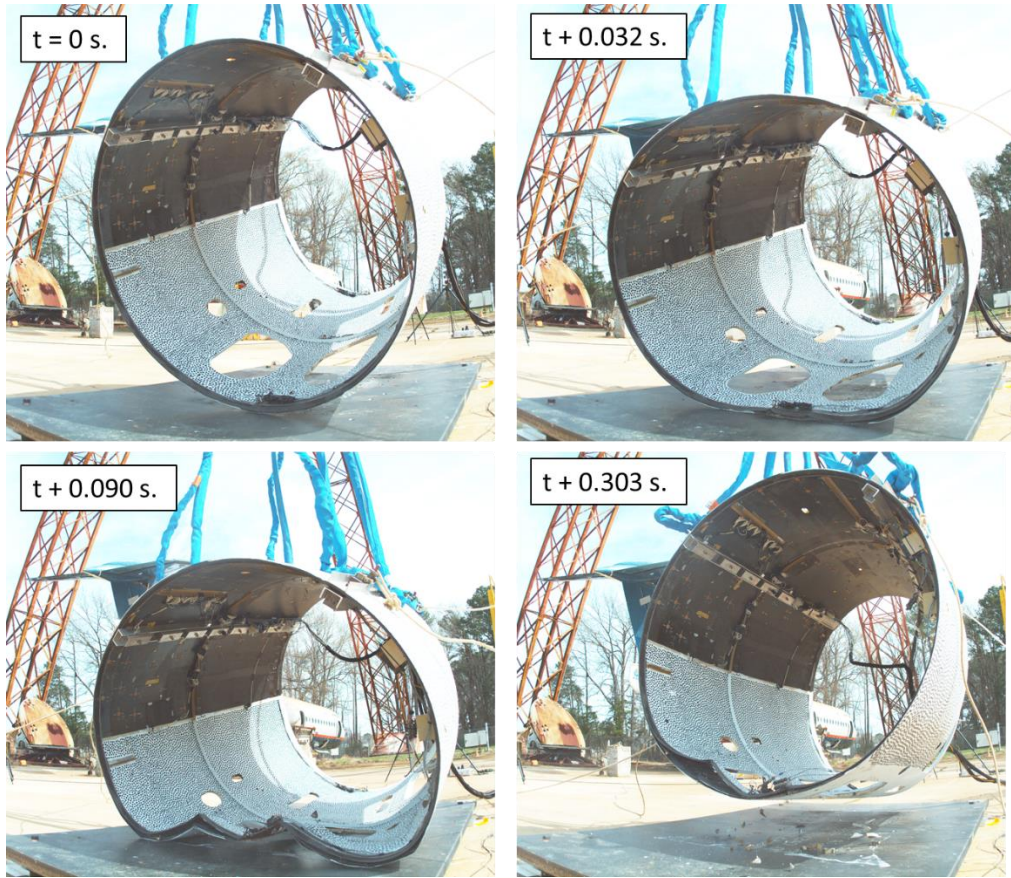
Figure 45 - Ground level forward side image sequence.

Paralleling the sequence shown in Figure 44, the test article at the time of impact is shown in the upper left image of Figure 45, noting that the forward end has contacted the impact surface. The upper right image shows the test article at the time in which the composite sandwich structure began to delaminate. The lower left image shows the test article at the point of maximum vertical deflection, noting the large amounts of delamination and failures that have occurred at the forward impact location. The lower right picture shows the test article at the time of maximum rebound. The permanent delamination and damage are also visible in this image. The vertical displacement corresponding to the image sequences shown in Figure 44 and Figure 45, as measured using 3D-DIC, is shown in Figure 46. Note that the maximum and minimum values of the contour scale, as designated by the red and purple colors respectively, are adjusted for each notable event.

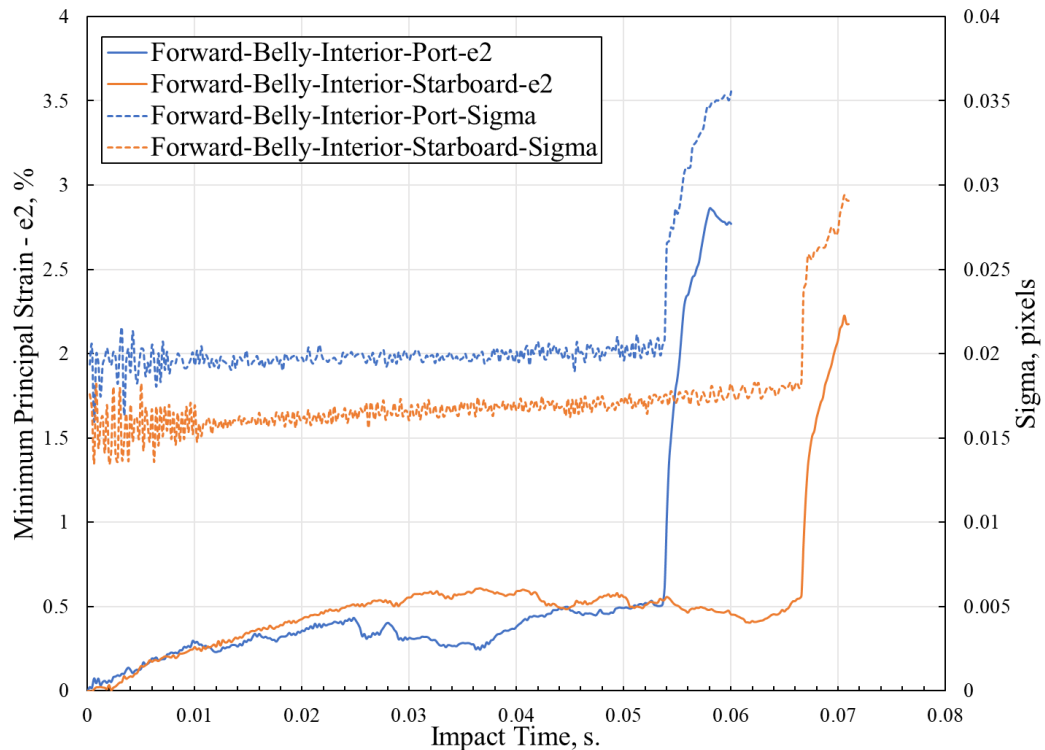
Figure 53 - Compressive fiber failure minimum principal strain-time history.

The minimum principal strain, ϵ_2 , and Sigma time-history for the port (blue) and starboard side (orange) compressive fiber failure cracking are shown in Figure 53 by the solid and dashed lines, respectively. The port side (blue) shows gradually increasing compressive strain for the first 0.053 s., until approximately

0.5% strain is reached. After 0.053 s., a sharp increase in strain occurs, shown by the sudden, sharp vertical ascent of the line, which is identical to the Sigma (damage) response, signifying a crack has occurred. Investigating the starboard side (orange) in the same manner, the compressive strain is gradually increasing for the first 0.066 s., until a similar level of strain is reached, followed by a sudden, sharp vertical ascent of the line signifying a crack has occurred.

The value of strain after failure is not important since failure has already initiated within the test article and localized damage generally results in erroneous strain values and decreased measurement accuracy, however the failure strain value prior to the onset of damage and cracking, of approximately 0.5%, is an important value to obtain, as this technique is one method to quantitatively identify material property failure within the test article. The portion of the test article aft of the center did not exhibit any visible sign of damage when examining the 3D-DIC data.

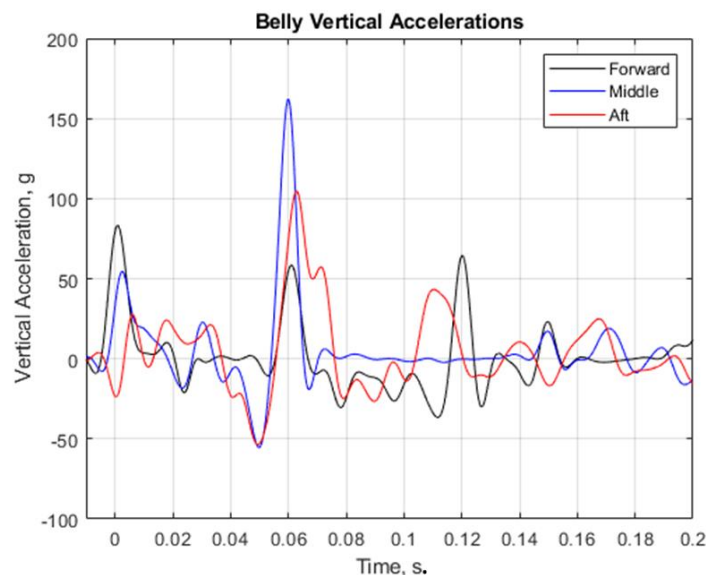
Figure 54 - Belly vertical accelerations.

The forward belly accelerometer recorded approximately 83.2 g at initial impact, followed by 54.3 g for the middle location and 27.3 g for the aft location. Approximately 60 milliseconds (ms.) after impact, a second event occurred. This event is the time where the middle of the test article impacted the load platform, which is shown in the measured accelerations as a second large spike. During the middle impact, the middle accelerometer registers the highest acceleration of the three locations, and additionally higher than the original acceleration measured by the forward accelerometer during the initial impact. The higher magnitude acceleration is due to the presence of an inner metallic stiffener restraining additional failure of the composite in the belly area.

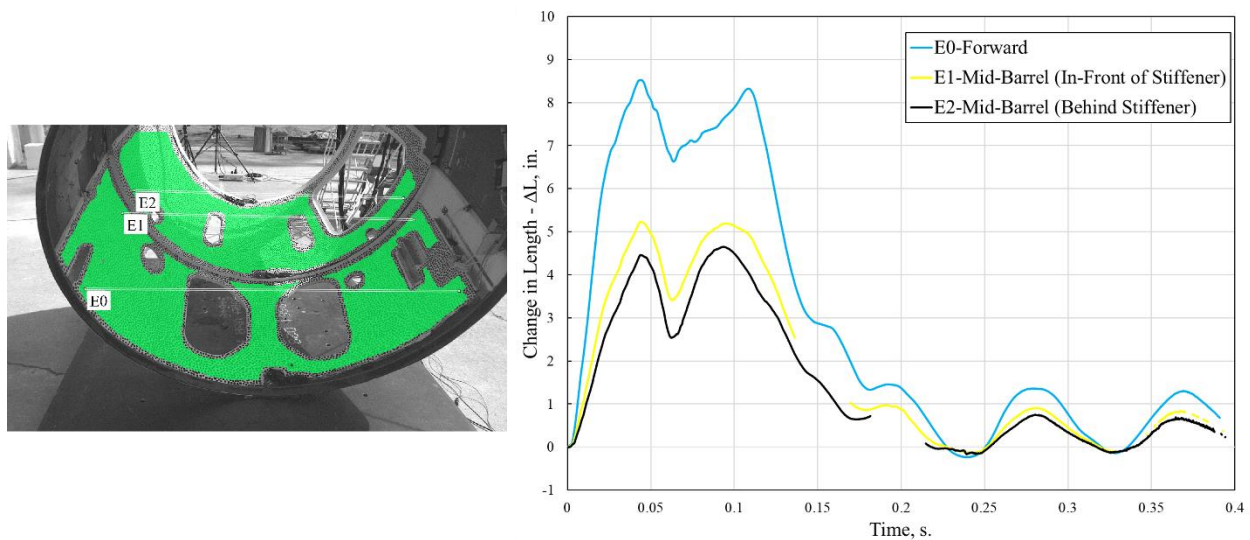
Figure 60 – Outward displacements of the sidewall.

This pulse duration of the lateral accelerations aligned well with the 3D-DIC displacements of the sidewall. The sidewall displacements were measured using virtual extensometers placed within the post-processed data set of the interior of the Forward Section, at three locations (forward, mid-barrel in front of stiffening ring and mid-barrel behind the stiffening ring) between the port side and starboard side at approximately the same vertical height/position. The change in length, ΔL , was then extracted and plotted, as shown in Figure 60. The port and starboard side exhibited large combined outward deformation (between 5 in. and 8 in.) during the first 0.15 s., followed by lower amplitude oscillations of approximately 1 in. After 0.4 s., the photogrammetry was unable to correlate during the remainder of the event due to the angle of the test article relative to the cameras.

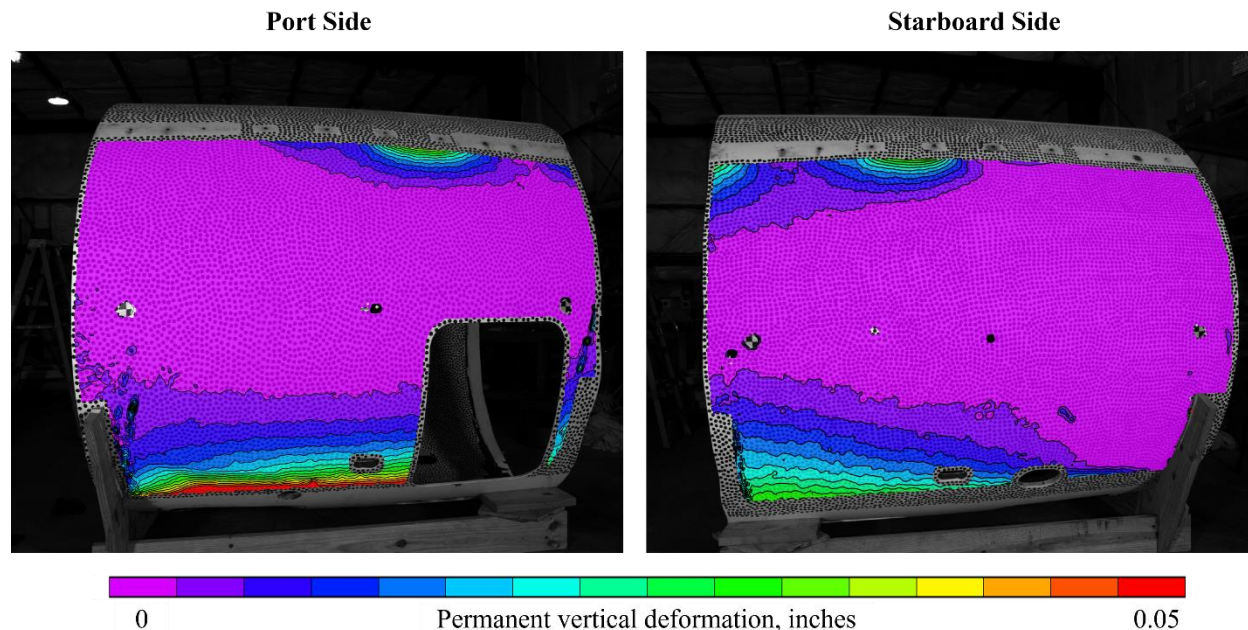
Figure 62 – Permanent vertical deformations. Port side (left) and Starboard side (right).

The permanent deformation in the vertical direction reveals two key findings. The first is there is a large amount of permanent vertical deformation in the forward belly area, which was the area that made first contact with the impact surface. The localization of the red also indicates that this permanent deformation is localized to the area immediately surround the two large openings of the forward belly section. There is also some additional deformation near the top of the test article at locations near the added ballast due to ballast motion during the test. This deformation is also localized toward the forward end of the test article.

The second item to note is the mid-height area of the test article exhibits little to no permanent vertical deformation. This data indicates that even though there was large amount of permanent deformation in the belly section, a large majority of the test article returned to its original pre-test shape. The obtained data were very helpful because these types of deformations would not be readily apparent through normal post-test inspections and provided insight into the nature of the behavior of the test article during the test. Additionally, these findings were used when examining the results from the full-scale simulations using the developed computational models, described next.

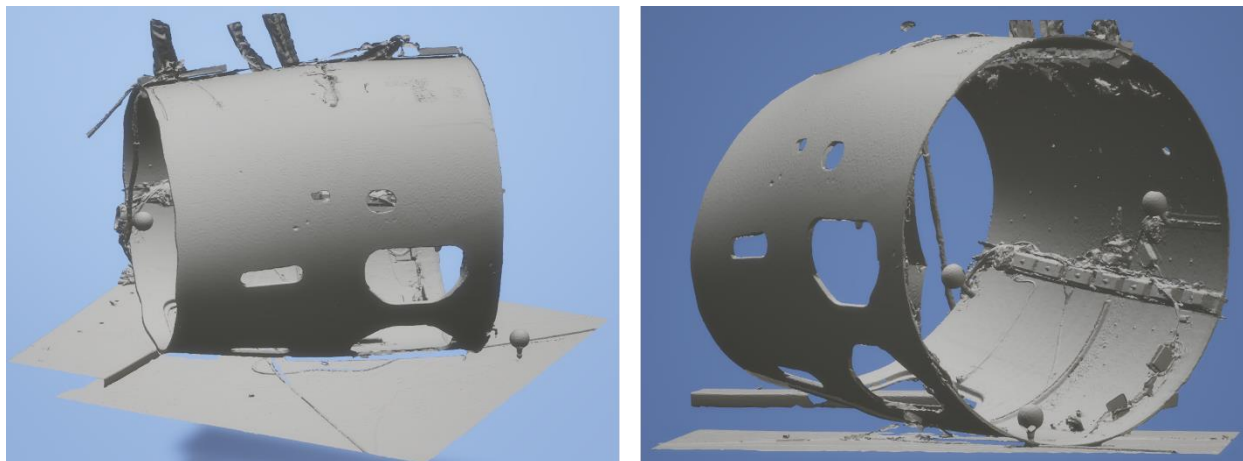
Figure 63 – Post-test 3D point cloud scan. Starboard side/belly (left) and Forward/IML (right).

Post-test 3D point cloud scans were also conducted at the test area on the Forward Section immediately following test in order to capture the final resting position of the test article, along with shape, deformation and damage information. The 3D point cloud scans are shown in Figure 63.

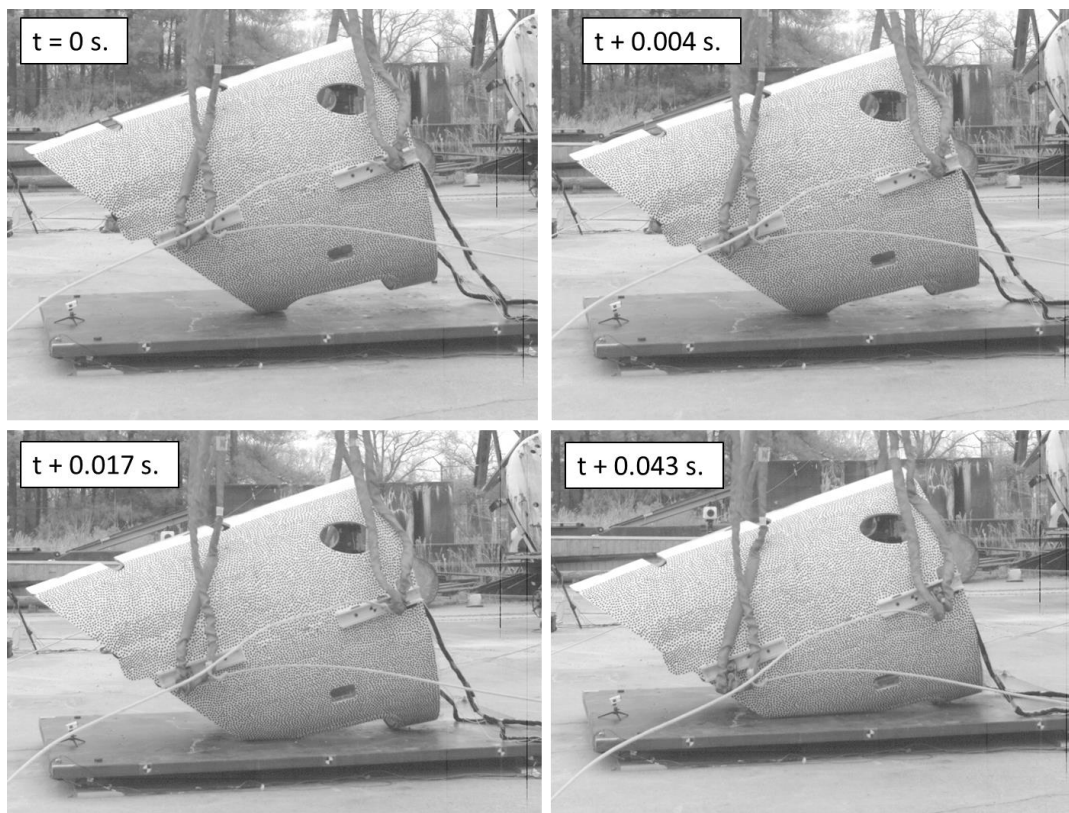
Figure 76 – Starboard side image sequence.

The image from this camera provided relevant information to identify some of the notable events that occurred throughout the test sequence. The upper left image shows the test article at impact. The pitch up orientation of the test article does allow for the small aft portion of the belly to contact the impact surface first. Almost immediately after impact, at 0.004 s., the contact at this location has caused the localized fracture in the aft belly impact location on the test article, as shown in the upper right image. It is also at this time where the measurement accelerometers have debonded from the inner surface. The lower left image shows the test article 0.017 s. after impact, which is the time at which the forward portion of the test article contacted the impact surface. The vertical motion of the test article continues until 0.043 s. after impact, which is at the point that the maximum vertical deflection of the test article has occurred. The same

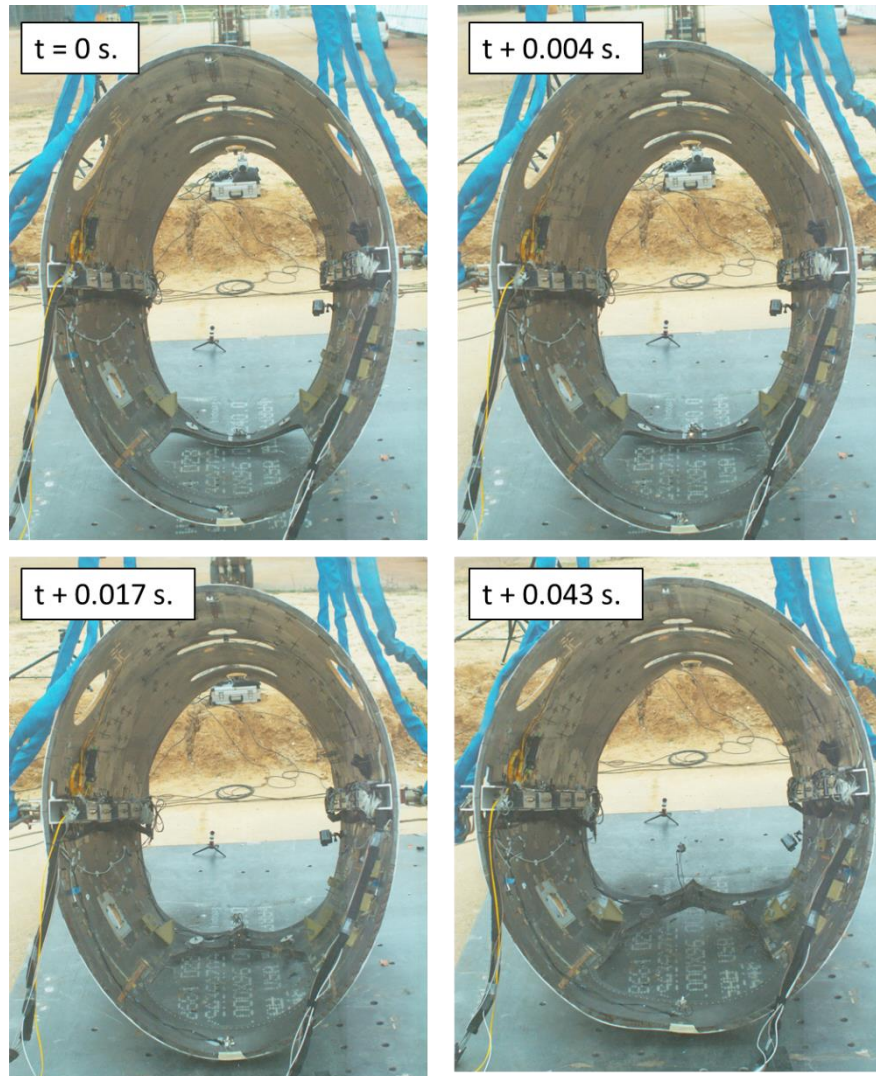
Figure 77 – Interior image sequence.

The impact is shown in the upper left image in Figure 77. The aft belly area, which is shown in the background for the image series can be seen to be in contact with the impact surface. The upper right image, which was acquired almost immediately after impact, shows the first fracture occurring in this same area. The lower left image shows the time of the forward belly area impact, also noticing that the aft belly section has begun to protrude inward due to the fracture. The lower right image shows the test article at maximum vertical deflection, which is depicted by the test article shape being noticeably different. Also shown in the lower right image is the large amount of inward protrusion in the aft belly section.

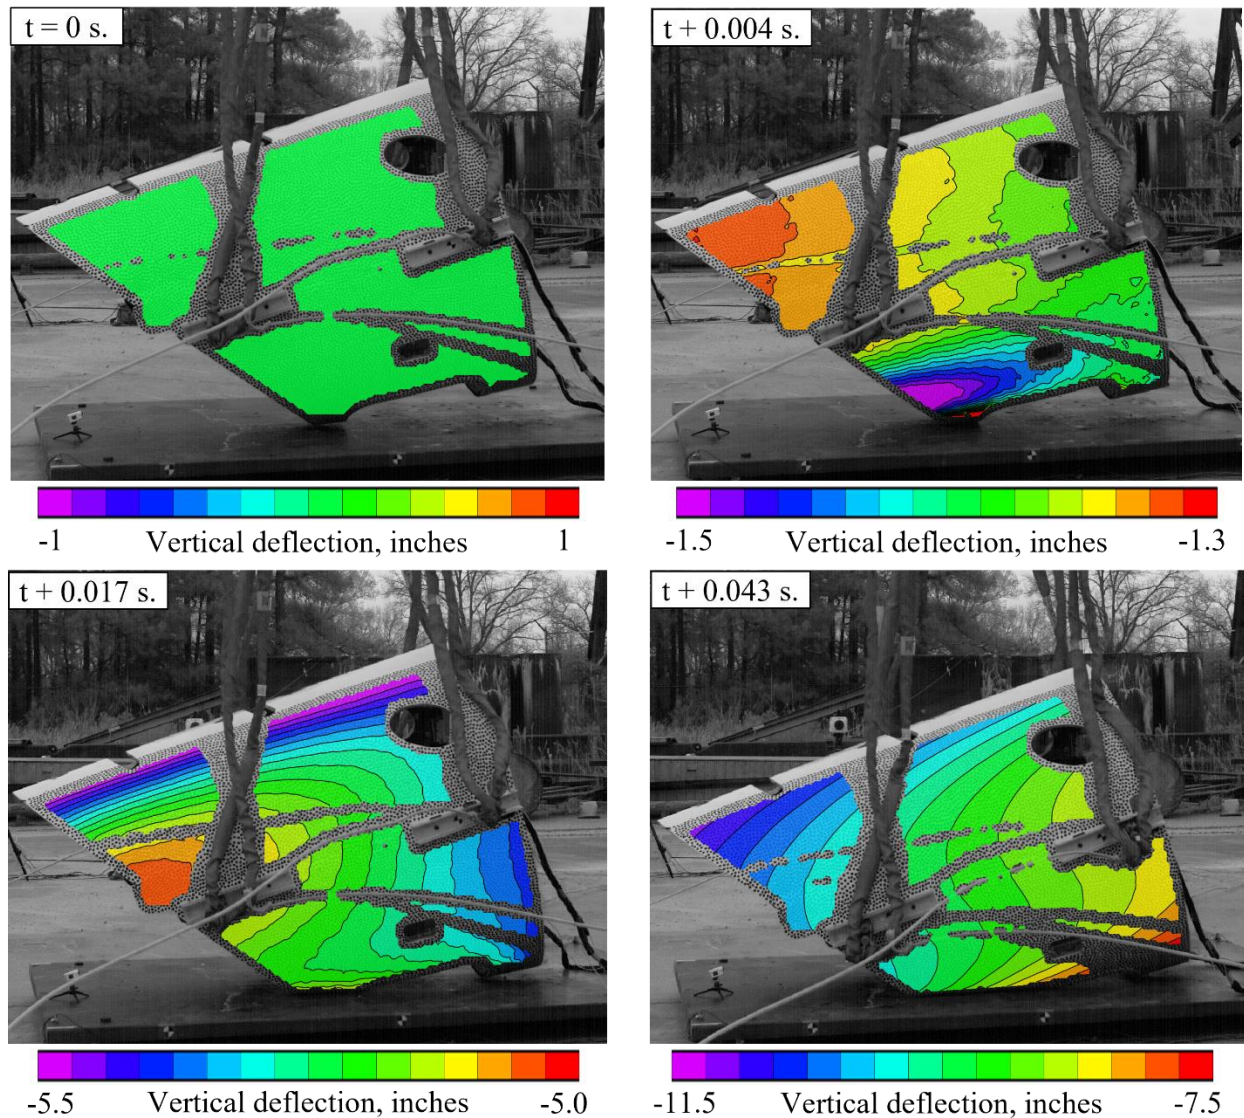
The vertical displacement corresponding to the image sequences shown in Figure 76 and Figure 77, as measured using 3D-DIC, is shown in Figure 78. Note that the maximum and minimum values of the contour scale, as designated by the red and purple colors respectively, are adjusted for each notable event.

Figure 78 – Vertical deflection of starboard side image sequence.

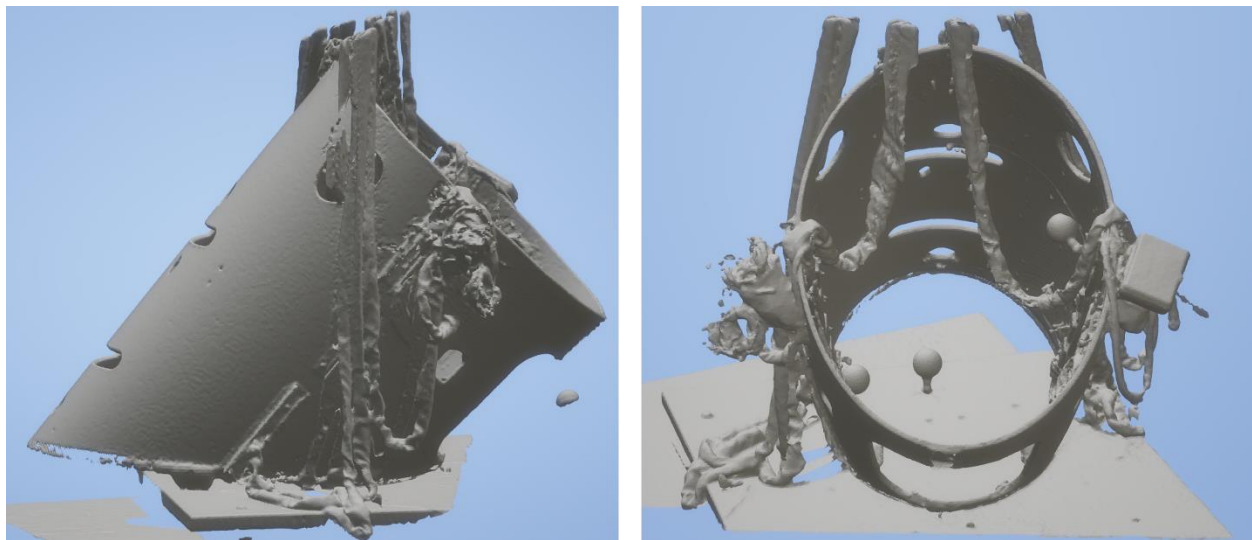
Post-test 3D point cloud scans were also conducted on the Aft Section, immediately following the drop test, to capture the final resting position of the test article, along with shape, deformation and damage, and are shown in Figure 89.

Figure 89 - Post-test 3D point cloud scan. Starboard side (left) and Forward (right).

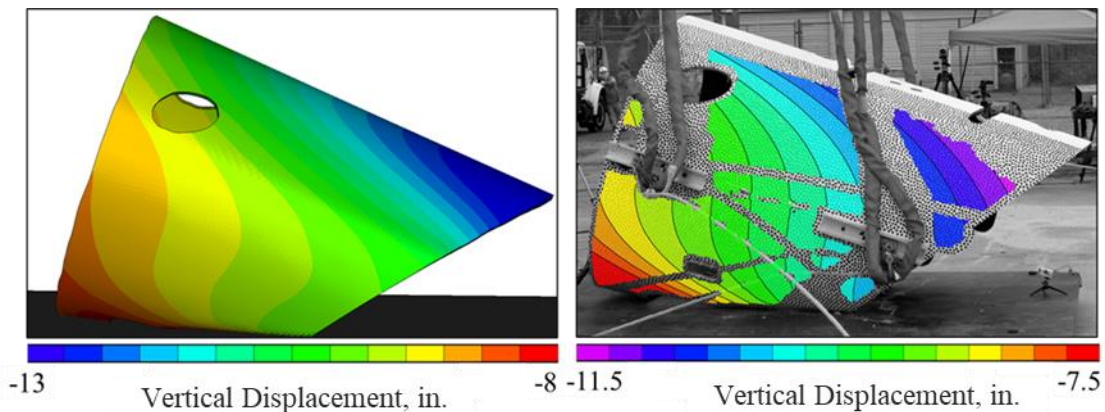
Comparison of vertical displacement at peak deflection measured on the Aft Section test article and representative model is shown in Figure 92. The Aft Section FE model was found to predict similar vertical displacement to what was measured across the surface of the test article. Close prediction of structural displacement by the reverse engineered model corresponded with the accurate prediction of damage. Prediction of displacement across the compared surface also indicates realistic estimation of structural stiffness of the test article by the reverse engineered model.

Figure 92 – Vertical displacement measured in Aft Section test article and predicted in the Aft Section FE model.
