SpaceX Dragon Spacecraft Post Flight MMOD Inspection Campaign

Abstract

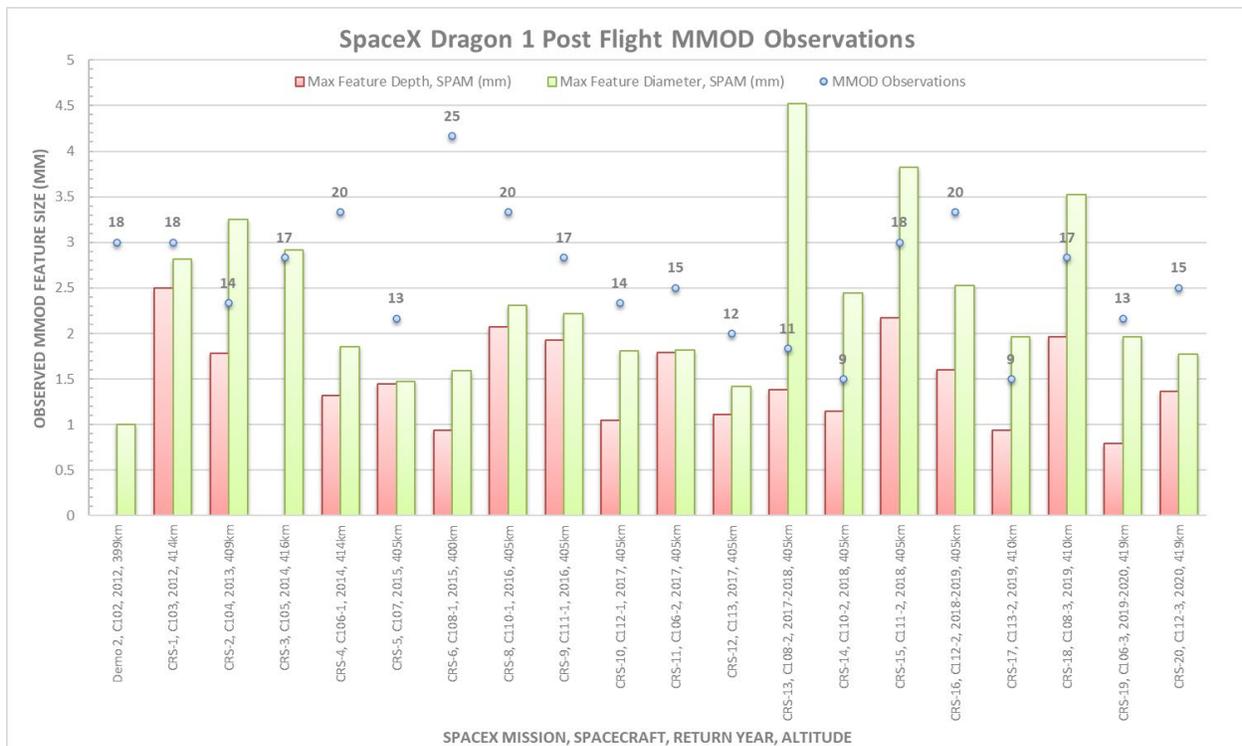
Figure 4. Results of Dragon 1 post flight inspection campaign

A summary of the inspection campaign results can be found in Table 1. The “Exp. Time” column lists the exposure time for each Dragon 1 spacecraft while berthed to ISS Node 2 nadir (i.e., pre and post berth free-flight exposure times are not tabulated here). If the Commercial Resupply Services (CRS) mission spanned two calendar years, the exposure time for each year is provided. The inspected areas for each mission varied depending on hardware availability. Table 1 list four different combinations of inspected areas and the associated area-time products. The “MMOD Sites” column lists the number of observations for each mission that remained after the post-flight imagery comparison. The “Impact Rate” column presents a ratio of the number of MMOD observations and the berthed exposure time for each mission. Excluding the Demo 2 mission, the average impact rate for the Dragon 1 flight program (CRS-1 through CRS-20) was just over 0.5 impacts/day. The distribution of all 315 MMOD observations spanning the 20 Dragon 1 missions are compared in Fig. 4. The plot also includes the maximum depth and diameters observed in the SPAM material for each mission. There is no apparent correlation between crater count and maximum damage size.

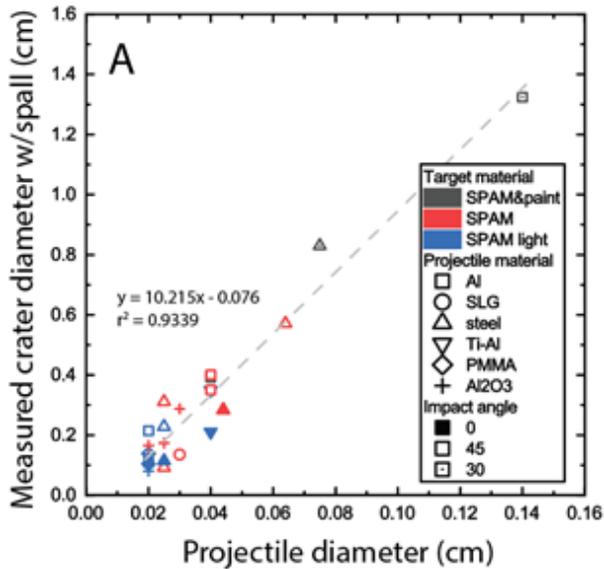
Figure 7A: Cross-plot of SPAM damage feature size and projectile diameter

An estimate of SPAM damage size as a function of projectile size was derived from multiple HVI tests using projectile densities between 1.2 and 7.667 g/cm³. Most of the tests were conducted at a velocity of 7 km/s, with two tests at 5 km/s and two more at 10 km/s. Projectile sizes varied between 0.02 and 0.14 cm. Figure 7A shows a cross-plot of the damage feature size (including coating spall) and projectile diameter. The fit to the data indicates a feature size to projectile ratio of ~10. Figure 7B provides a similar cross-plot for five PICA-X HVI tests. The results of the linear regression of the data shows a feature size to projectile ratio of ~11 for the PICA-X material.

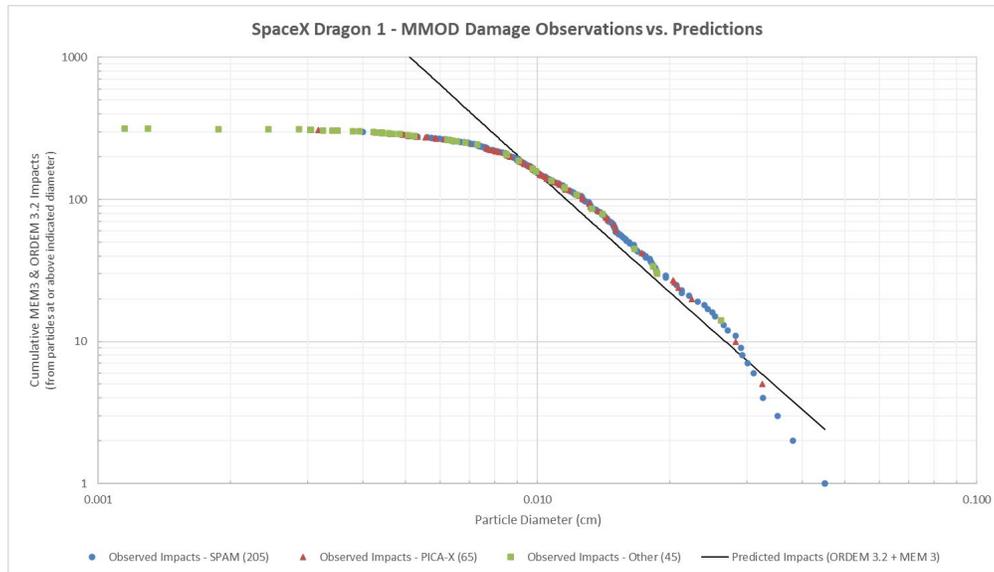
Figure 5. MMOD damage observations compared to Bumper 3 predictions

For each of the 20 Dragon 1 missions to ISS, an expected number of impacts from a representative set of particle diameter were computed for the MEM3 and ORDEM 3.2 environments considering the mission year, exposure time and inspected areas using the Bumper 3 analysis tool. The predicted number of impacts for the Dragon 1 flight program is plotted in Fig. 8 as a solid black line. Estimated sizes of impactors (based on feature size) are plotted in ascending order. Observations are grouped by SPAM, PICA-X and “others” and the SPAM impacts dominate the larger diameters and the “others” (mostly coated aluminum (Al) & niobium alloy (C-103) are more common at the lower end of the size spectrum. In general, the Bumper 3 predictions match the observations well.
