Orion Artemis I As Flown MMOD Analysis

2nd International Orbital Debris Conference

Kevin D. Deighton | Jacobs CLG
JSC-XI5 (JETS II) Hypervelocity Impact Technology (HVIT) Team

Post-Flight Inspection

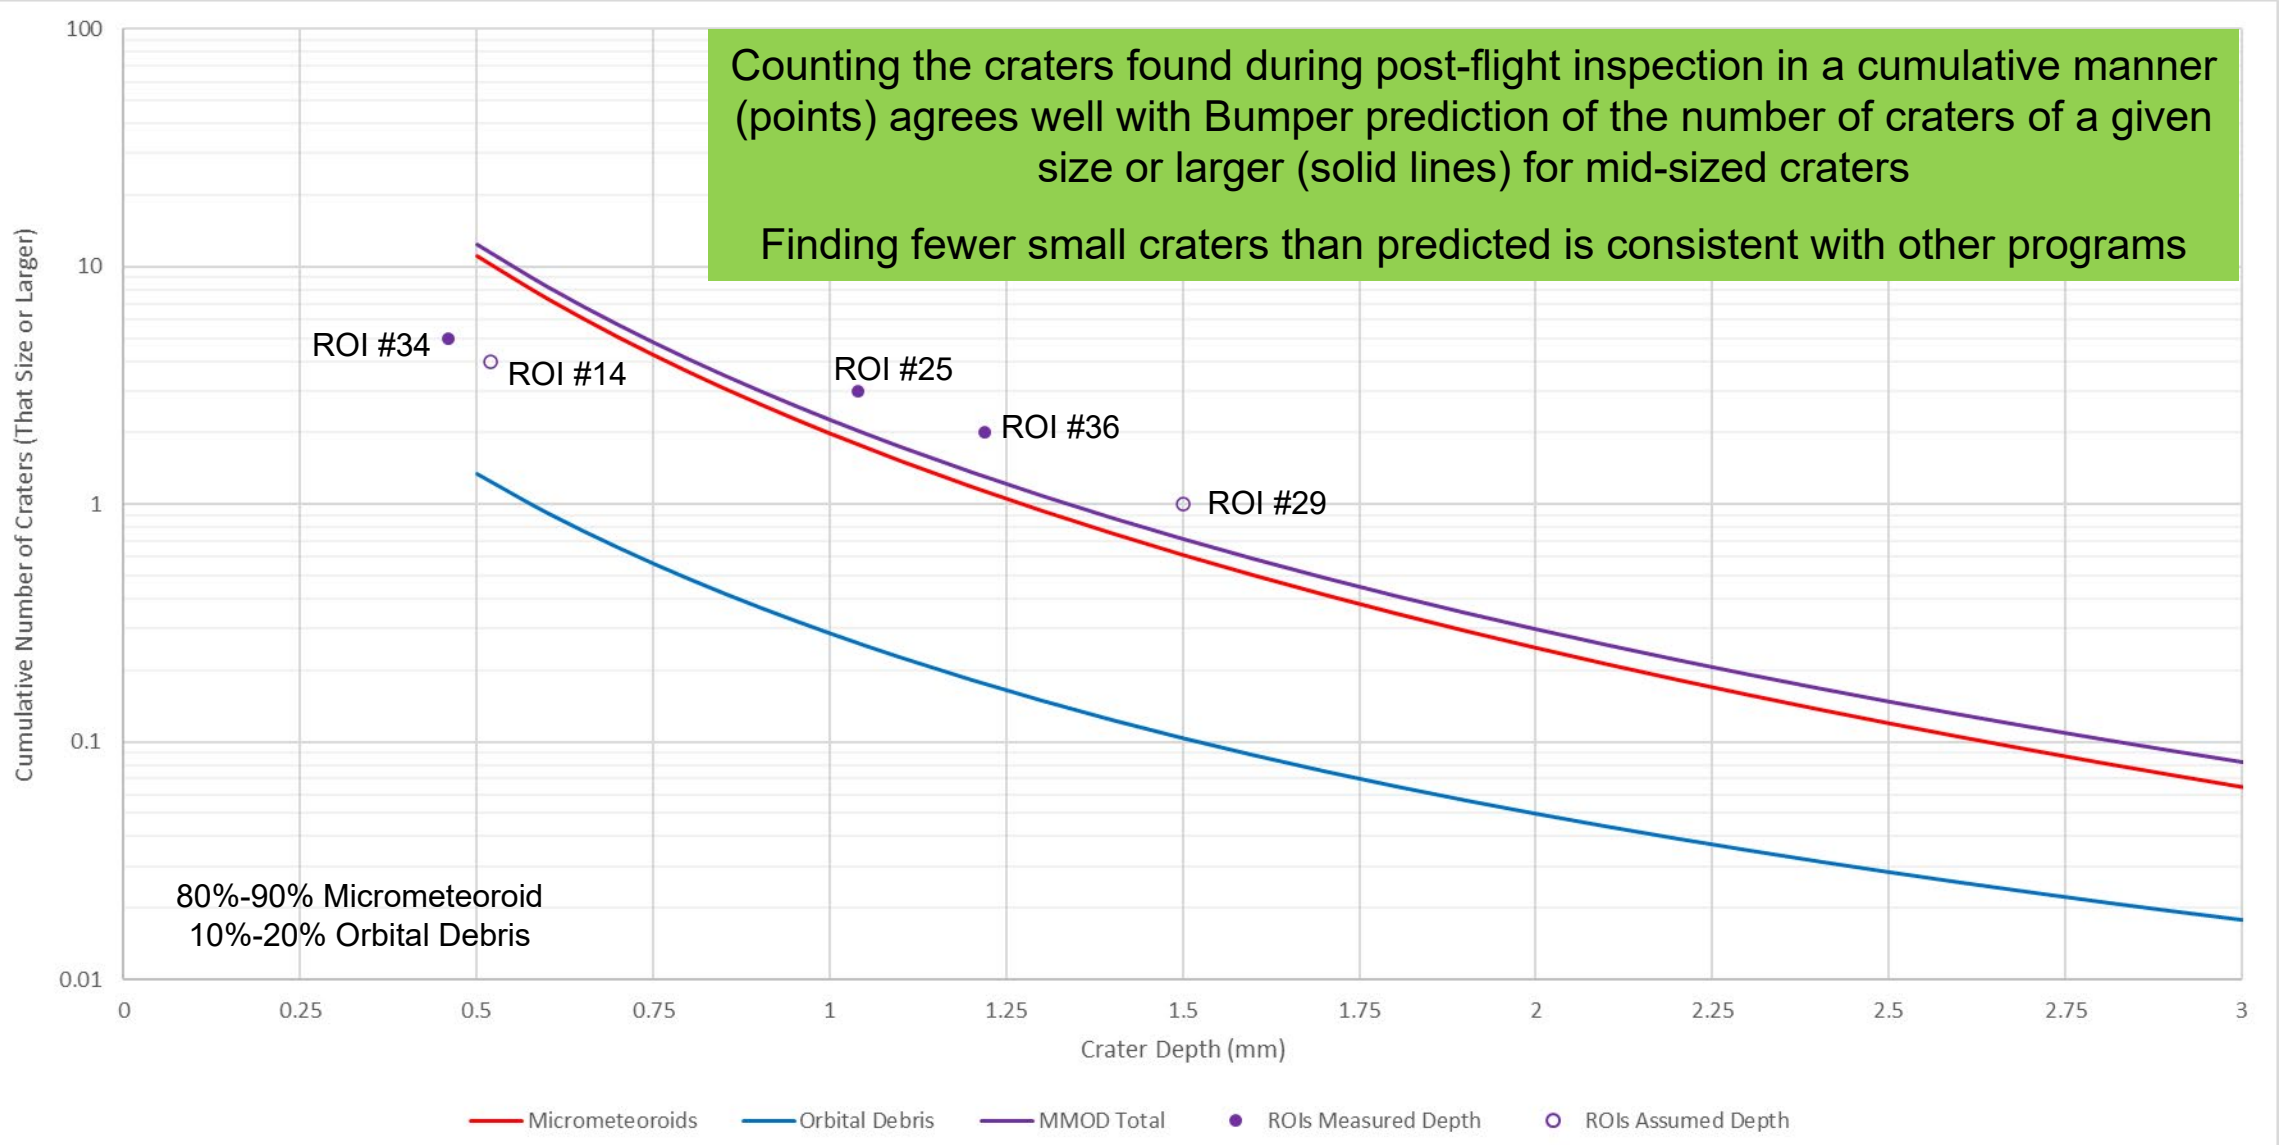
Thermal Tile As-Flown vs. Post-Flight Inspection

Counting the craters found during post-flight inspection in a cumulative manner (points) agrees well with Bumper prediction of the number of craters of a given size or larger (solid lines) for mid-sized craters

Finding fewer small craters than predicted is consistent with other programs

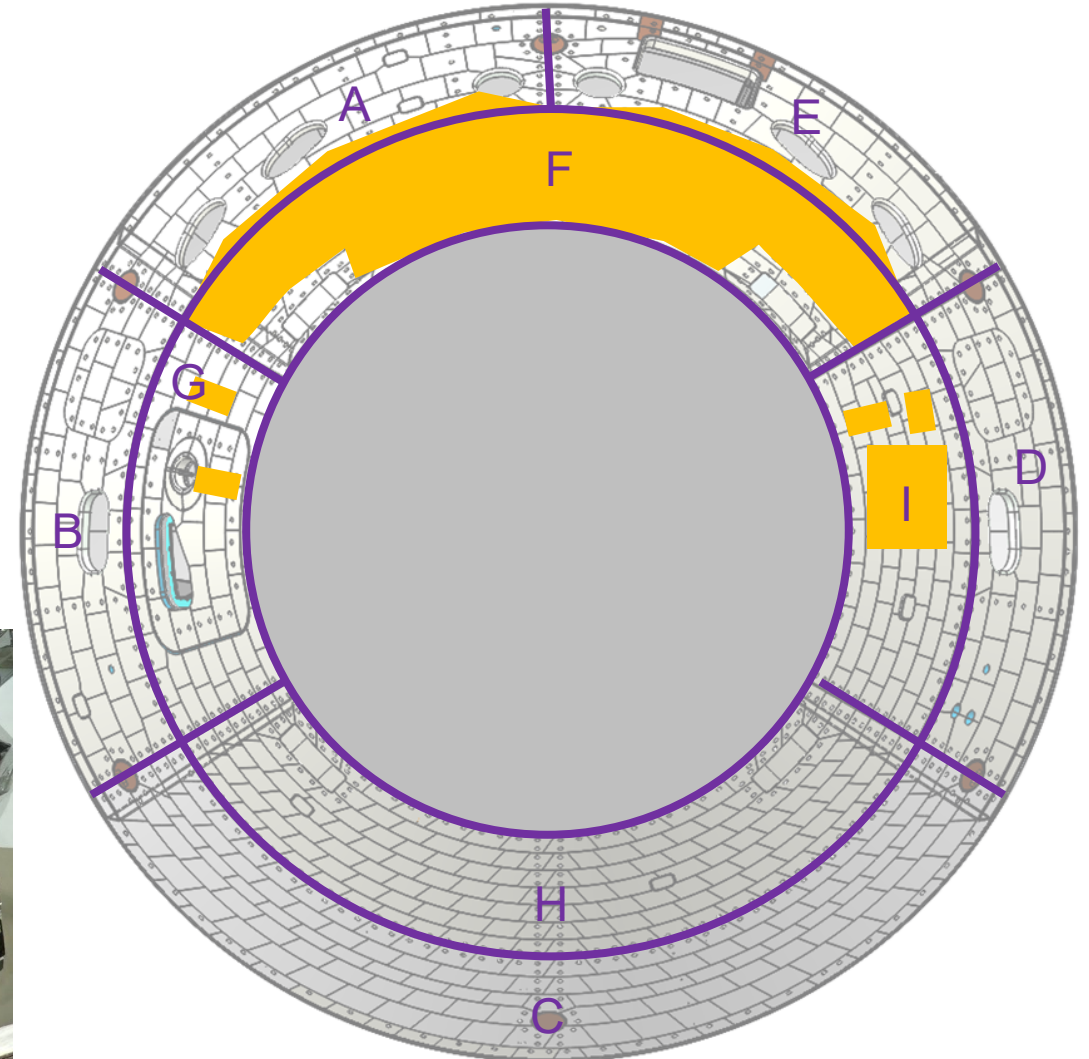
- Reflective tape was applied to the thermal tiles to achieve various desired properties for the flight
- Most of the tape burned off during reentry
- Some tape remained, especially on Panel F, where the main windows are located
 - Scattered small squares of tape remained across the whole capsule (shown on Panel E)
- A Bumper analysis was performed to calculate the number of tape damages expected to be caused by MMOD
 - Analysis included adjustment for how much tape remained

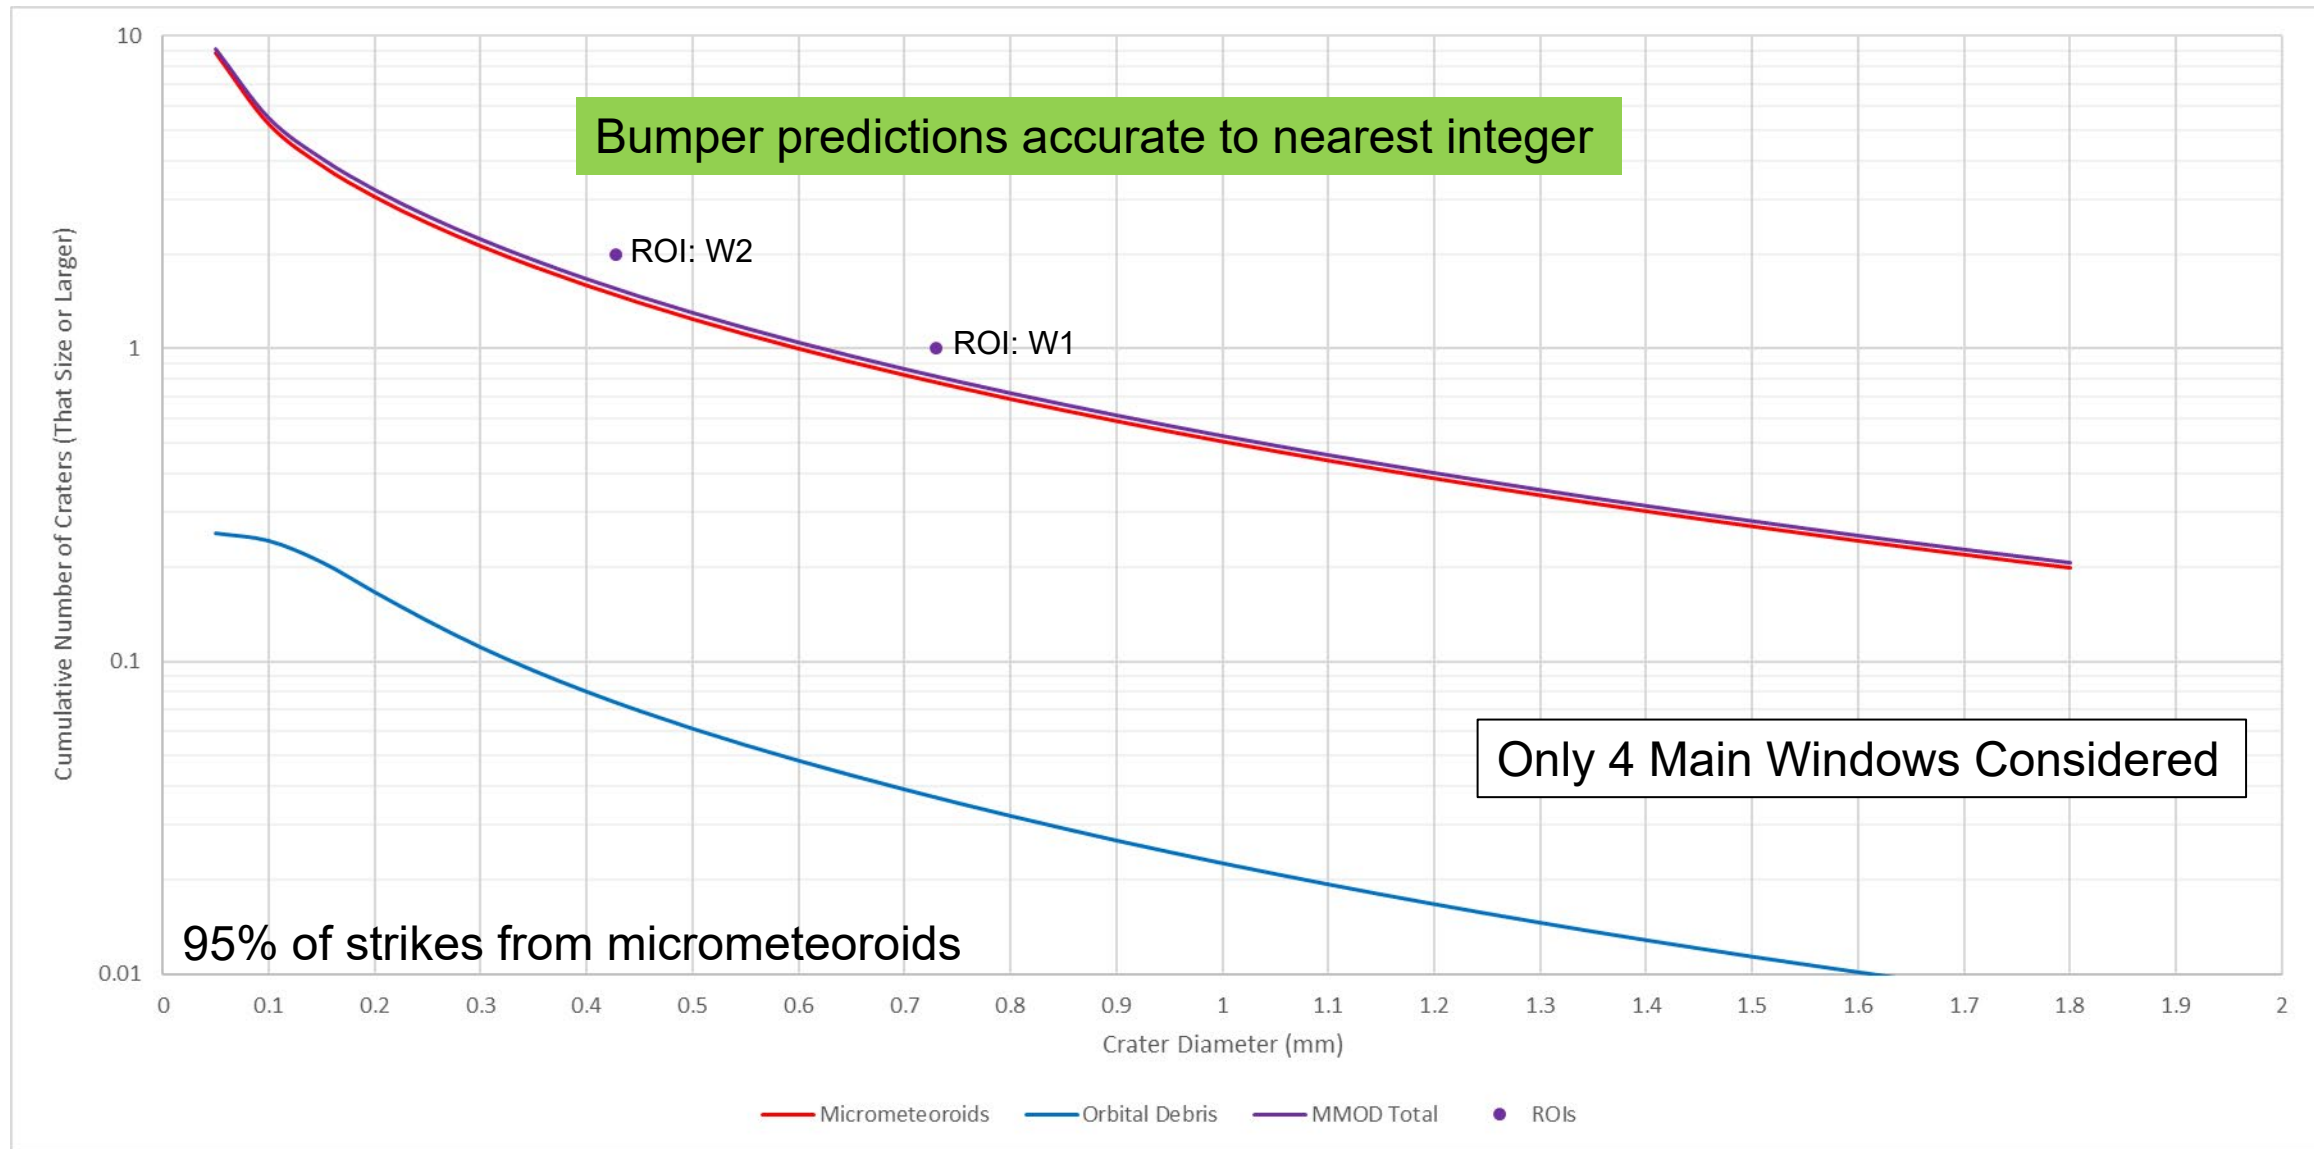
Window Comparison

- 2 potential MMOD craters were found in the main windows
 - Prediction of crater numbers matches well with inspection findings for diameters > 0.5 mm
 - Smaller craters: Bumper predicted more craters than were found, which is consistent with historical trends and may be explained by the difficulty in finding very small craters
