# Risks from Small Orbital Debris

Eric L. Christiansen  
Jim Hyde, Josh Miller, Alan Davis, Frankel Lyons  
JSC-X15 Hypervelocity and Orbital Debris Branch  
NASA Johnson Space Center

2<sup>nd</sup> International Orbital Debris Conference  
December 4, 2023

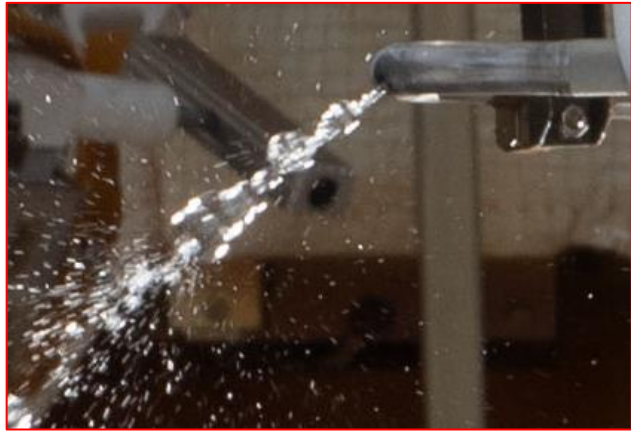
Iss070e006528: MLM Radiator Line Leak Location

- **Example 3: Russian module radiator leak that occurred in Oct. 2023**
  - Leak of radiator interconnect line on the Multipurpose Laboratory Module (MLM) could be due to small MMOD particle: 0.36mm diameter steel projectile at 10 km/s results in observed 1.3mm diameter hole in the radiator line

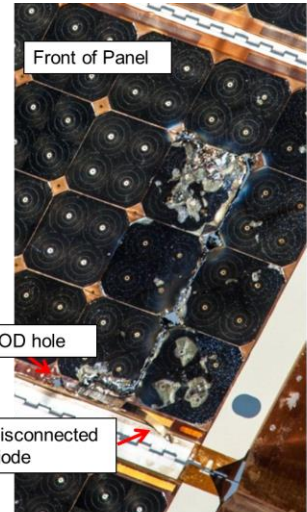
iss040e064550

- ISS solar array power degradation due to disconnected bypass diode (several burned out solar array strings, loss of 400 cells per string)
- ISS P4 PV radiator through perforation with 13cm exit hole: likely due to 4mm-5mm diameter MMOD particle
- ISS Service Module window #7 damage that resulted in the window shutter permanently closed and inner pressure cover installed
- ISS Ku-Band antenna gimbal hole identified on STS-126 causing alignment control issues
- STS128 impact on flow tube that had been augmented with doubler (would have resulted in radiator leak without doubler and early end of mission)
- STS86 near perforation of radiator interconnect line

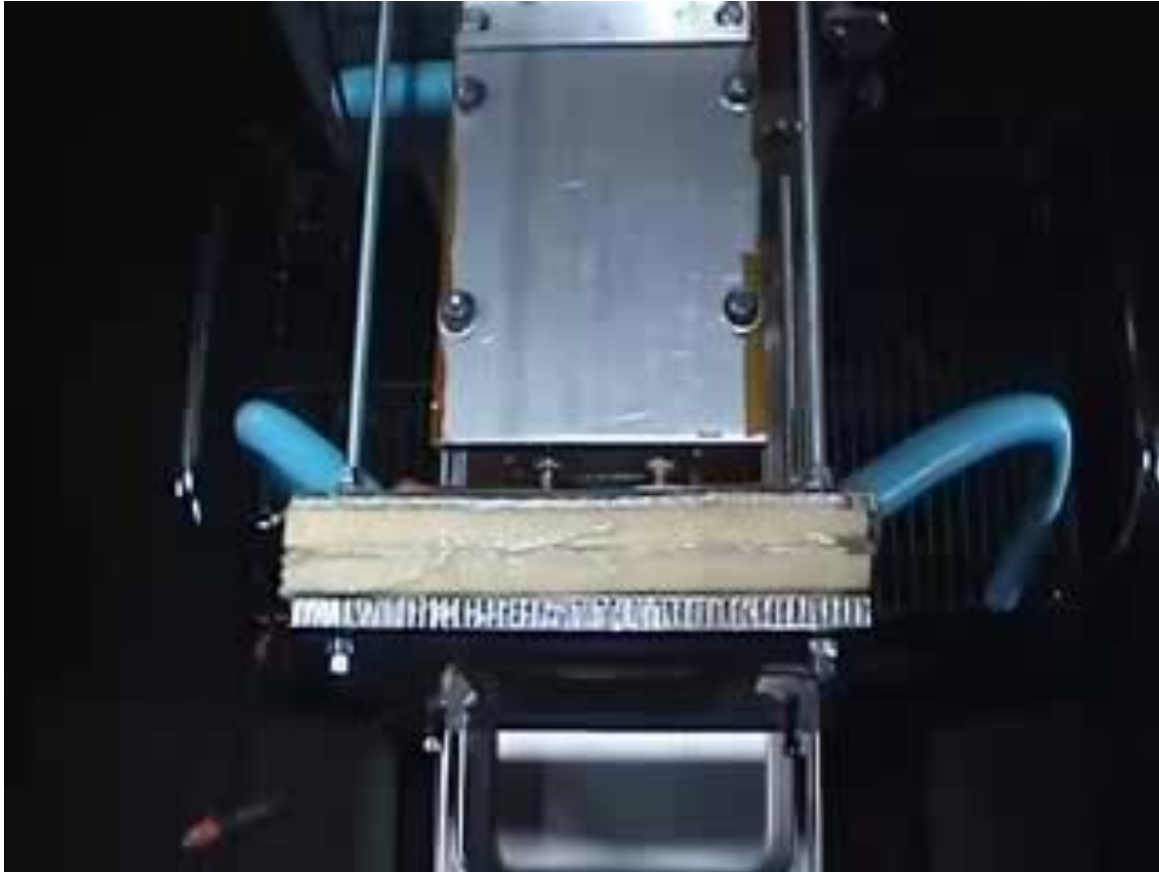
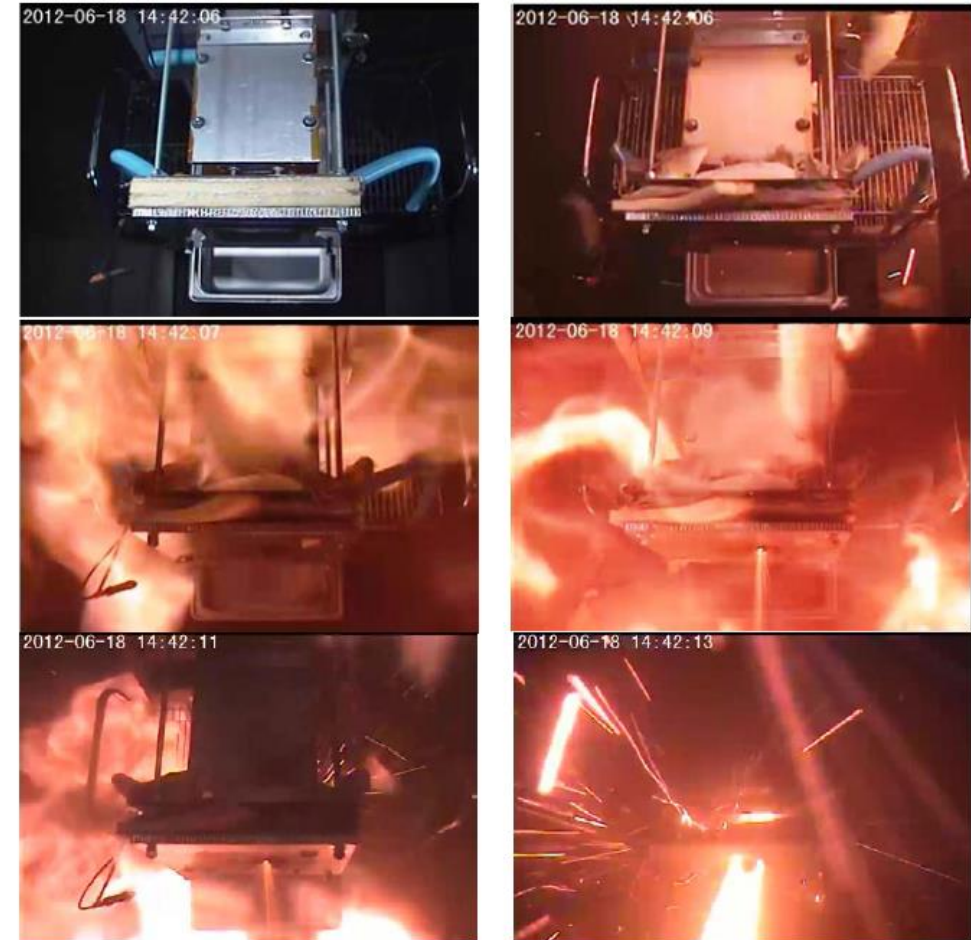
Test: HITF-12143, 1cm diameter Al @ 6.86 km/s

Figure 1.2-1. HITF12143 visible video frames at 1s-2s intervals after impact.

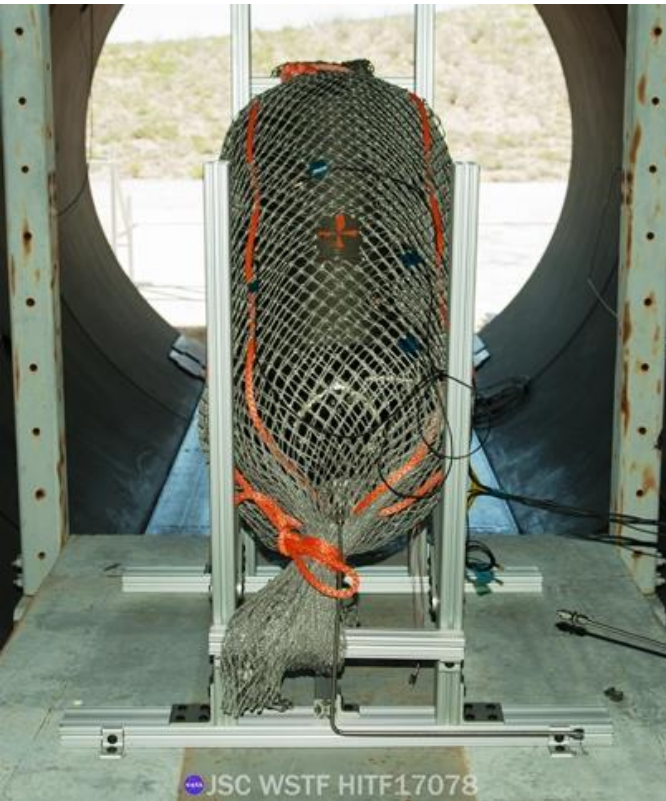
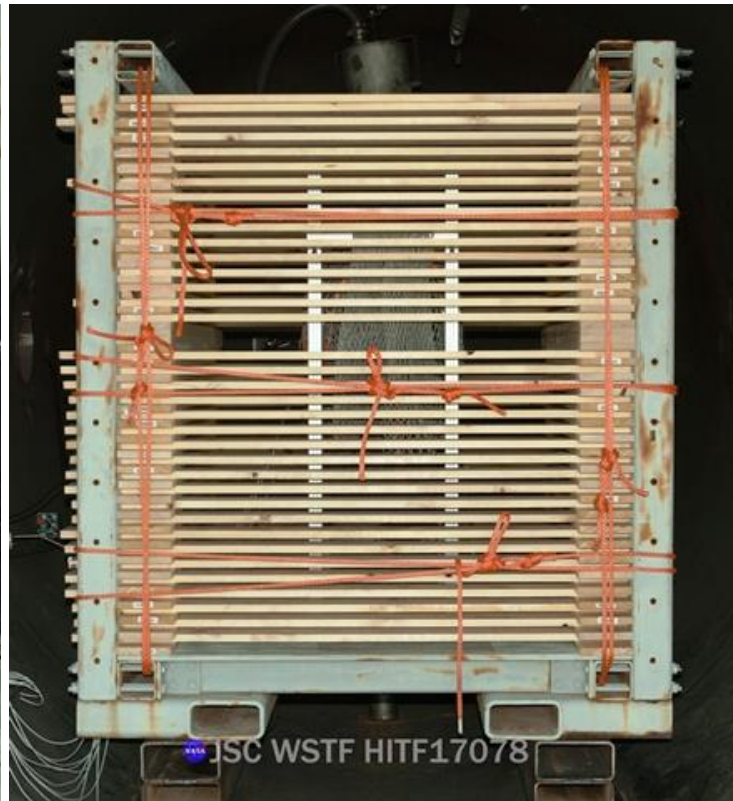
Before Test HITF17078  
(similar setup as HITF17552)

HVIT17552: 5.0mm Al @ 6.82 km/s, 0deg  
(note: buckling of 5/8" thick steel plate under the test article)
