# **STS-1 FORWARD RCS OXIDIZER TANK SUBSYSTEM STRUCTURAL FAILURE ASSESSMENT**

**K. Chauncey Wu  
Science Office for Mission Assessments  
NASA Langley Research Center  
[k.c.wu@nasa.gov](mailto:k.c.wu@nasa.gov)**

**CoSEM CDT  
University of Bristol  
June 3, 2024**

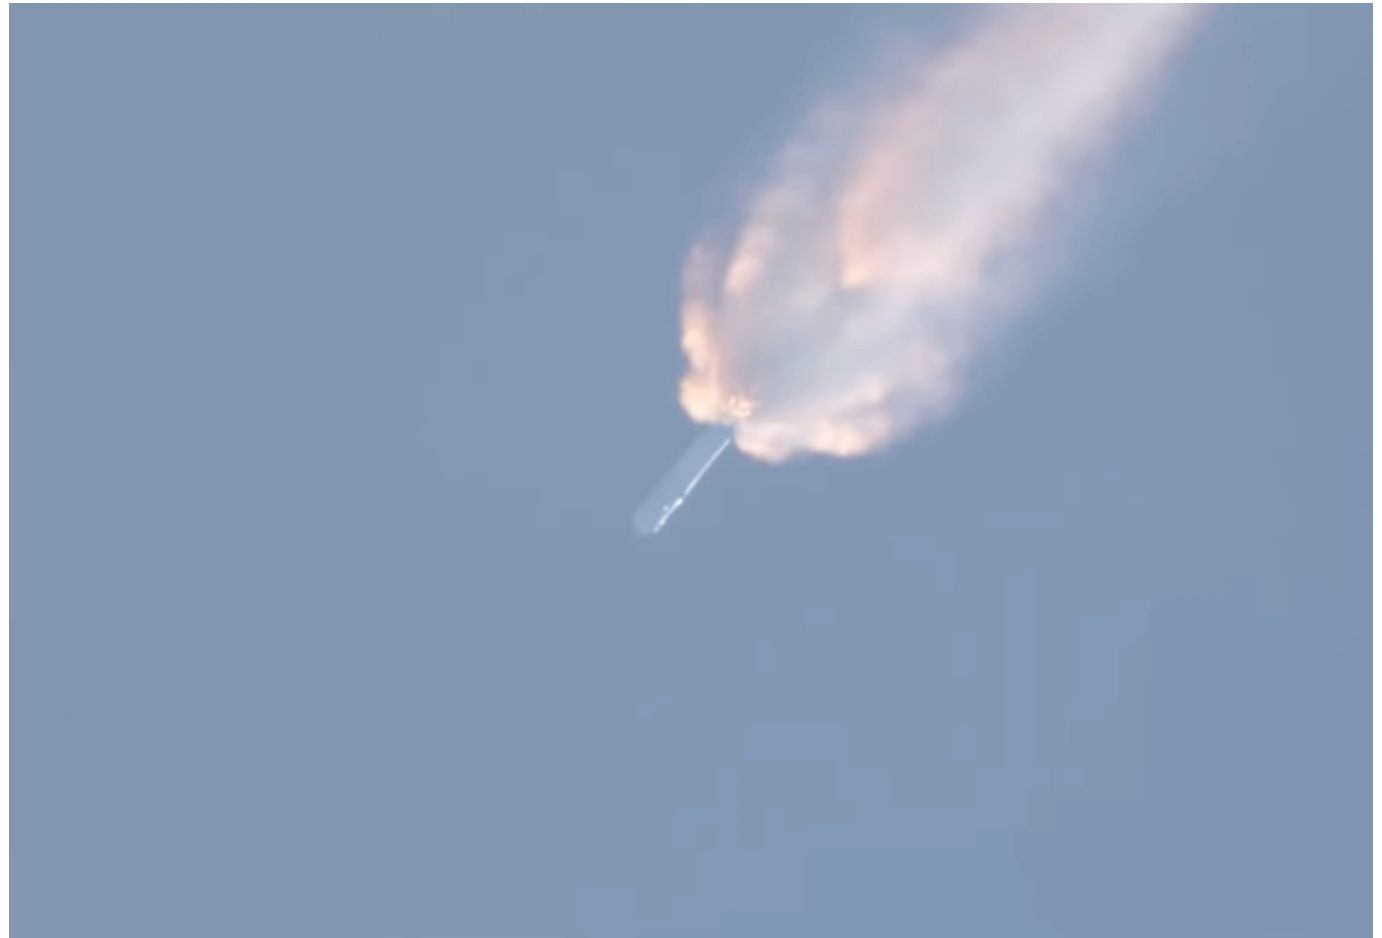
- ISS resupply mission CRS-7, July 2015
- 19th launch of SpaceX Falcon 9
- Stage 2 LOX tank ruptured on ascent
- He COPV *strut failure credible root cause*

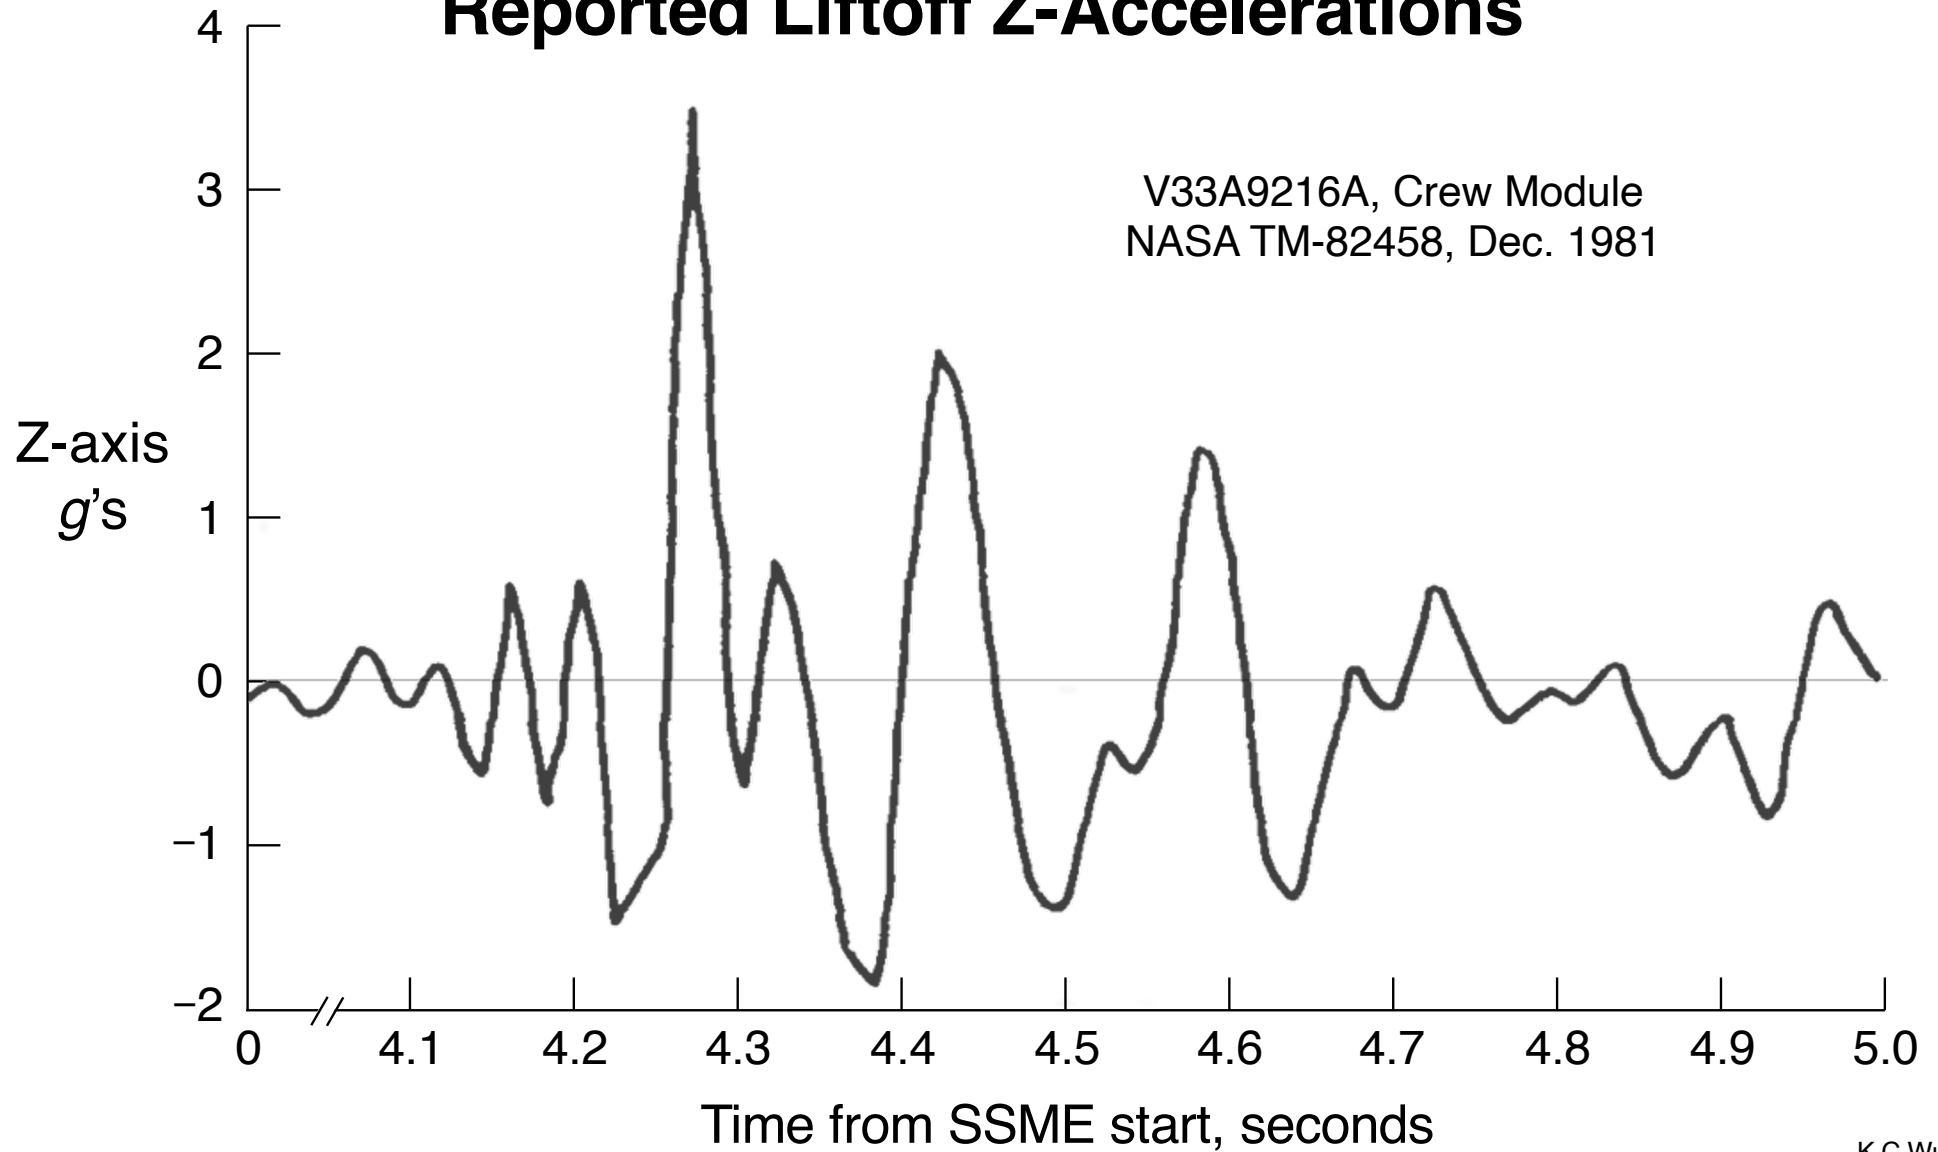
# Reported Liftoff Z-Accelerations

- At solid rocket booster (SRB) ignition, a strong transient IOP wave swept up the Shuttle stack
- SRB IOP environment was predicted pre-flight with analyses and scale-model testing
- **Orbiter frequency response to IOP was greater than pre-flight predictions, exciting vehicle bending**
- **Peak Z (normal) accelerations of  $-2\text{ g}$  to  $+3.5\text{ g}$  were reported in Orbiter cockpit**
- IOP also caused aft heat shield and aerosurface acoustic loading at or near design limits

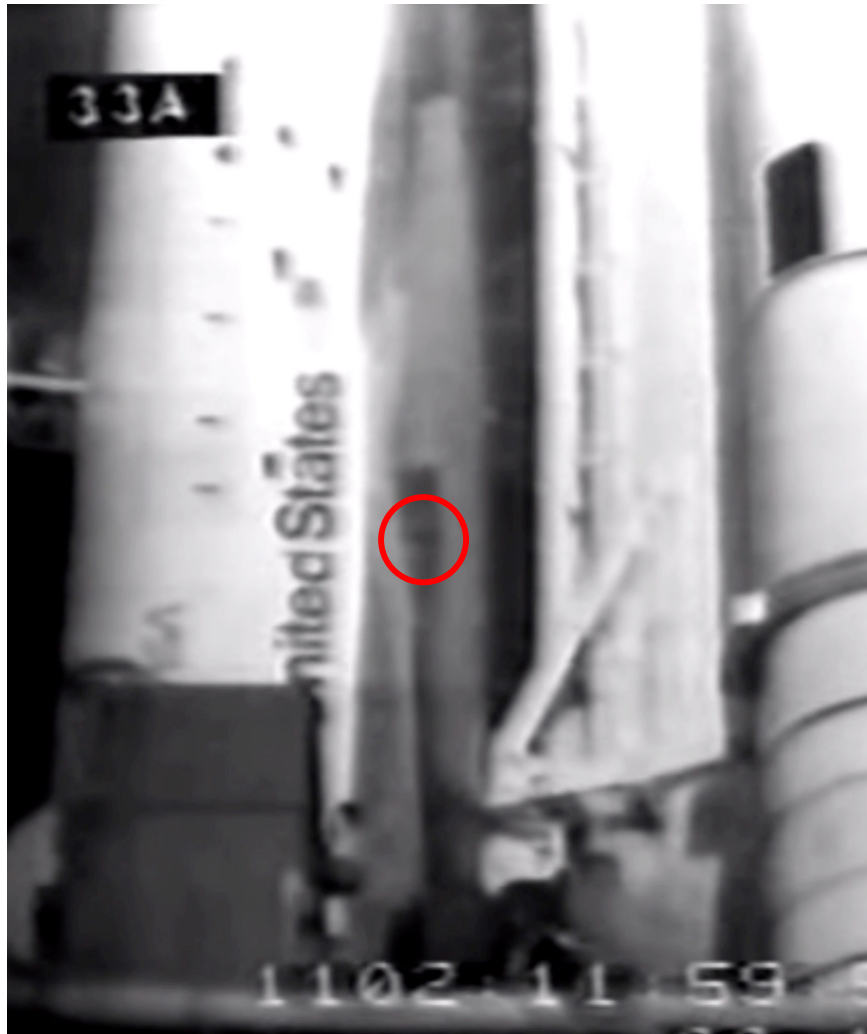
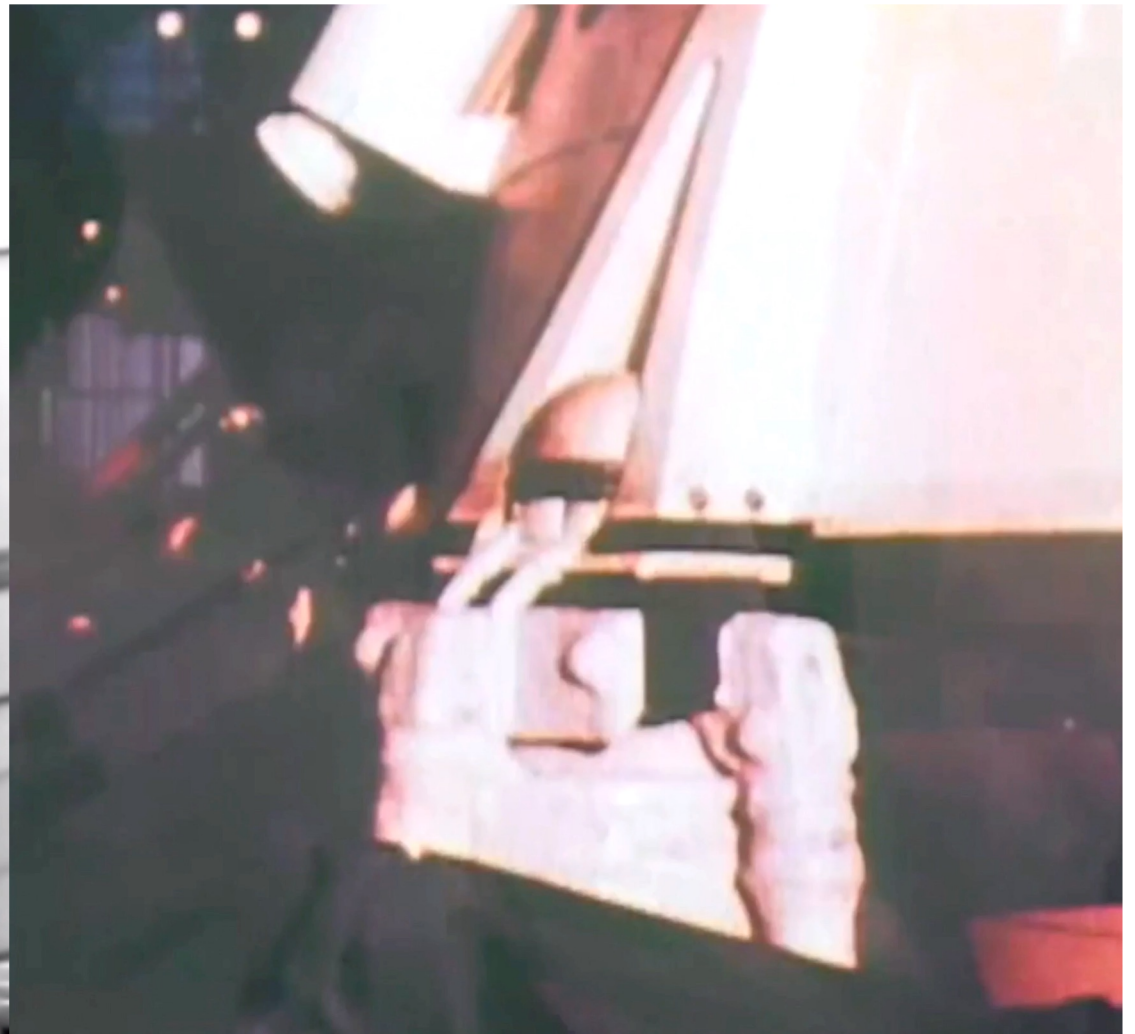
## Orbiter Aerosurface Response to IOP

- At solid rocket booster (SRB) ignition, a strong transient IOP wave swept up the Shuttle stack
- SRB IOP environment was predicted pre-flight with analyses and scale-model testing
- Orbiter frequency response to IOP was greater than pre-flight predictions, exciting vehicle bending
- Peak Z (normal) accelerations of  $-2\text{ g}$  to  $+3.5\text{ g}$  were reported in Orbiter cockpit
- **IOP also caused aft heat shield and aerosurface acoustic loading at or near design limits**

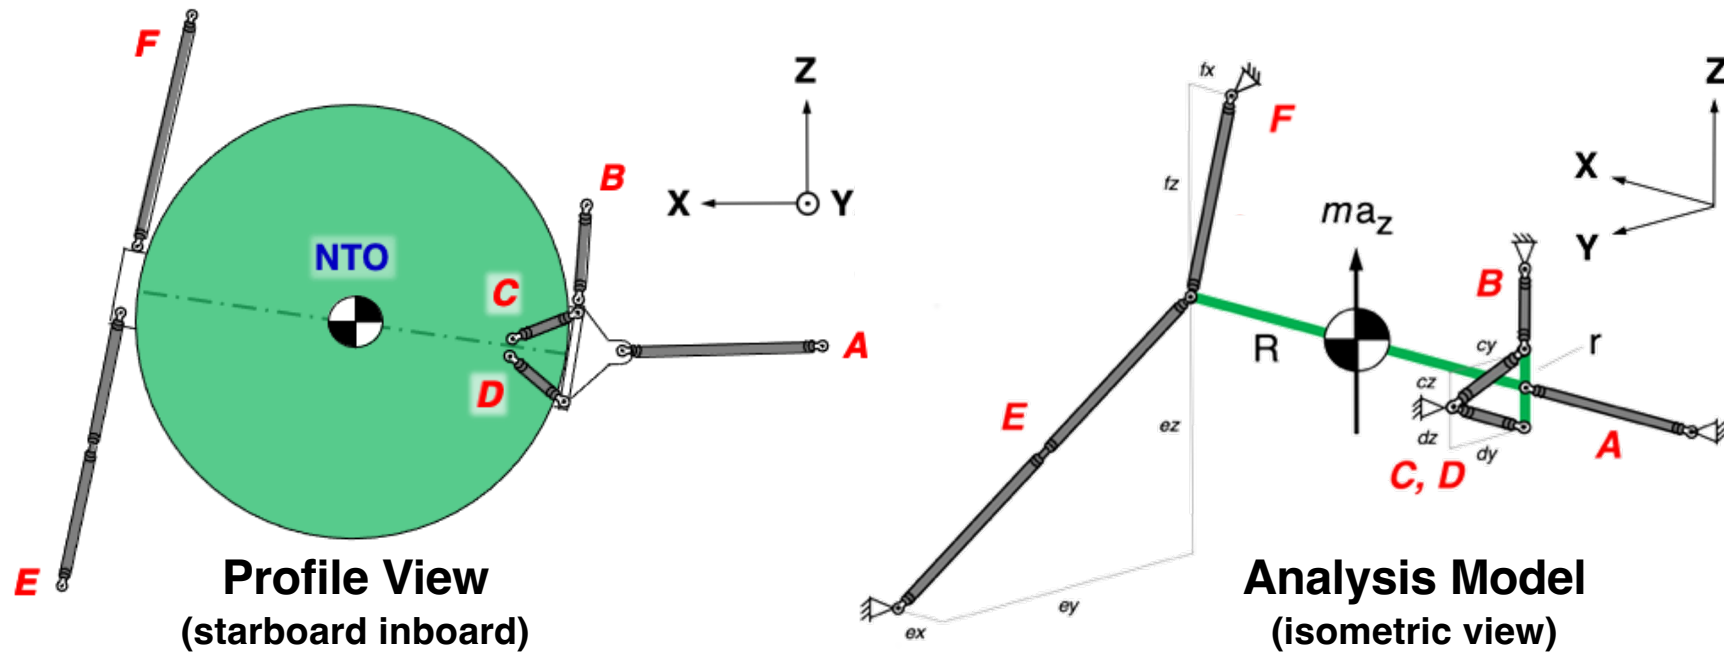
# Oxidizer Tank Subsystem Model

- Rigid tank and FRCS module structures
- Statically determinate  $\Rightarrow$  Solve equilibrium for individual strut forces  $P_i$ ,  $i = A, \dots F$
- Calculate  $P_F = -ma_z / (2 f_z)$ ,  $P_B = -ma_z / 2$

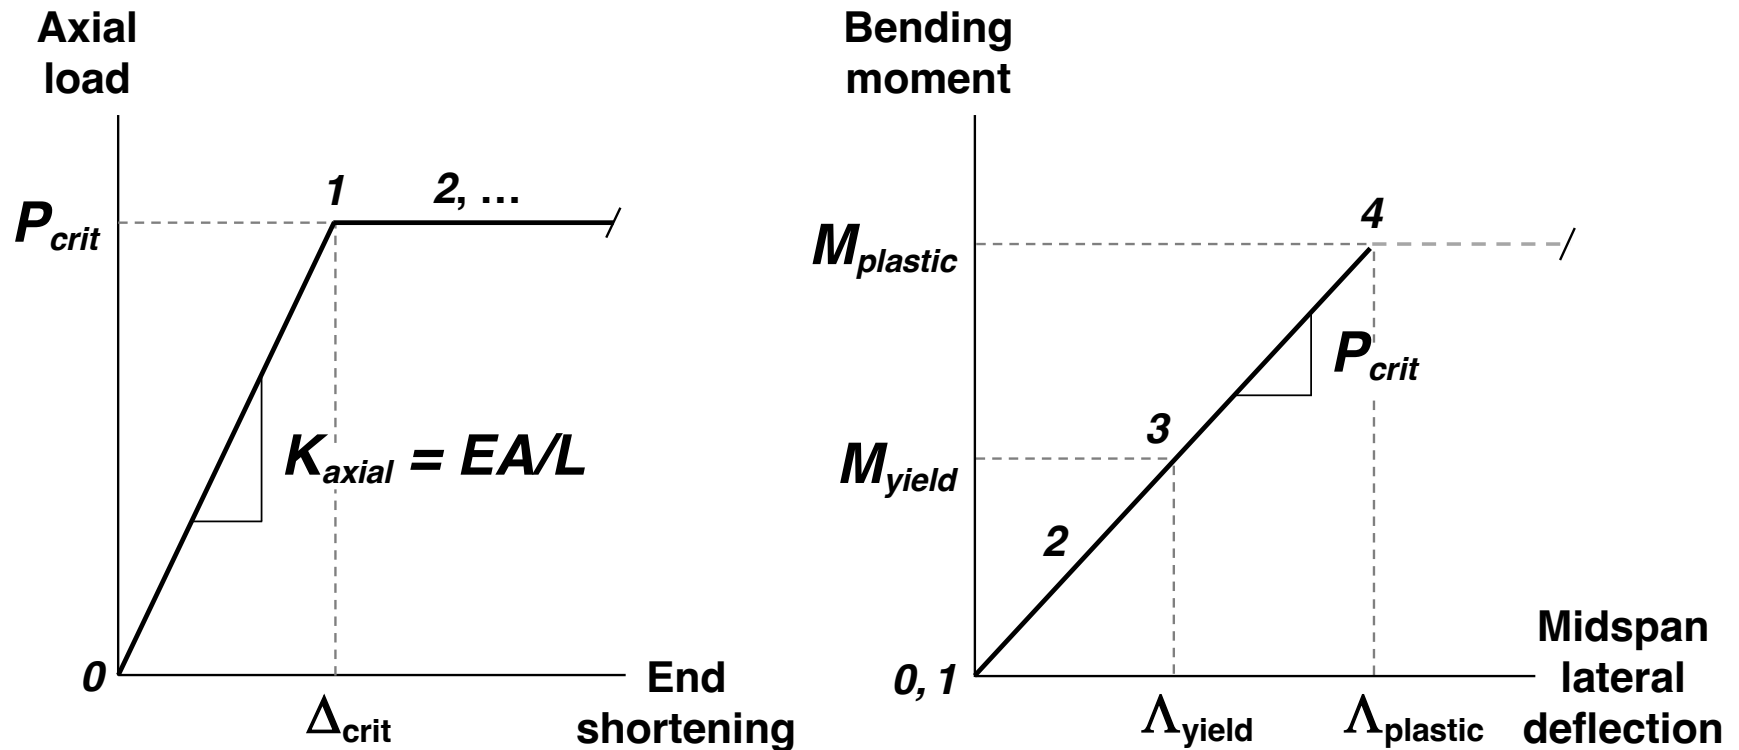
# Idealized Strut Structural Response

**Ti-3Al-2.5V material assumed elastic-perfectly plastic**

$$E = 15.4 \text{ Mlb/in}^2, \sigma_{cy} = -108 \text{ klb/in}^2$$

- Calculate Euler buckling load for slender strut  
 $P_{euler} = -4142$  lbf
- Static  $a_z = +5.24 g$  required for buckling
- Euler buckling is *elastic* failure  
 $\Rightarrow$  No lateral deflection for  $P < P_{euler}$ ;  $\Lambda = 0$

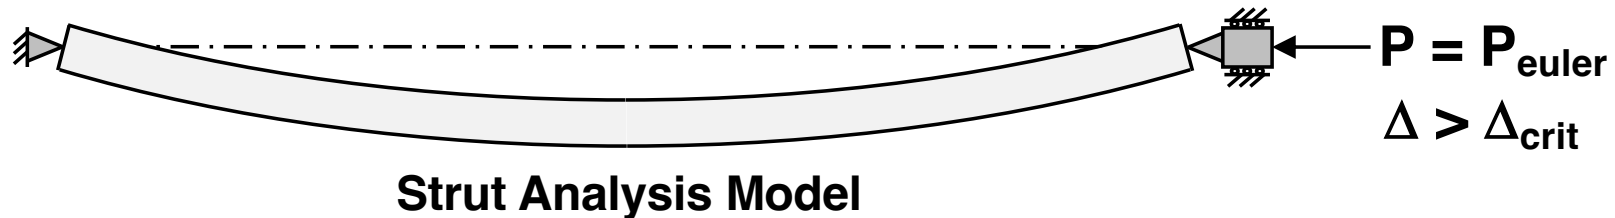
# NTO Strut *F* Structural Analysis

- Simplified analysis model developed
  - Actual dimensions;  $D = 1.25$  in.,  $T = 0.025$  in.
  - No geometric imperfections, pinned ends
  - Elastic-perfectly plastic material;  $E$ ,  $\sigma_{cy}$

- Calculate Euler buckling load for slender strut  
 $P_{euler} = -4142$  lbf
- Static  $a_z = +5.24 g$  required for buckling
- Euler buckling is *elastic* failure  
 $\Rightarrow$  Lateral deflection  $\Delta > 0$  for  $P = P_{euler}$ ,  $\Delta > \Delta_{crit}$
