NASA Exploration Toilet Hardware Status and Crew Feedback from ISS Artemis-2 Demonstration

Melissa McKinley¹, Melissa Borrego²,
NASA Johnson Space Center, Houston, Texas 77058

The Universal Waste Management System (UWMS), ISS operational nomenclature "Toilet", was initially installed on the International Space Station (ISS) in 2020 with final installation completed in 2021. Technical progress continues to be made with each on-orbit operation and will ultimately culminate with nominal US crew use of the hardware on ISS. During 2023, the Artemis-2 Demonstration was started, and this paper discusses issues encountered, on-orbit troubleshooting, subsequent ground failure investigation and proposed repairs as well as near-term plans to resume the Artemis-2 demo. Also discussed is an update to the commercial-off-the-shelf (COTS) Conductivity Monitor (CCM) which is planned to be flown for the resumption of the demo along with additional UWMS hardware and Toilet Integration Hardware (TIH). An updated design of the commode seat and fecal bag for Artemis-2 UWMS will be demonstrated on ISS and a summary of the hardware is included in the paper. Use of the hardware during the first days of t

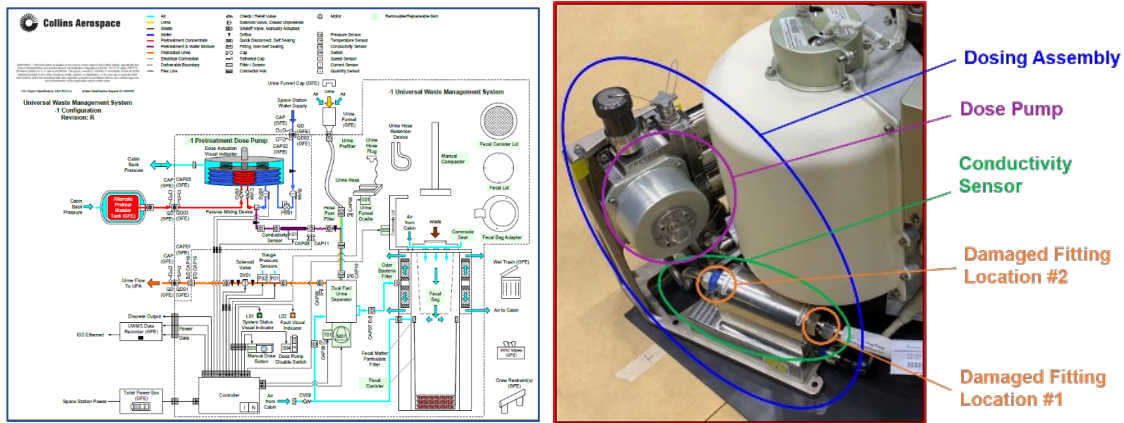
Figure 3, a. UWMS Flow Path for Urine and pretreatment, b. UWMS Dosing Assembly Hardware

Pretreatment of the urine is performed in both units to stabilize the urine for processing on ISS or venting on Orion. Orion uses Oxone, a heritage solid form for urine treatment. For the ISS unit, a strong acid solution of phosphochromic acid is used in liquid form. A nested bellows pump uses ISS water bus pressure to expand the bellows which draws pretreat solution in. Actuation of the dose pump dispenses both fluids into the urine stream. See Figure 3, a. flow path and b. for Dosing Assembly hardware identification.

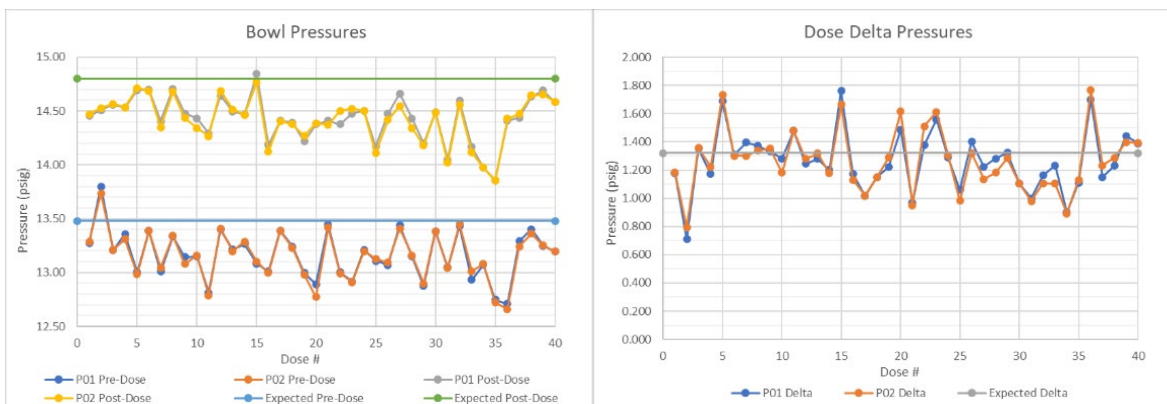
Figure 4. UWMS separator bowl pressure and Dose Delta Pressures during CCM check out operations.

The data used for indication of pretreat had previously been used successfully as seen below in data from the checkout of the COTS Conductivity Monitor (CCM). The pressure data indicated pretreat was successfully dispensed during the CCM Check out as seen in Figure 4. Forty manual doses were dispensed during the checkout of the MSFC supplied CCM to evaluate if pretreat was being dispensed. This was for two purposes; one to evaluate the new CCM operation but also to prepare for additional crew use of UWMS. Pressure readings were similar to previous data seen during the checkout of UWMS in 2021. The average pre-dose pressure was 13.16 psig and the average post-dose pressure was 14.43 psig. The average delta-pressure was 1.27 psig. This indicated that pretreat seems to be present, if possibly 10% low, and crew operations can be started. Pressure readings are compared to previous data on the ground and on-orbit and reflect a comparison to expected differences in specific gravity for water and the pretreat concentrate and water mixture.

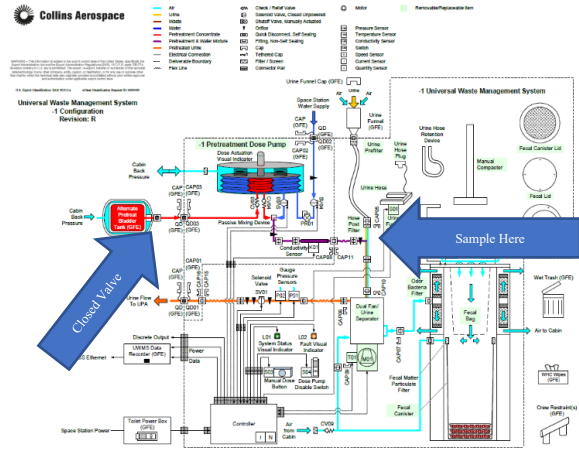
Figure 10. Location of sample taken and valve closed for troubleshooting

Troubleshooting was performed on-orbit to validate the pressure data and determine if pretreat was not actually dispensing. This troubleshooting included drawing a sample from the base of the urine hose for a color check as seen in the schematic below, Figure 10. Crew reported that the fluid retrieved was a very small sample but very obviously a clear liquid. If pretreat was present the liquid is expected to be some hue of orange because at this point in the schematic the fluid is expected to be pretreat/water only (no urine). This finding supported the pressure data analysis that no pretreat was present. The color of the urine and fluid collected in an external tank was evaluated as well. As seen in Figure 11, the color was seen to be urine only. At this point in the process, the pretreat and urine solution is expected to be a deep green color (changes during oxidation from orange to green.) The color of the collected fluid was seen to be yellow, Figure 11, which also supports the pressure sensor data review.

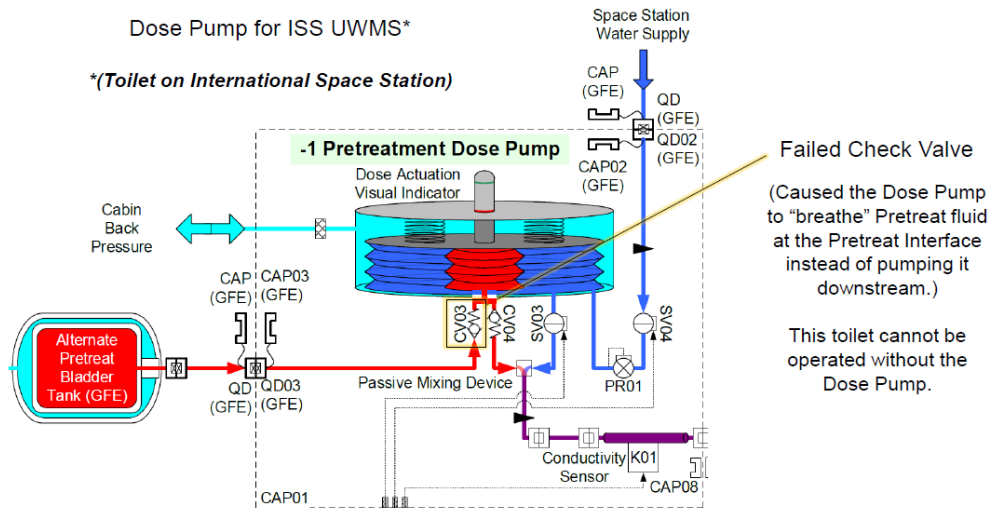
Figure 12. Dose Pump schematic for ISS UWMS

Further testing was done on-orbit to provide insight into the cause of the failure of the dose pump to dispense pretreat solution. The pretreat tank valve was closed (See Figure 10) and dose pump was cycled to inform if the issue within dose pump is with the inlet or outlet check valve, see Figure 12 for details on dose pump and location of check valves. Testing confirmed that it was likely the inlet check valve, CV03, had failed although there was some concern that the outlet check valve, CV04 failed. Ground testing was needed to confirm actual status of these valves.

Based on the pressure sensor data and the testing performed on-orbit a fault tree was developed to guide additional testing. The Dosing Assembly was returned on SpX-28 and was delivered to the Collins Houston lab for evaluation. Testing confirmed that the inlet check valve, CV03, was not operational. Testing on the UWMS failed Dose Pump returned from ISS showed the same results as seen on-orbit with determination that the inlet check valve (pretreat tank side) failed open. Inspection of the check valves after removal from the dose pump showed a piece of the Polyether Ether Ketone (PEEK) shroud from the inlet check valve (CV03) in the inlet side of the outlet check valve (CV04). A

photograph of the inlet of CV04, showing the fractured piece of PEEK shroud (approximately ¼ of the total circumference) with pretreat still present is also shown in Figure 13. Subsequent inspection and disassembly of CV03 at the Raytheon Technology Research Center (RTRC) did confirm that the PEEK piece found in CV04 came from the CV03 shroud. Additional fragments were also recovered from the dose pump bellows assembly after flushing operations.

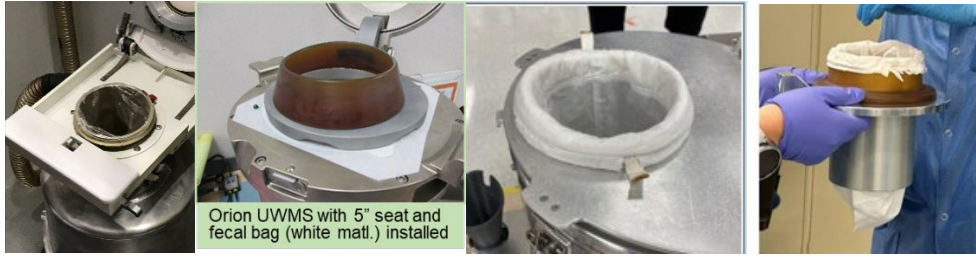
Figure 22. Russian WHC use with fecal bag, Orion UWMS with original 5" seat and original UWMS fecal bag installed, LOO seat design with fecal bag installed, updated seat with updated fecal bag (design #2).

The Russian WHC opening with the seat lifted out of the way is 4” in diameter which is equivalent to the smaller of the UWMS seats provided. The HLS LOO seat is 4.3” in diameter. The updated designed seat matches the current WHC opening which crew says is preferred. Two designs were developed. Both have the same interface and bag attachment. The second design has an extended section to direct air flow down the length of the bag. Seats are seen in Figure 22. Testing is needed to validate which design will be chosen to fly on Orion’s Artemis-2 mission.

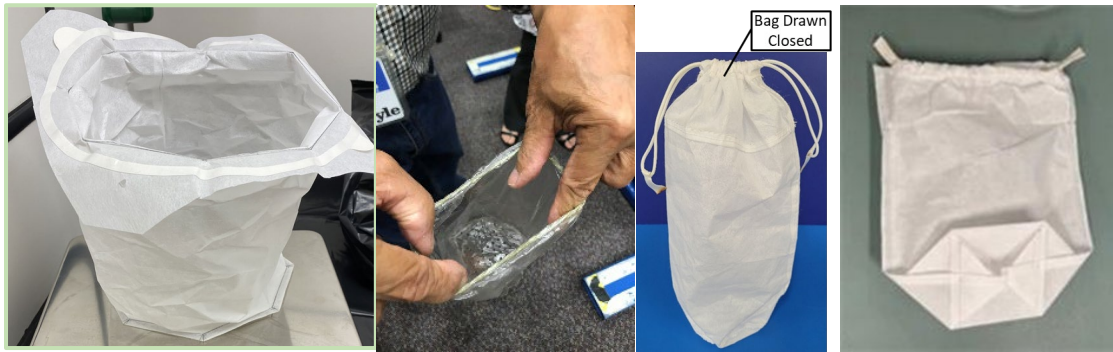
Figure 23. Original UWMS fecal bag, Russian WHC fecal bag, LOO fecal bag and updated fecal bag.

The fecal bag has a significantly reduced volume based on crew comments that the size was too large. The fundamental design change is the location over the seat which mimics the WHC arrangement. The bag also utilizes

a drawstring closure which is very similar to the WHC design. These design updates were made at crew request. Fecal bags are shown in Figure 23.

Testing on-orbit is needed to validate air flow, efficiency, and actual use in micro-gravity with air flow.
