# NASA Exploration Toilet Hardware Technical Challenges and Accomplishments

**The Universal Waste Management System (UWMS), ISS operational nomenclature “Toilet” was initially installed on the International Space Station (ISS) in 2020 with final installation completed in 2021. Technical progress continues to be made with each on-orbit operation and will ultimately culminate with nominal US crew use of the hardware on ISS.**

**During 2024, another attempt was made to perform the Artemis II Demonstration on ISS with a re-flight of the Dosing Assembly using original components. This paper discusses the issues encountered when the Dosing Assembly failed to dispense pretreat as well as a subsequent failure to start of the UWMS and the on-orbit troubleshooting resulting in the removal and return of the controller. A summary of ground troubleshooting of the controller (which is the Orion common controller used in the Orion vehicle for numerous systems) as well as planned repairs is discussed. An updated design of the commode seat and fecal bag for Artemis-2 UWMS was demonstrated on ISS and a summary of the hardware, results and selection of seat for use on Artemis-2 is included in the p

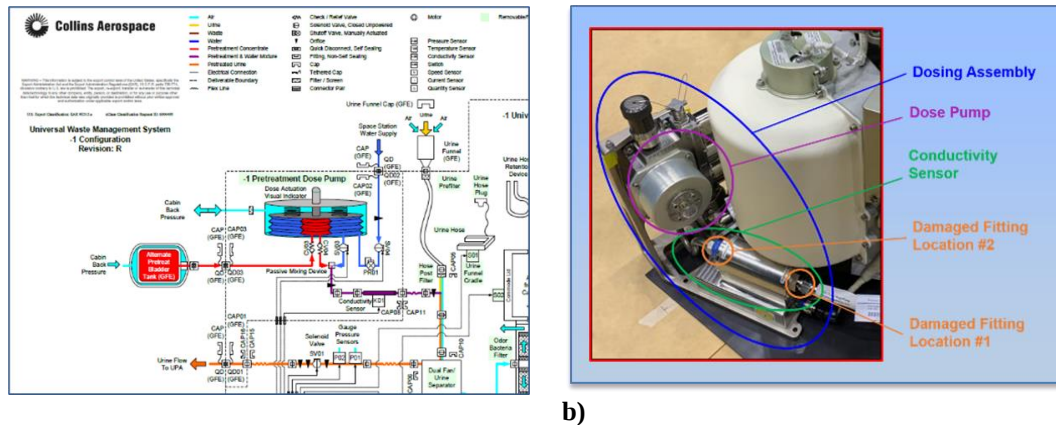
Figure 4. a) UWMS flow path for urine and pretreatment, b) UWMS dosing assembly hardware.

the urine stream. See Figure 4, a) flow path and b) for dosing assembly hardware identification.

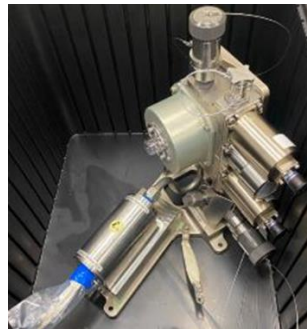
Figure 5. UWMS spare dosing assembly.

After 70 manual doses, the CCM read ~0.0 mS/cm consistently indicating only water in the lines. The separator delta-pressure readings agreed with that condition suggesting only water is entering the bowl. A visual inspection by crewmembers of the Dose Pump Pretreat Hose Quick Disconnect indicated no pretreat was present. Pretreat concentrate (dispensed by dose pump) is a dark orange-red, when diluted with water during dosing, it goes to a dark yellow-orange (pretreat.) Pretreat Lite (used for launch) is a light-yellow fluid. Water has no color which in this case indicated no presence of pretreat solution of any concentration.

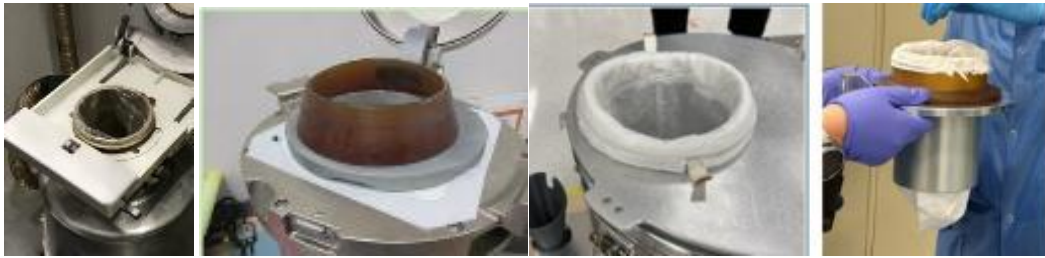
The Russian WHC ACY opening with the seat lifted out of the way is 4" in diameter which is equivalent to the smaller of the UWMS seats provided. Crew uses WHC ACY in this manner to avoid excessive cleaning needed with the ACY seat. UWMS originally included a 4" seat and a 5" seat (referring to the opening size.) The HLS LOO seat is 4.3" in diameter. The updated seat opening matches the current WHC opening (4") which the crew prefers. Two designs were developed. Both have the same interface and bag attachment. The second design has an extended section to direct air flow down the length of the bag. Seats are seen in Figure 8. Testing is needed to validate which design will be chosen to fly on Orion's Artemis II mission.

**Figure 8. a) Russian WHC use with fecal bag, b) Orion UWMS with original 5" seat and original UWMS fecal bag installed, c) LOO seat design with fecal bag installed, d) Updated seat with updated fecal bag (design #2).**

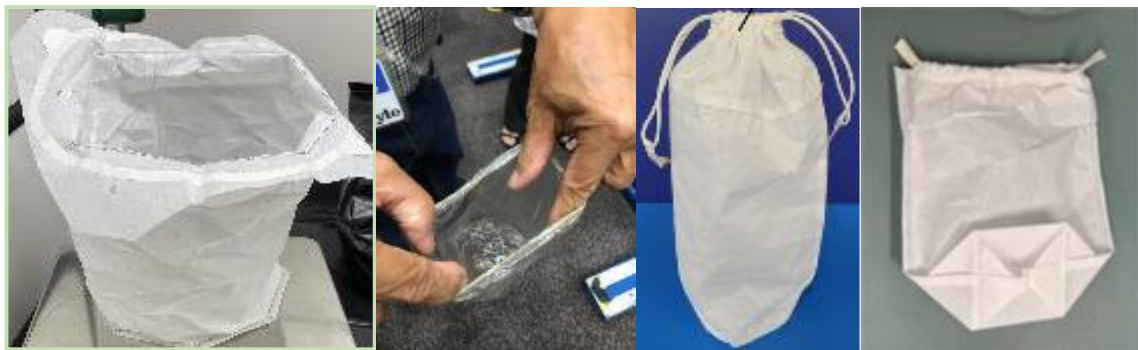
The fecal bag has a significantly reduced volume based on crew comments that the size was too large. The fundamental design change is the location over the seat which mimics the WHC arrangement. The bag also utilizes a drawstring closure which is very similar to the WHC design. These design updates were made at crew request. Fecal bags are shown in Figure 9.

**Figure 9. a) Original UWMS fecal bag, b) Russian ACY Insert, c) LOO fecal bag, d) Updated fecal bag.**

Based on crew opinion detailed above, the Orion program is building replacement fecal bags and seat in these updated designs for Artemis II. The hardware is in production and delivery is planned for April 2025. The seat will be installed into the Artemis II UWMS unit prior to launch and the fecal bags will be stowed in place of the original fecal bags currently manifested. Final acceptance by Orion includes a slight mass increase of the seat shown in Table 3.

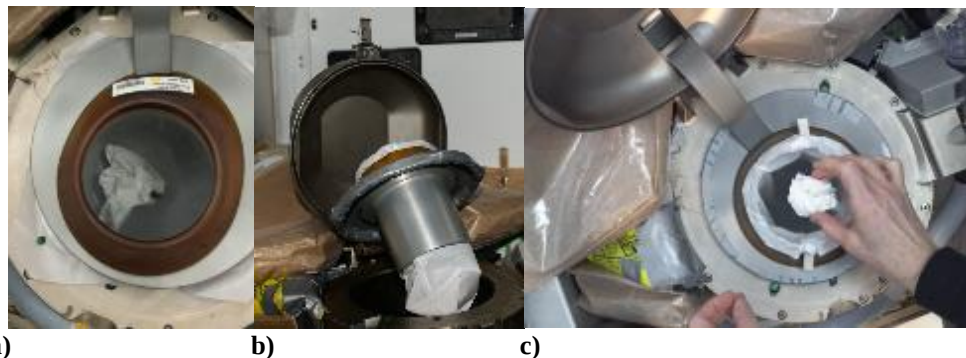
Testing of the updated designs of the fecal bag and commode seat was done on-orbit using UWMS in June 2024 with UWMS on but was only an air flow evaluation. No actual crew use (defecation or urination) was performed during the evaluation. The crewmember was asked to tape the sides of the seat carrier to force the air inlet down the interior of the seat/bag combination. The original design bag placement was under the seat and air flow was directed under and above the seat seen in Figure 10 a). The updated design attaches the fecal bag around the top of the seat

**Figure 10. a) Original 5" Toilet Seat, b) 4" Toilet Seat, Grooved with Tube, c) Overhead view showing tape locations and placement of tissue for test.**

Results of the on-orbit testing were shared with the crew community at the Artemis crew tag-up. Crew member who performed the test spoke with Artemis II prime crew members who concurred with using the recommended seat selection as indicated from the on-orbit testing results, 4" Toilet Seat, Grooved with Tube and the Fecal Bag, Elastic 7".
