# CT Scanning of Commercial Cells for Space Flight Applications

IAPG CWG Safety Panel Meeting

David Delafuente, NASA JSC

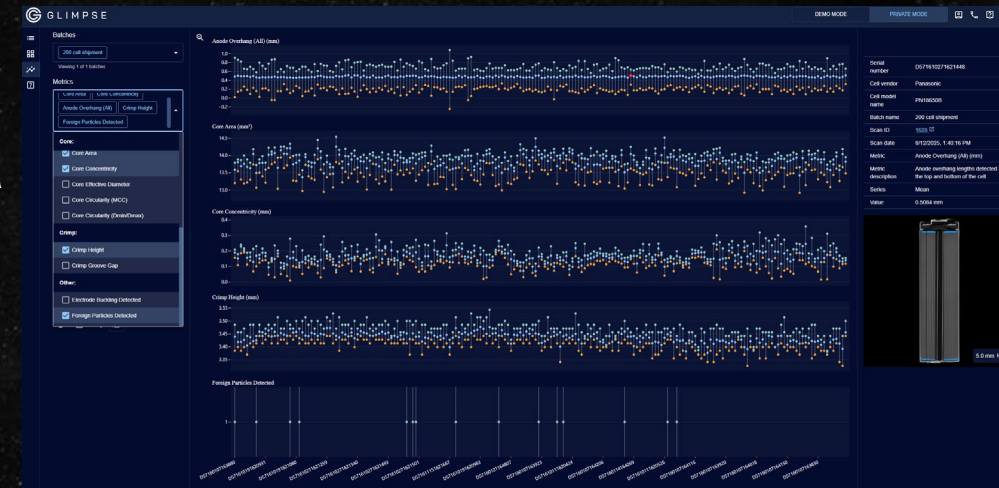
Example scan of the cell header region and analysis for multiple parameters

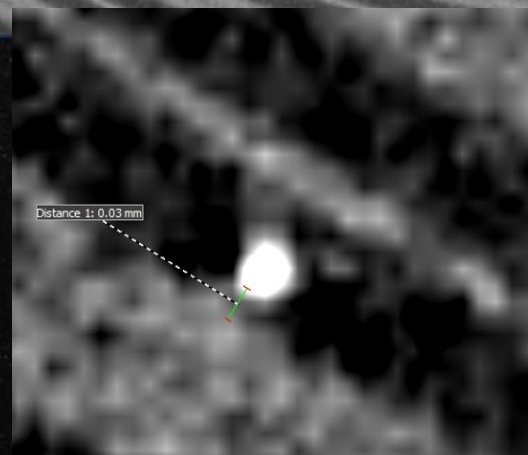
# Scan 1506

~50 $\mu$ m in size

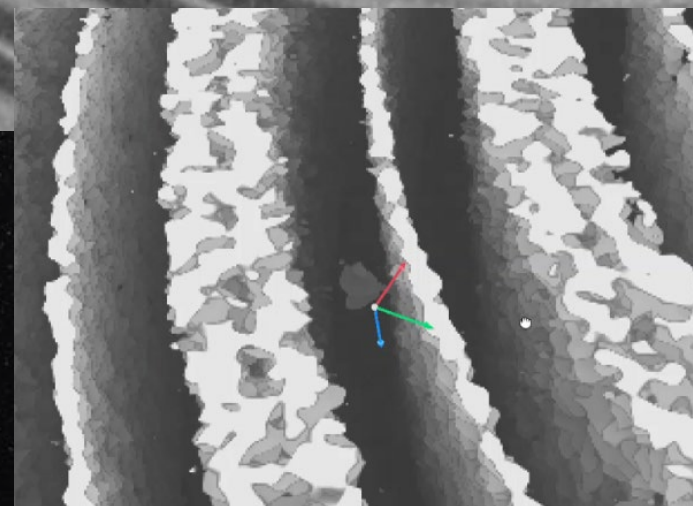
# Scan 1571

~60 $\mu$ m in size

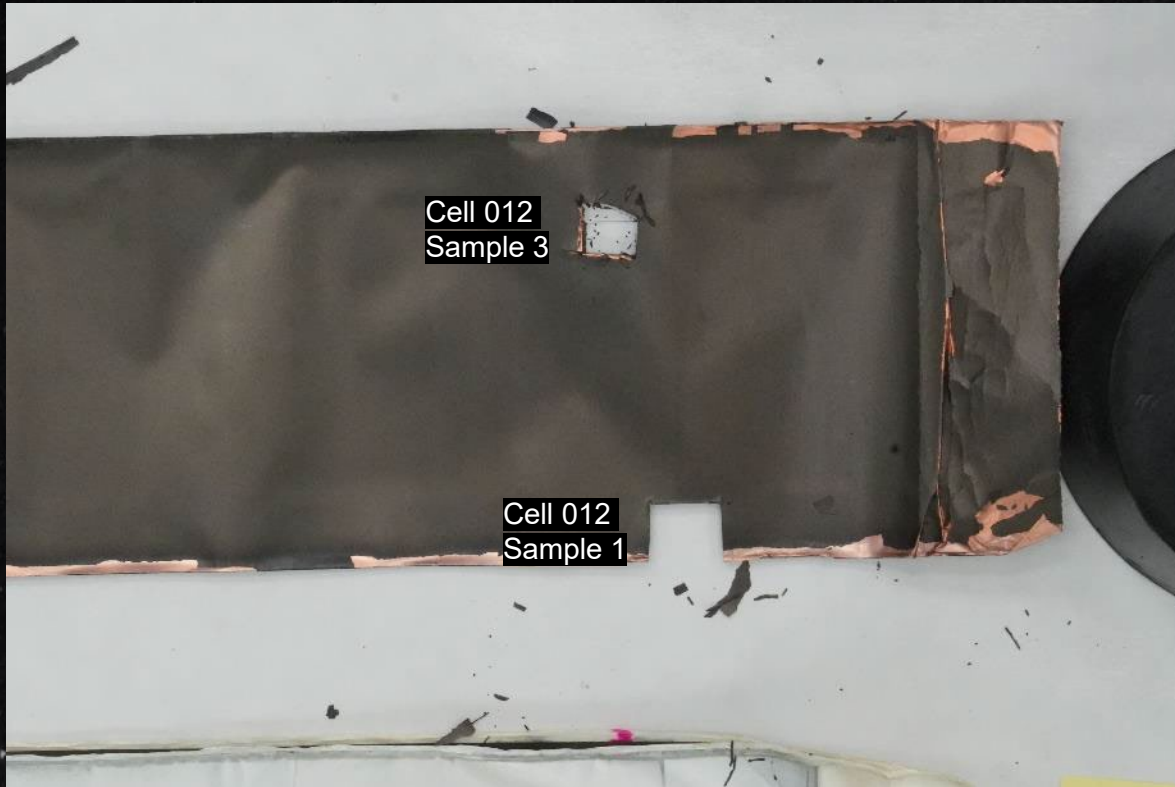
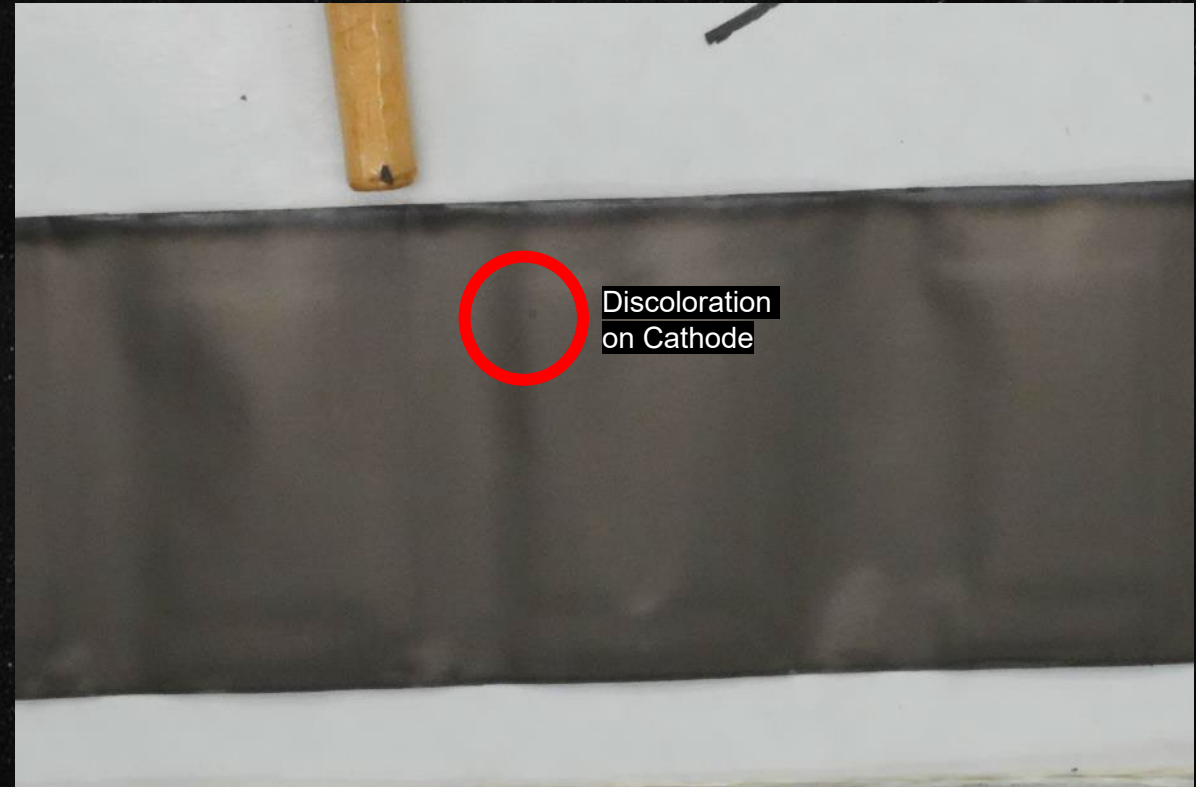
# Cell 1517 – Samples Taken & Defects

- CT Scan found metallic particle
- Sample 1 taken to search for this particle based off where it should be in cell
- Nothing was found matching CT scan
- More noticeable particle seen on Sample 3, on opposite side of cell

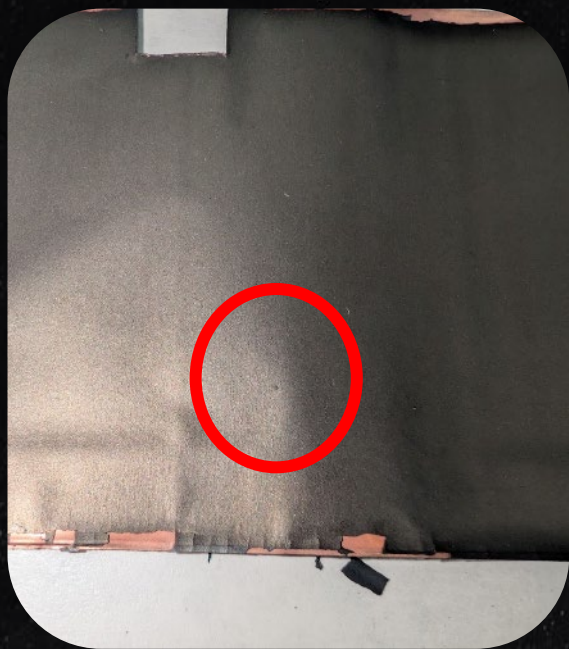
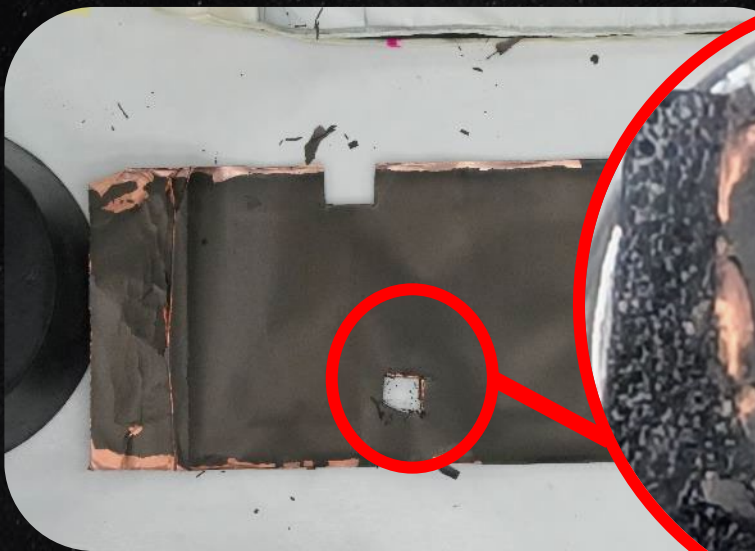
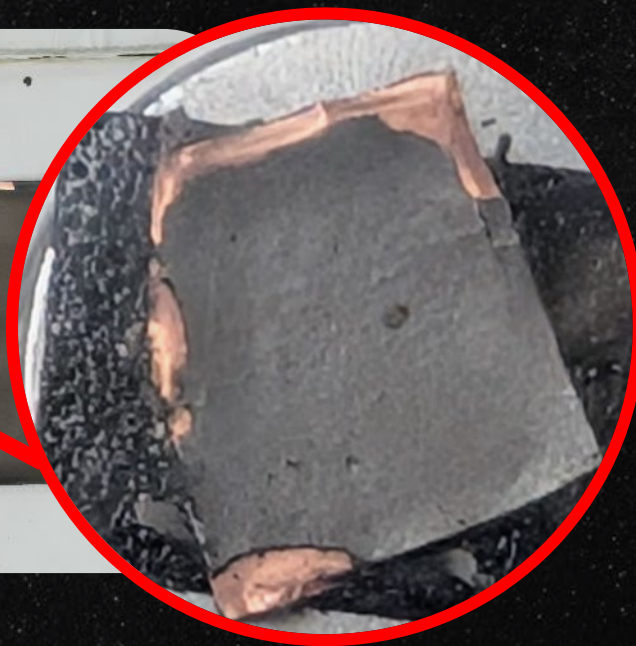
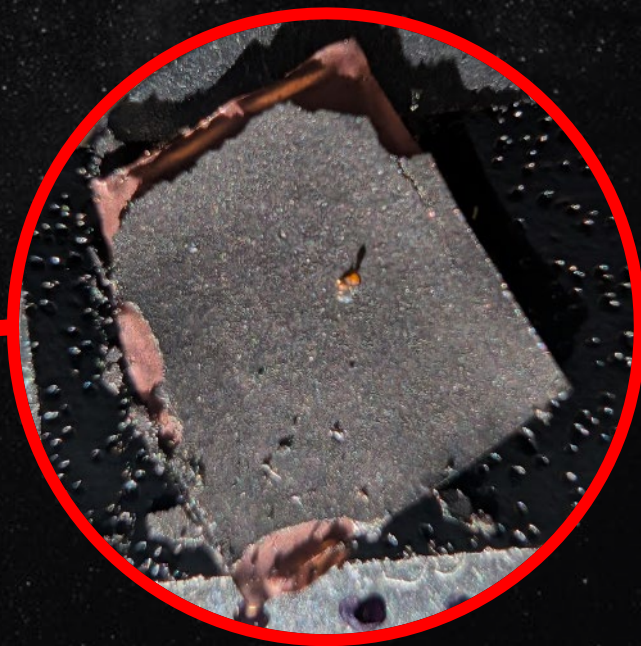
# Cell 1571, Sample 3

- Small bump seen on Anode Side C
- Not seen in CT scans
- Perhaps there was somehow a migration from one location to another? Seems unlikely
- Unlikely to be FOD from DPA process or something that fell on this while unrolling jellyroll. Saw this right as jellyroll was unrolled
- SEM & EDS seen in next slides

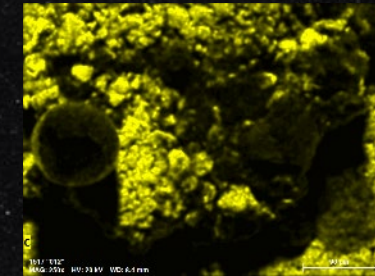
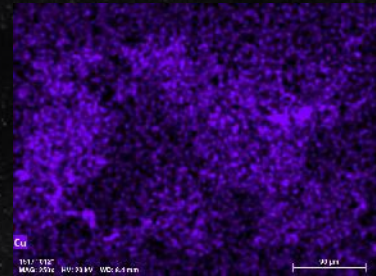
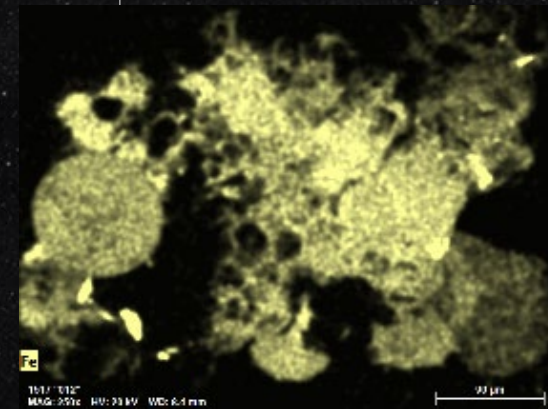
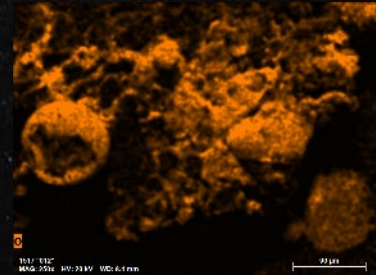
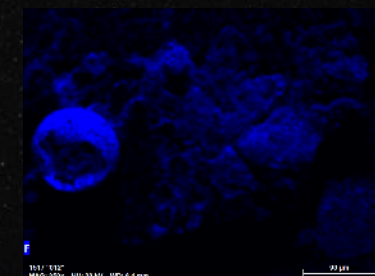
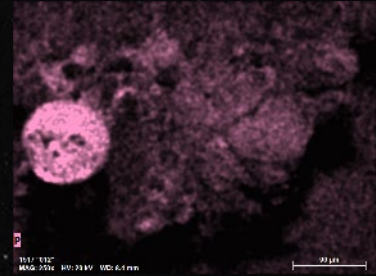
# Cell 1517, Sample 3

- EDS indicates this is composed of mainly iron, oxygen, fluorine, phosphorus

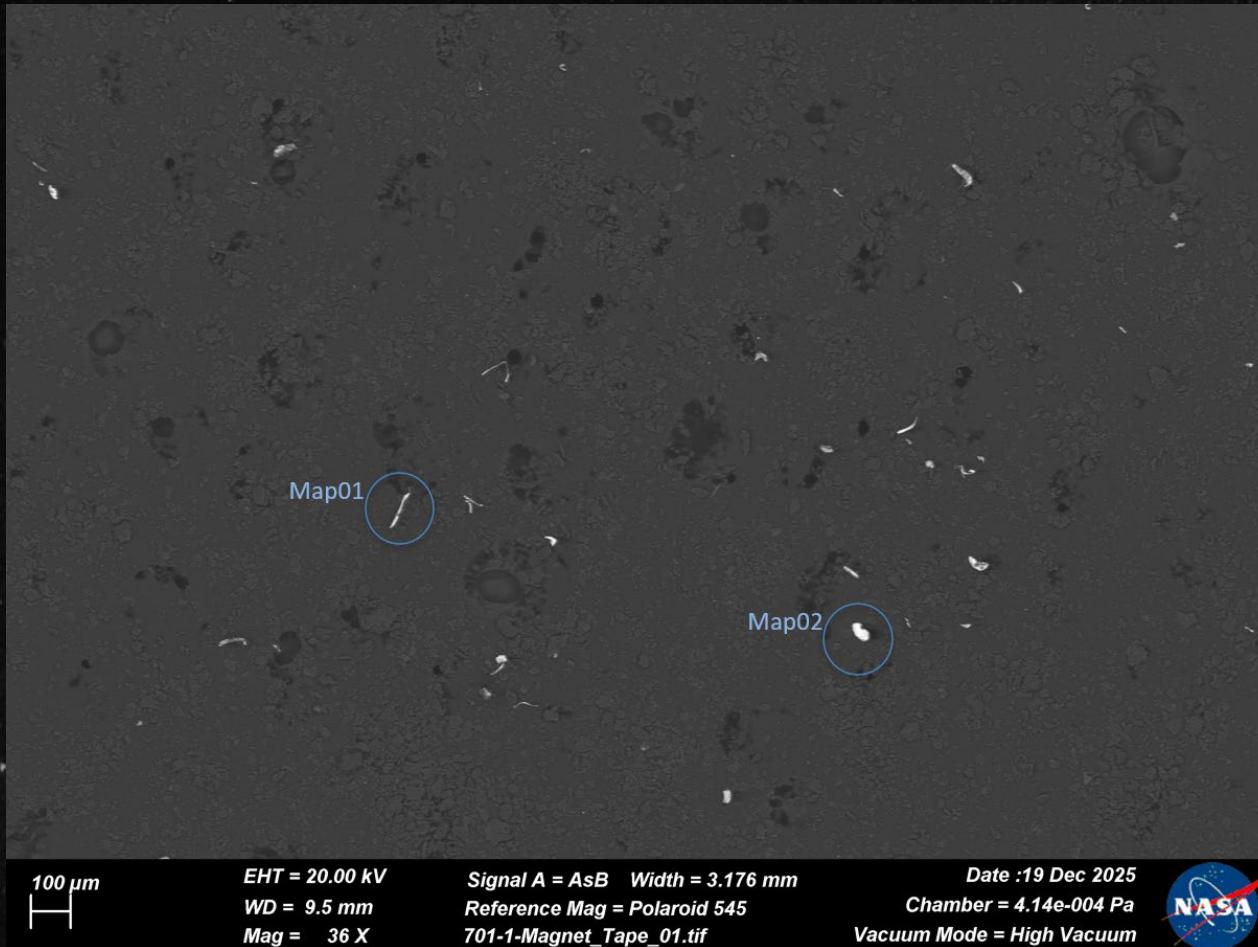
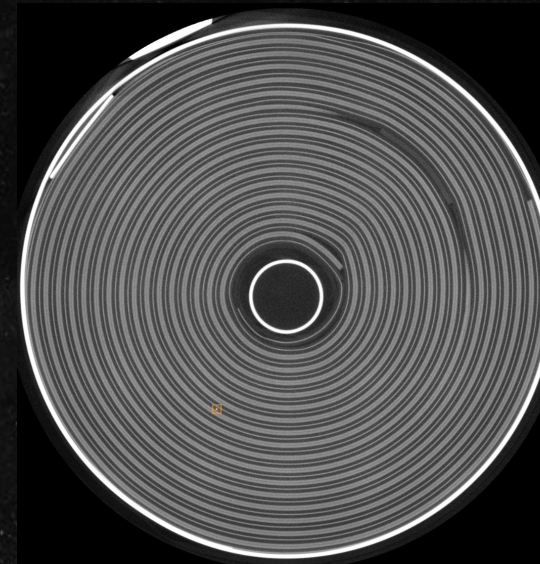
1506, particle of interest

- Anode was scraped and collected using a ceramic blade then using a magnet to extract the particles onto carbon tape
