# ISS Radiator Face Sheet Anomaly Investigation and Return to Function

Aaron Rodriguez<sup>1</sup> and Richard Morton<sup>2</sup>  
*NASA, Houston, TX, 77058*

Maintaining sufficient heat rejection on the International Space Station (ISS) is critical to the function of the Low-Earth Orbit station. The External Active Thermal Control System (EATCS) rejects the excess heat generated by the US On-Orbit Segment (USOS) modules. The system uses single-phase liquid ammonia to collect the heat and reject it to six radiators (three on the Starboard side, three on the Port side). Each radiator is made up of eight panels. In September 2008, imagery of the Starboard radiators was conducted and showed one of the panels' face sheets had peeled up from the internal honeycomb core structure. Out of an abundance of caution, the radiator was isolated from the rest of the EATCS and the ammonia was vented to space. Since the radiator was vented, periodic imagery of all radiator panels was taken to monitor any changes in the face sheet and inspect for other radiator anomalies. In January 2025, after years of trending and inspections, the radiator was reintegrated into the system to increase heat rejec

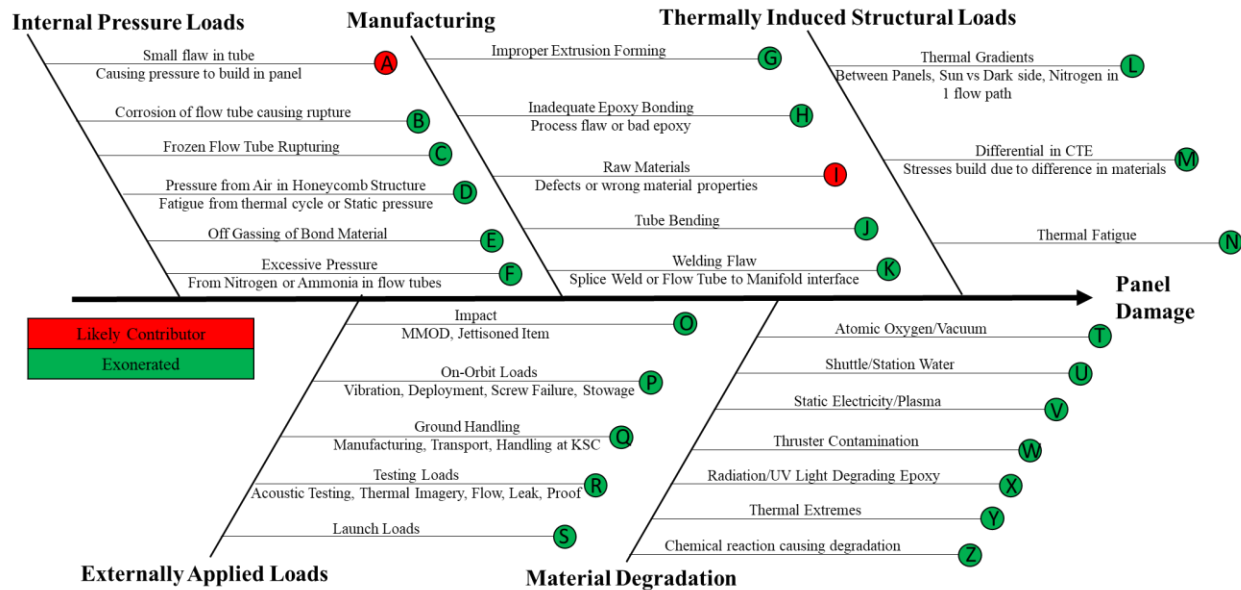
Figure 3. Simplified Fault Tree.

The failure team used a combination of analysis and data from Qualification and Acceptance testing to close many of the branches of the fault tree. The thermal load induced by gradients, differences in CTE (Coefficient of Thermal Expansion), and thermal cycling of the hardware all had margin to failure. The thermal extremes were also well below the temperature that would impact the material properties.

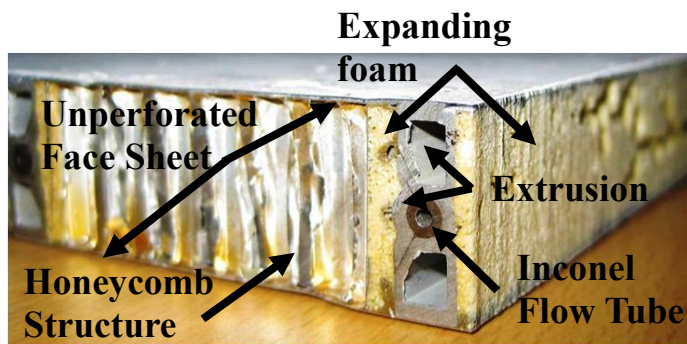
A suite of testing was proposed but due to funding constraints, only a subset was funded by the NASA Engineering and Safety Center (NESC). Four tests were conducted to inform the failure investigation. The first was an evaluation of the qualification radiator. The second tested residual stock of 12-foot flow tubes with the third test using flow tubes taken from the qualification radiator. The final test pressurized a representative sample of the panel including flow tubes, epoxy, honeycomb structure, and face sheets (see Figure 4).

Figure 4. Cross Section of Radiator Panel.
