# A Review of Pump Package Assembly Anomalies and Demonstration to Gain Motor Controller Replacement Capability

Authors: Aaron Rodriguez (NASA JSC), Colton Krutilek (S&K Technologies)

55th International Conference on Environmental Systems

ICES-2026-280

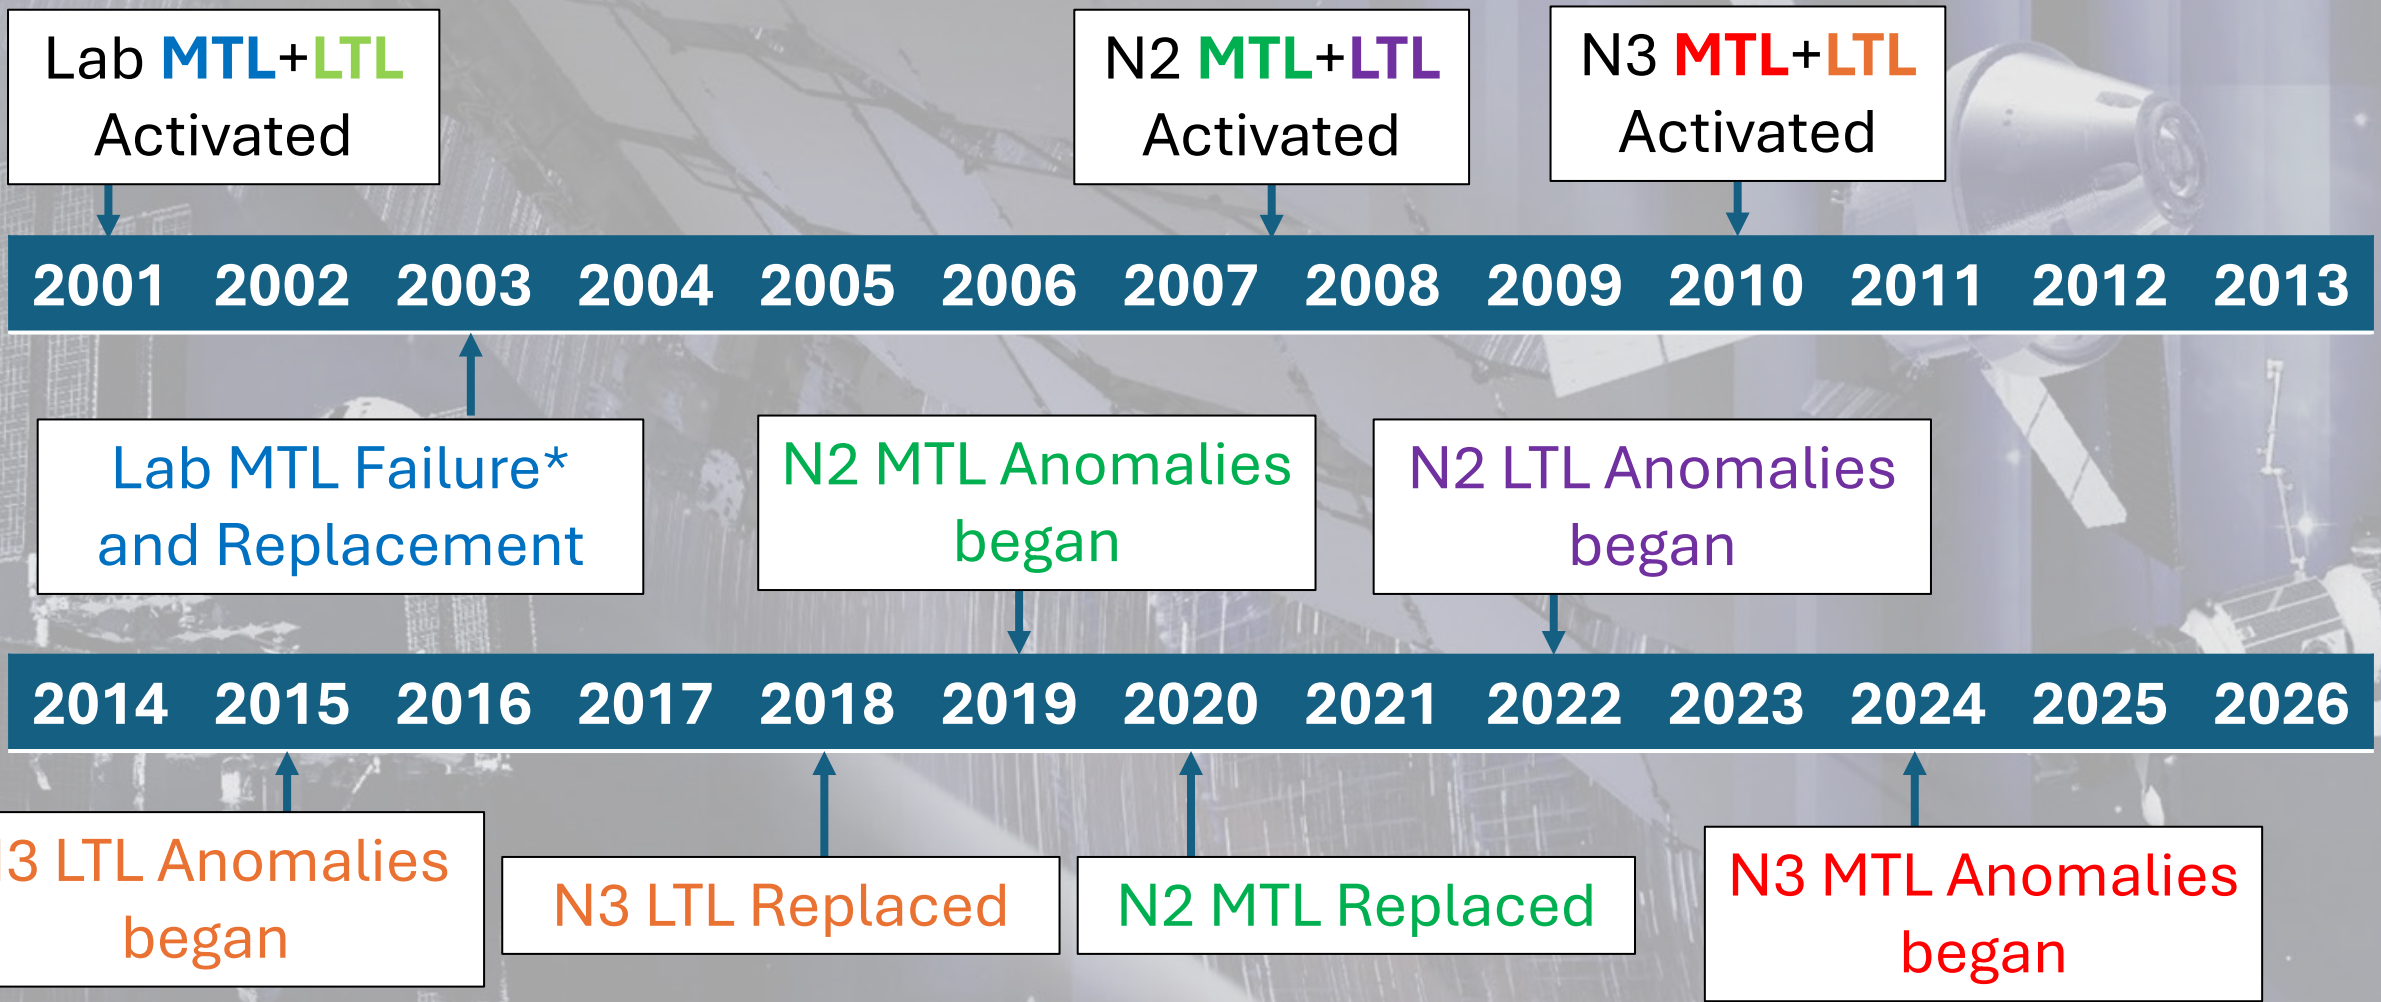
# History of PPA Failures and Anomalies

\*Due to Coolant Chemistry, not covered in paper

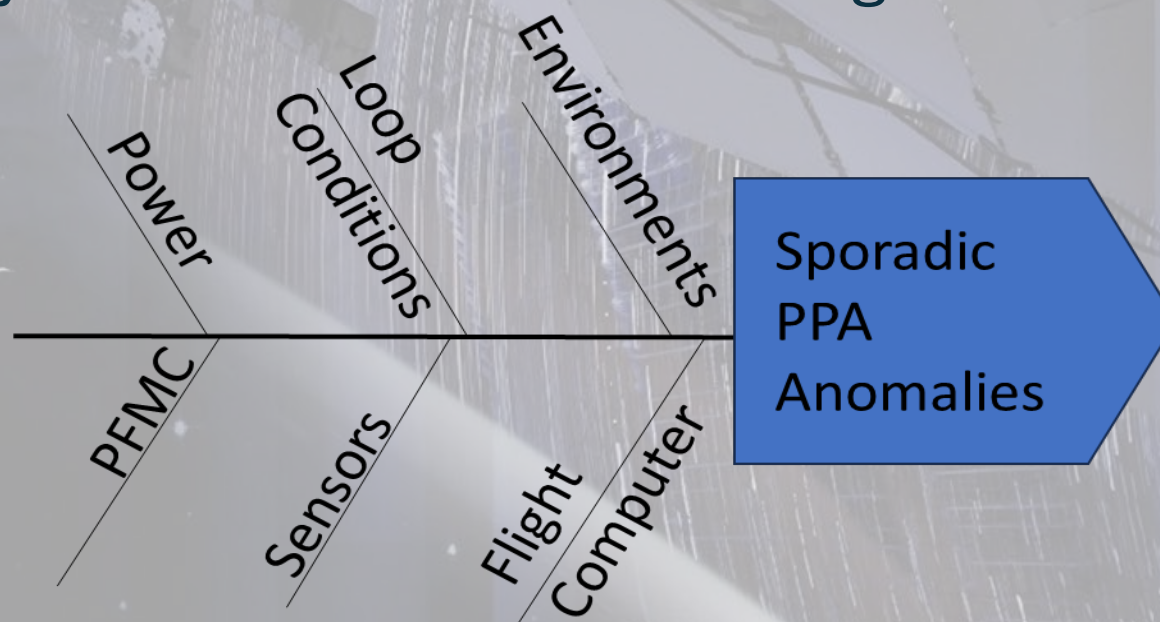
- PFMC has a Built-In Test (BIT) but doesn't always trigger
- 1Hz telemetry is insufficient for capturing highly dynamic events
- Limited troubleshooting techniques
- Limited ability to return hardware to the ground for TT&E
