NASA TECHNICAL NOTE

NASA TN D-563

INVESTIGATION OF S-IV ALL SYSTEMS VEHICLE EXPLOSION

Compiled and edited by J. B. Gayle

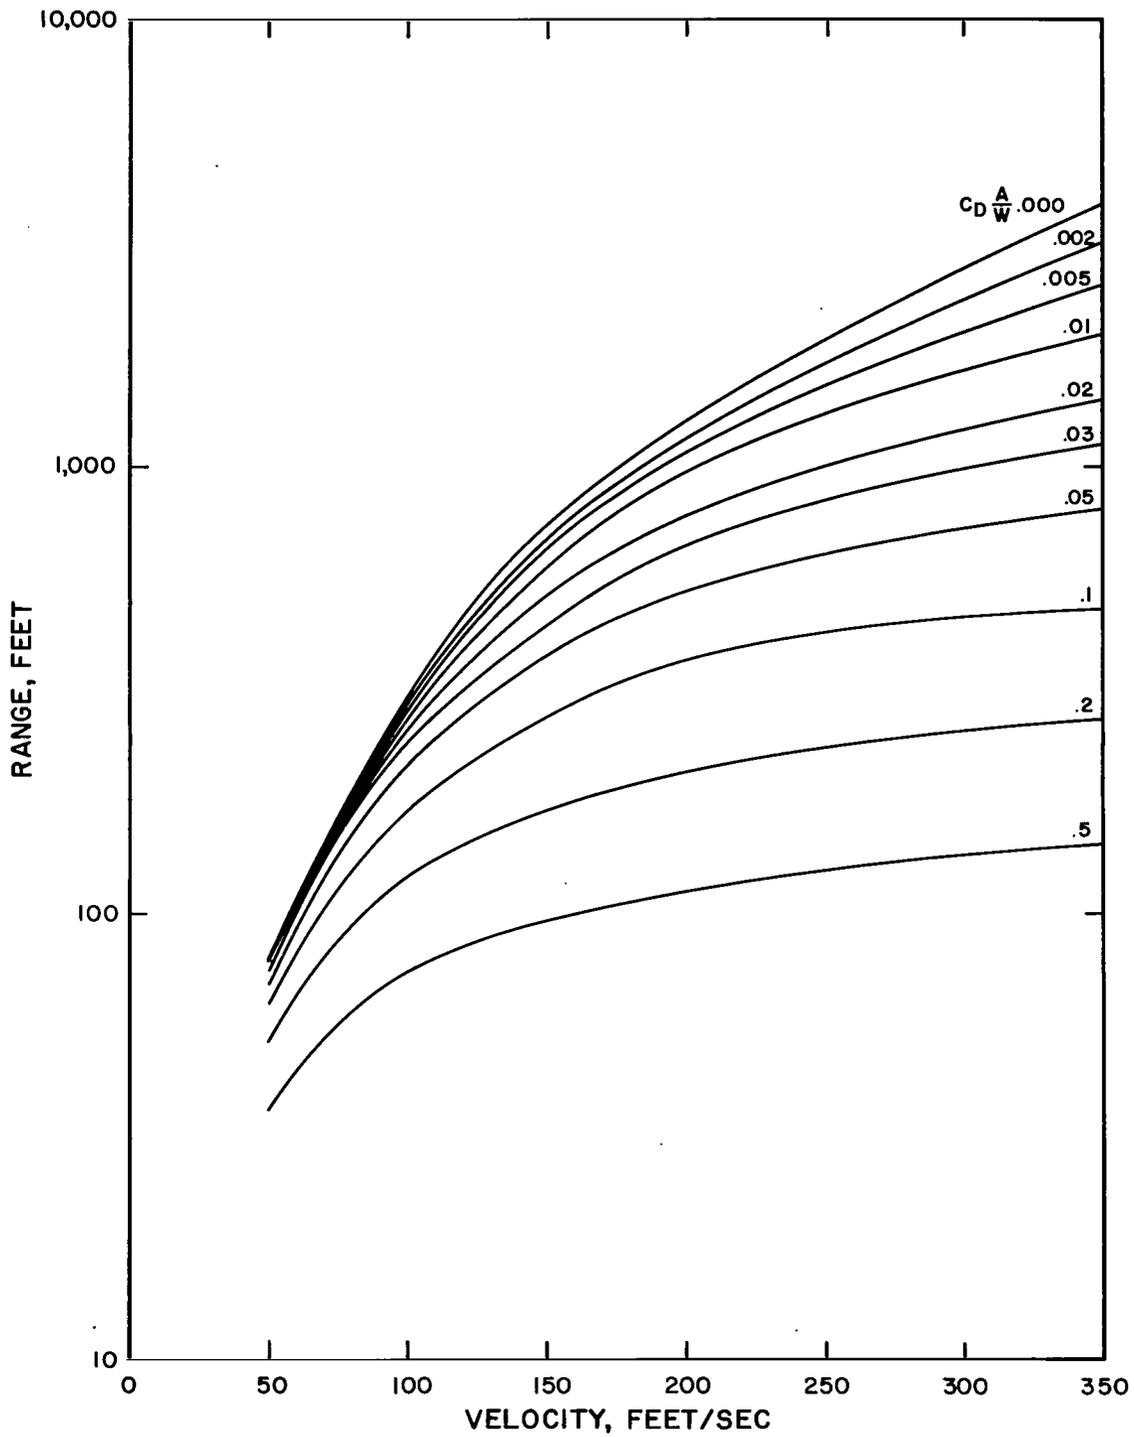
FIGURE 12. RELATION BETWEEN INITIAL VELOCITY AND GROUND RANGE (LOW VELOCITY RANGE)

Figures 12 and 13 indicate the relation between initial velocity and distance traveled for fragments of different drag coefficients, cross sectional areas, and weights using an assumed flight angle of 45°. Table IV gives the identities and pertinent data for selected fragments from the S-IV All Systems Vehicle explosion and initial velocities estimated from FIG 12 and 13.
