NASA TM X-1195

ANALYSIS OF AN EMERGENCY
DECELERATION AND DESCENT OF THE
XB-70-1 AIRPLANE DUE TO ENGINE DAMAGE
RESULTING FROM STRUCTURAL FAILURE

by *Chester H. Wolowicz*
Flight Research Center
Edwards, Calif.

NATIONAL AERONAUTICS AND SPACE ADMINISTRATION • WASHINGTON, D. C. • MARCH 1966

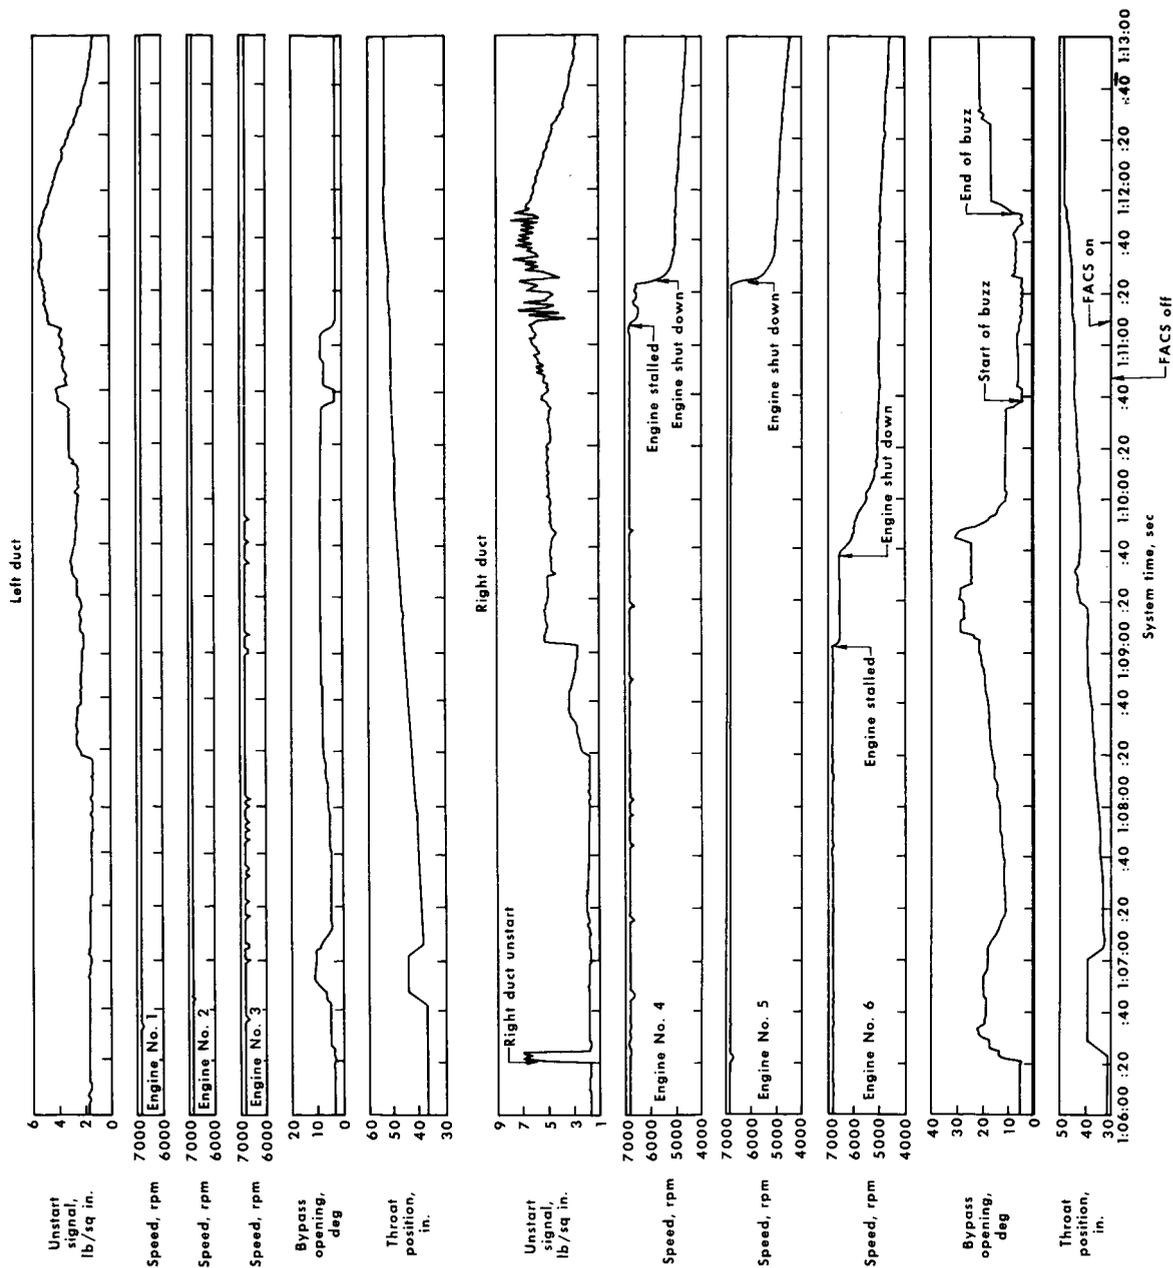
Figure 6. - Time history of propulsion-system performance. XB-70-1; flight 12.

throat. Because of the deteriorated condition of the damaged engines and the consequent reduced airflow conditions, as well as the reduction of aircraft speed, this bypass angle did not provide sufficient opening to restart the inlet. At $M = 2.17$ (time 1:09:18) the unstart signal light went out, possibly leading the copilot to believe that the right-duct inlet had started. However, the light went out because of an automatic disarming of this warning system at $M = 2.17$, even though inlet start conditions prevail down to $M = 2.0$, as shown in figure 2(a). Inability to recover engine No. 6 from the stalled condition subsequently resulted in it being shut down at time 1:09:38 at $M = 2.08$. This was followed by a closing of the right bypass doors to 11° .

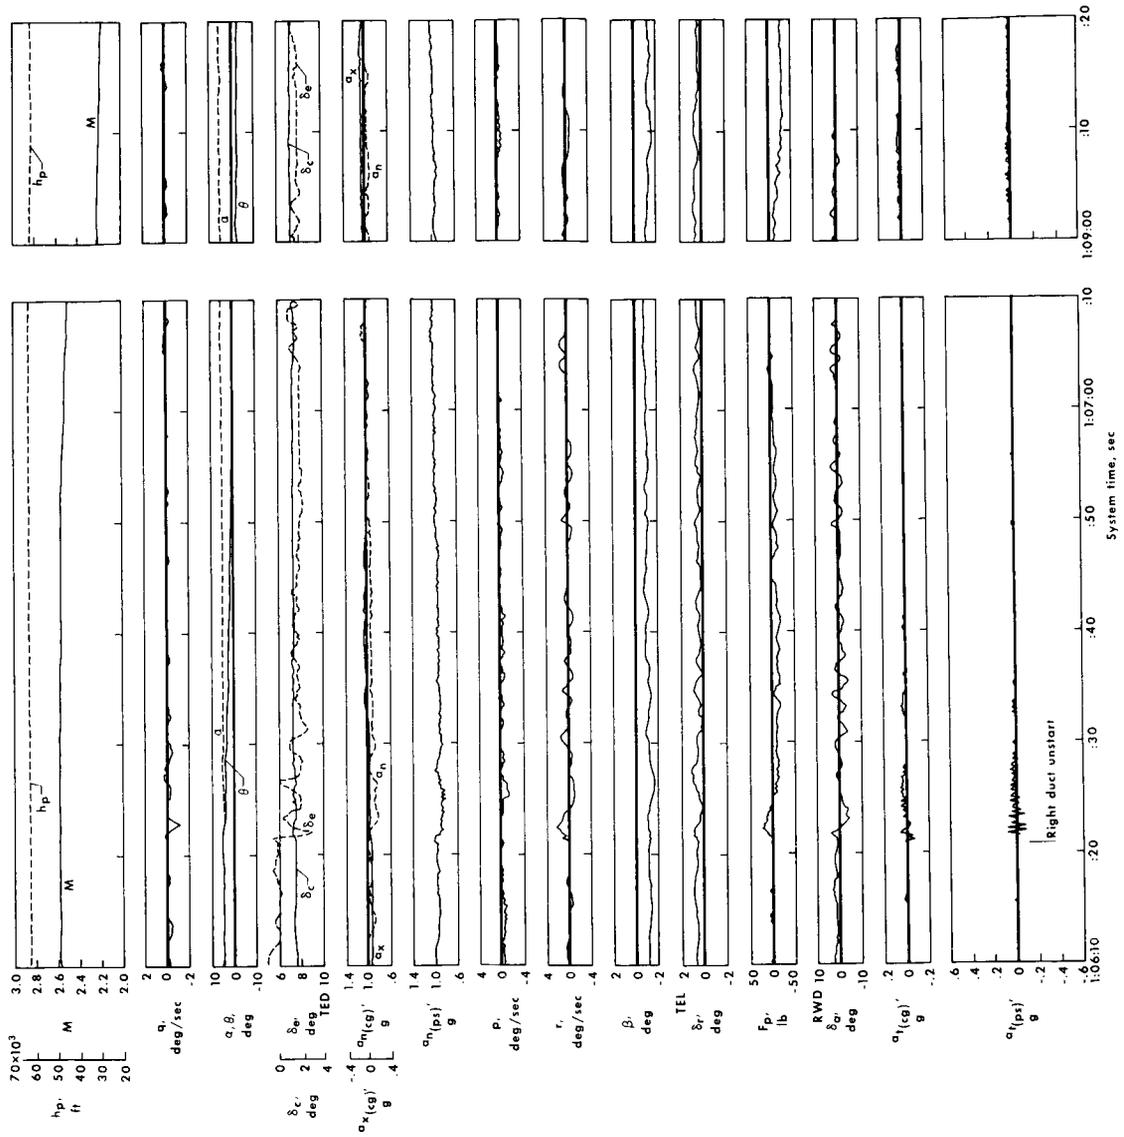
Figure 7. - Time history of aerodynamic aspects. XB-70-1; flight 12.

At the time, and as a result of the unstart, the pilot took counteractions to anticipated pitch and yaw resulting from the unstart (fig. 7(a), time 1:06:21). The disturbances resulting from the unstart, the control inputs, and the change in longitudinal and lateral-directional trim, due to the abrupt opening of the right-duct bypass doors, were brought under control in the following 11 seconds. The trim changes in elevon, rudder, and aileron due to the opening of the right bypass doors can be seen in figure 7(a) by comparing the trim setting prior to time 1:06:21 to that following time 1:06:32. The continuous movement of the control surfaces up to time 1:06:57 is due to the pilot's attempt to manually maintain the vehicle in trim. At time 1:06:57, rudder trim was initiated, as evidenced by decreasing pedal force to maintain rudder deflections required (with $F_p = 0$ lb) to counter yaw moments caused by the overall engine-duct-bypass situation.

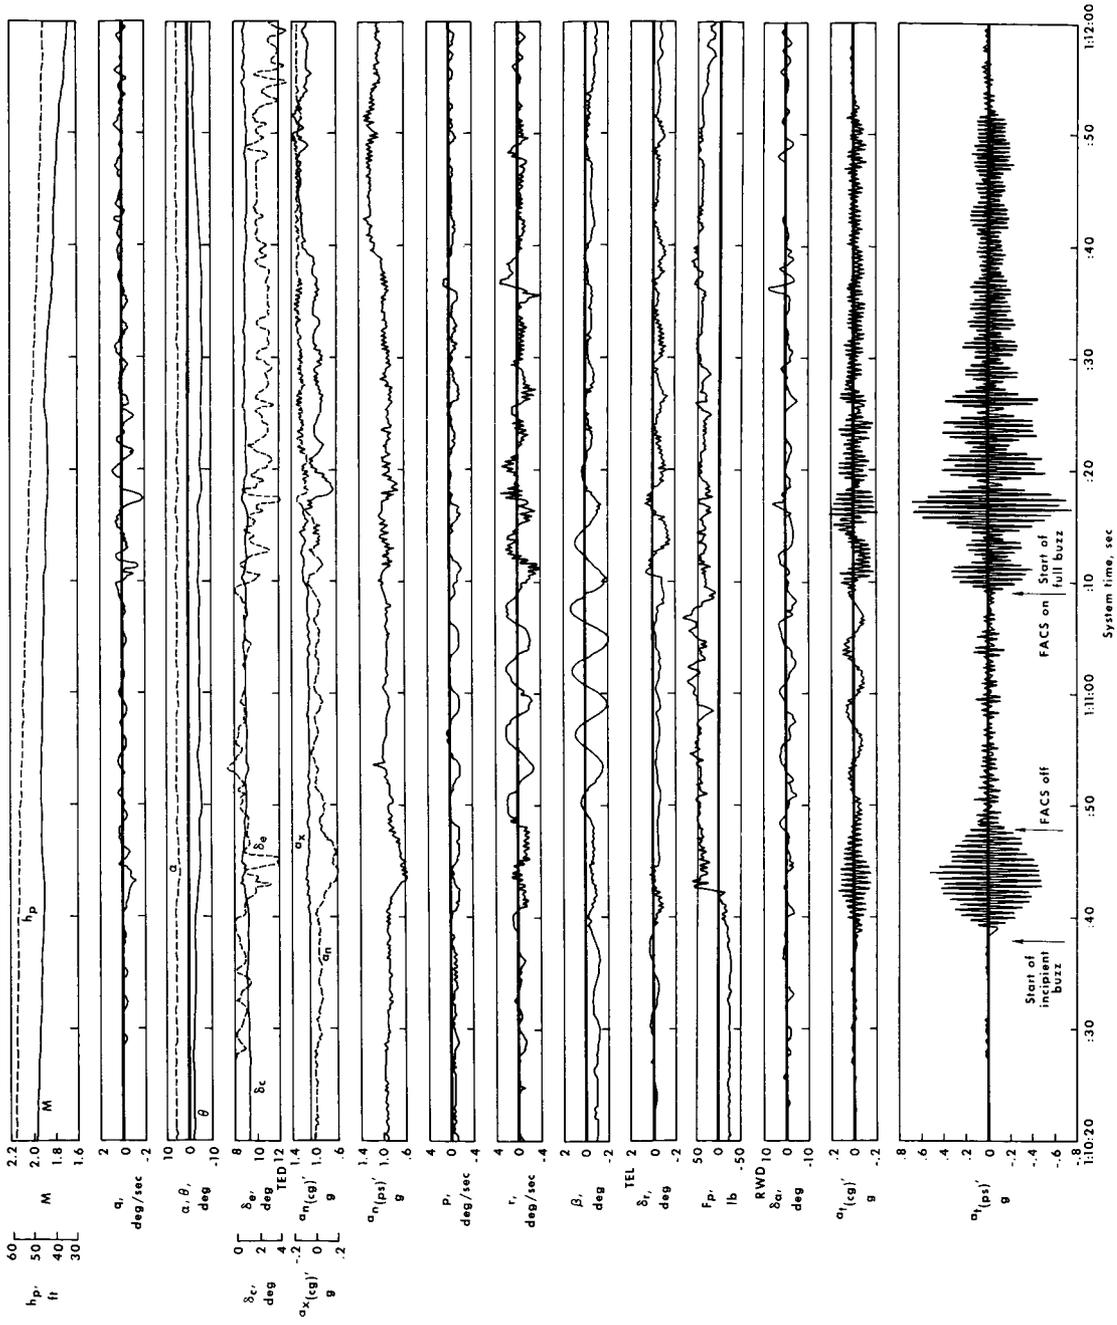
Figure 7. - Concluded.

As the doors were reaching the $4\frac{1}{2}^\circ$ setting, an incipient buzz was encountered which, in turn, induced heavy transverse resonant acceleration vibrations at the pilot's station that built up in amplitude (fig. 7(b)). At time 1:10:44 when the resonant acceleration had built up to $\pm 0.45g$, the copilot opened the right bypass from $4\frac{1}{2}^\circ$ to 6° . This action appeared to have alleviated the magnitude of the vibrations which started to subside and decreased to $\pm 0.1g$ amplitude at time 1:10:48. At time 1:10:48 the FACS was shut off in an attempt to ascertain if the system were contributing to the vibration.

appears to have contributed to the steady-state stall of engine No. 4, which occurred at time 1:11:08. At time 1:11:09, the FACS was turned back on. The closing of the right bypass doors to $4\frac{3}{4}^\circ$ and the steady stall of engine No. 4 forced the inlet into a full buzz situation at about the same time the FACS was turned on, and the mild resonant transverse vibration which was present during FACS-off increased to a peak magnitude of $\pm 0.7g$ (fig. 7(b)). Figure 7(b) shows an irregular beat-frequency pattern in the transverse accelerations. The cause of the irregular beat frequency of approximately 3 seconds is not known. Whether or not this vibration would have built up to the maximum of $\pm 0.7g$ in beat-frequency fashion at the pilot station had FACS been left off is unknown.

One of the most interesting insights into the handling characteristics of the vehicle under the pressures of the emergency occurred during the period of the buzz and severe transverse-acceleration vibrations at the pilot's station which started at time 1:10:38 (fig. 7(b)). At the time the vibration started, the pilot had been holding a 25-pound left-pedal force to maintain trim condition. About 2 to 4 seconds after the vibrations started, the pilot applied right-pedal force to eliminate a left-yaw trend. By maintaining a right-pedal force of approximately 35 pounds, he was able to hold the vehicle in directional trim. Shortly thereafter, at time 1:10:48, the FACS was shut off in an attempt to eliminate the vibrations; however, in doing this, a sideslip was initiated. In attempting to counter this sideslip, the pilot found himself contending with a mildly divergent, 6-second-period Dutch roll oscillation which was primarily a yawing or "wallowing" motion due to the very small value of $C_{l\beta}$ as evidenced by the low $\frac{|p|}{|r|}$ amplitude ratio of approximately 0.50 (fig. 7(b)).

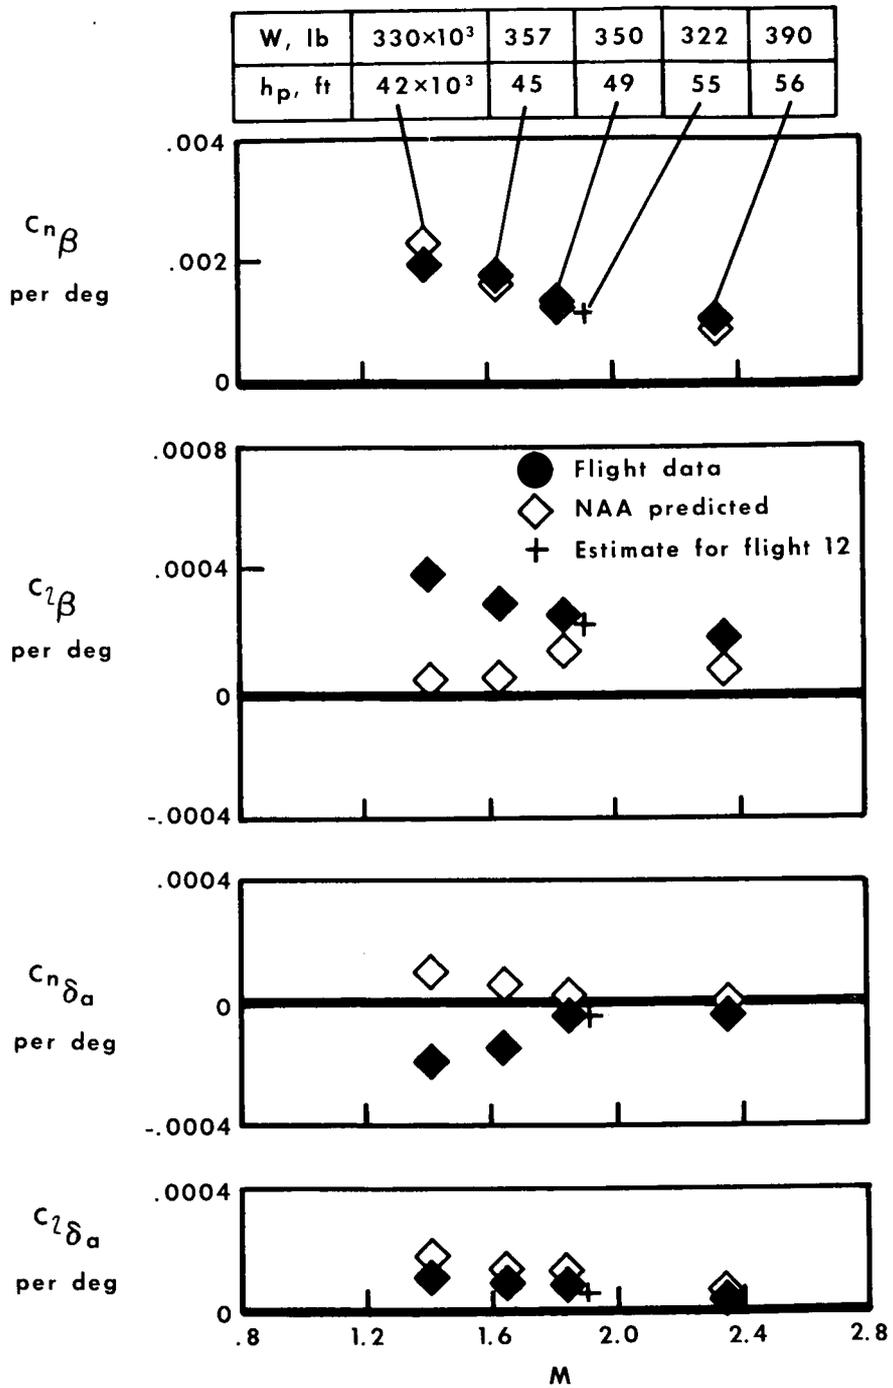
Figure 8. — Comparison of predicted derivatives with derivatives determined by analog-matching of flight data from various flights.

Limited results have shown some serious differences between predicted and flight-determined (analog matching of flight data) values of $C_{l\beta}$ and $C_{n\delta_a}$ (fig. 8). With due consideration to the weight and altitude of the aircraft for the data shown in figure 8, the values of the derivatives pertinent to equation (1) for the divergent oscillation ($M = 1.9$) were estimated--on the basis of the flight data--to be of the order shown in the figure by the crosses. Pertinent values of the moments and products of inertia were supplied by the manufacturer. Substituting all pertinent values into equation (1)

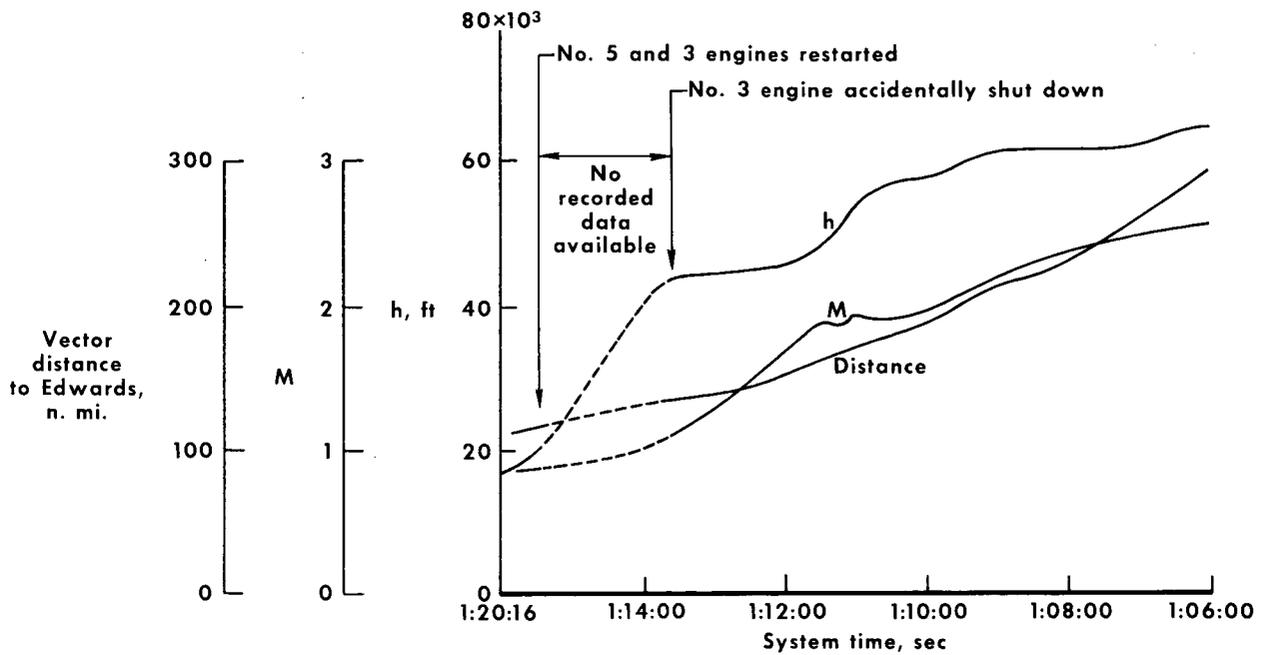
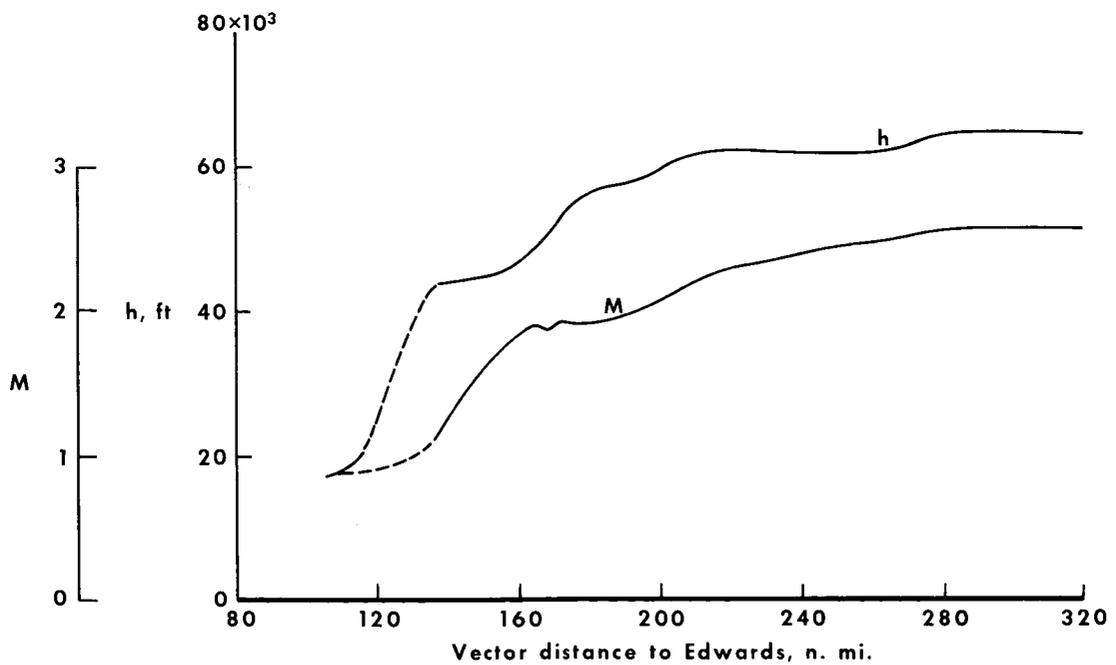
Figure 9.— Time and distance histories of altitude and Mach number for emergency portion of flight. Data based on NASA radar.

subjected to a 24,000-foot decrease in altitude from 44,000 feet in the 1 minute 40 seconds that followed and before the restart of engines No. 5 and No. 3 (fig. 9). In this same time period, Mach number decreased from 1.07 to 0.87 and the airplane traveled approximately 18 nautical miles (fig. 9). This represents an average rate of descent of 14,400 feet per minute or an average glide angle of 12.3°. The crew believes that, had a restart of No. 5 and No. 3 engines not been successful, they could possibly have reached their home base (Edwards) on the two remaining engines at the time they pulled out of the descent.

Slight discrepancies in the time history of the pressure altitude in figure 7 exist in comparison with the altitude time history shown in figure 9, obtained from NASA radar data. The discrepancy is not considered important for the purposes of this analysis.
